# THE CONSERVATION OF A NINETEENTH-CENTURY SIDEBOARD TABLE

by Deborah Bigelow\* and Tamsen Fuller\*\*

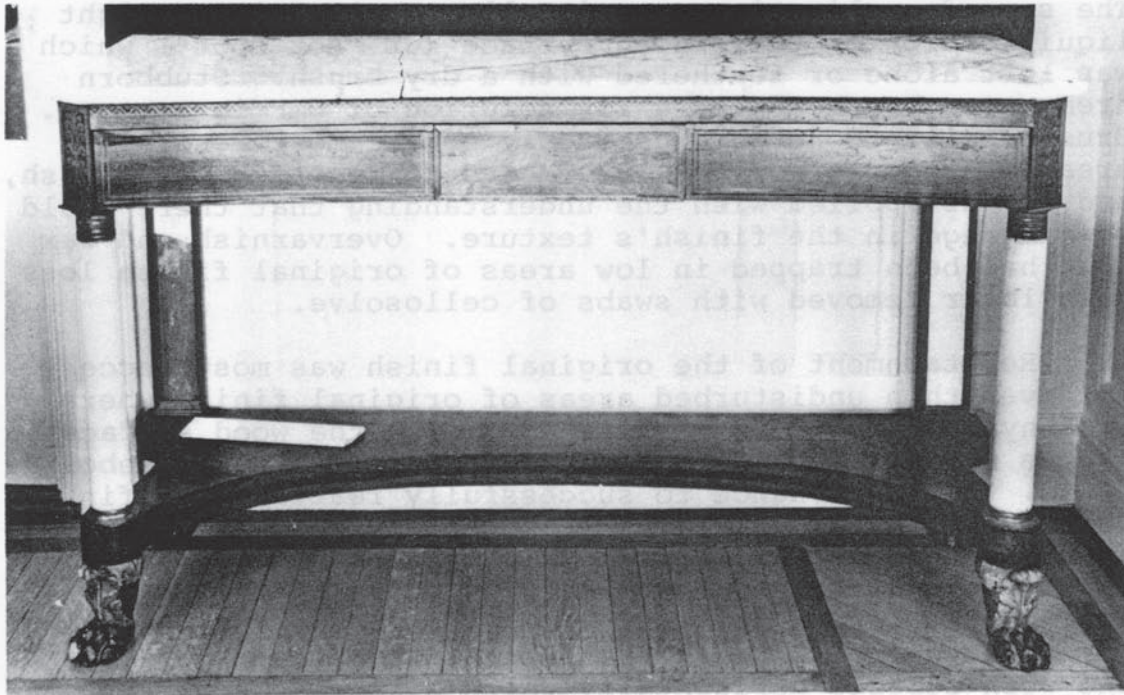
Visual examination and solvent tests established numerous problems with both the substrates and the surface coatings. The carcass was loose at several joints, and there were splits in the boards used to make the top and the platform. Sections from the top moulding edge were missing above the canted corners, while the remainder of the moulding was extensively worn with numerous small losses. A flat moulding section was also missing from the center drawer. The drawers' mahogany runners were worn; several had been previously repaired. The top's maple medial braces had suffered extreme wear.

The marble top was broken into two pieces, on a line roughly perpendicular to the long axis. One major chip, approximately 3/4-inch wide, and a number of smaller chips were missing along the break. The breaks were also soiled and abraded from subsequent handling. In the absence of any contused area indicating that the marble was struck by a falling object, it was concluded that the slab probably broke under its own weight while being carried flat rather than on edge. The proper right marble pilaster had two breaks which were seriously discolored, and the pieces, after having been repeatedly reglued into the wood channel, were held in place with masking tape. Both front marble columns were faintly and unevenly discolored with chips, scratches and other abrasions visible across their polished surface. The extant brass-and-veneer inlay had an extremely dark patina over which were the remains of a deteriorated spirit varnish coating. Streak marks down the surface of the proper left foliate brass pattern resulted in an uneven appearance of light and dark areas. The ormolu capitals and base rings had a discolored coating with thick accumulations of dirt in the design crevices. The lacquer coating on the bronze-vernici abaci was discolored with the presence of several corrosion-products in areas across its surface. The faux-rosewood finish on the top's moulding edge was chipped with numerous losses. The surface coatings on both the gilded and the painted areas of the paw feet were dessicated with deep crack patterns in the gesso, serious cleavage and losses throughout the layers. The coatings on the front feet bore evidence of accelerated deterioration due to the reaction of uric acid with the upper layers of paint and gold leaf.

There were areas of extensive finish loss (e.g., around the edge of the platform). Most losses, however, were more random in nature and resembled missing pieces from a finish puzzle. From the opaque yellow color, in addition to the nature of the losses, it was concluded that the finish had lifted away from the wood substrate and was holding itself together as much as it was being held to the wood's surface. A restoration coat of pigmented spirit varnish had been brushed over the deteriorated original finish on the platform and across the top from under the edge of the moulding edge to and including the drawer fronts. A second restoration occurring only on the front of the top, involved the removal of the first two finish layers and was followed by an application of padding lacquer and wax. The second restoration stopped, abruptly, midway across the top in the middle of the center drawer.

**Sideboard Table. Before Conservation. (Photograph by John Parnell.)**

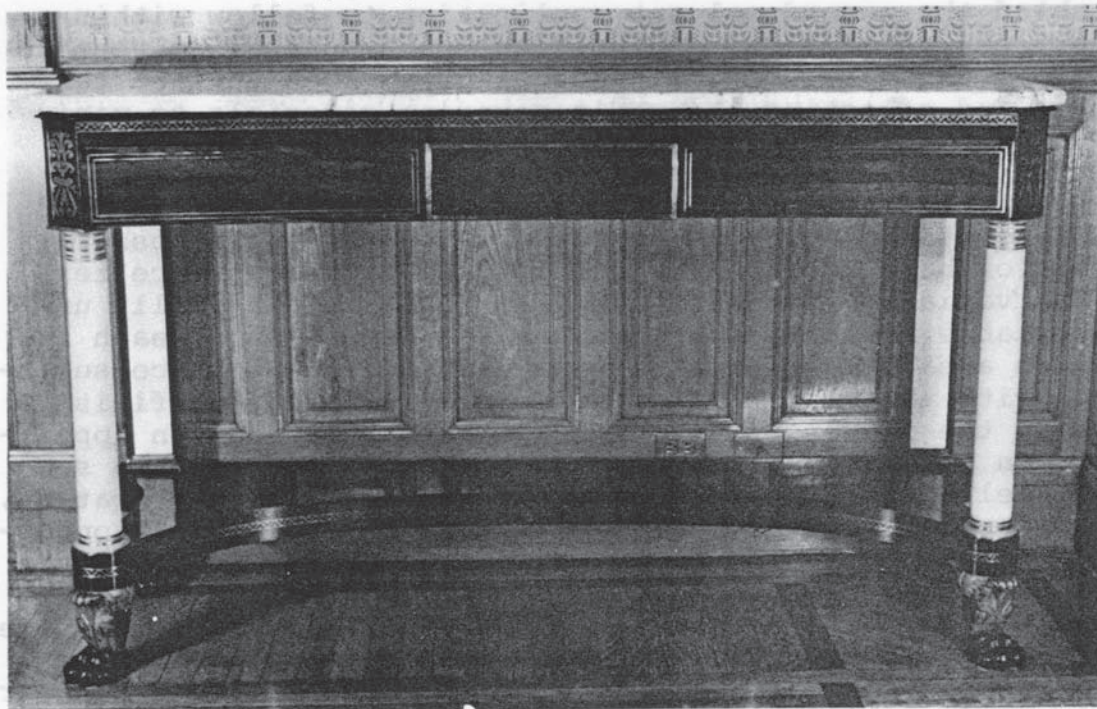
**Sideboard Table. After Conservation. (Without marble top.)**

At this writing, treatments on the substrates, metals, paw feet and marble pilasters and columns have been completed, permitting reassembly of the table in the client's home. Only the conservation of the marble top remains. The treatment regimen which will be carried out includes: cleaning the break sites with organic solvents to remove grease and dirt; manipulating the slab halves on a support to insure alignment; devising a clamping system for use with the mending adhesive (a white knife-grade Akemi polyester resin which will be tinted to a neutral color) to bring the broken edges tightly together; and using solvents and mechanical paring tools to remove excess resin.<sup>16</sup> After curing overnight, the marble will be turned over and reinforcing strips of an epoxy-impregnated fibreglass material will be applied along the join. Left overnight, the marble will be turned face-up and final cosmetic work such as sanding the polyester and inpainting and filling the loss with pigmented wax will be undertaken. The marble top will then be placed on the sideboard table.

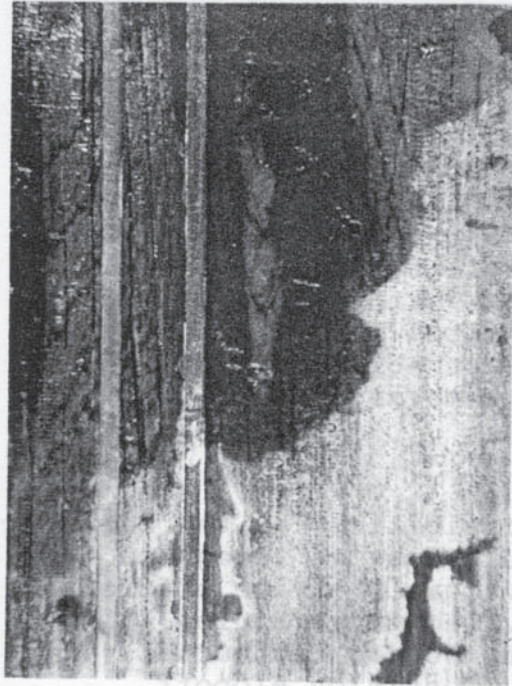
**Finish reattachment with butyl cellosolve. In Progress.**

Tests with ethyl alcohol, dimethylformamide (DMF), ethylene glycol monoethyl ether (cellosolve), ethylene glycol monobutyl ether (butyl cellosolve) and mixtures of ethyl alcohol, DMF, cellosolve and acetone (varying the number and concentration of chemicals in solution and their sequence and method of application) were conducted over areas of original finish and areas where the over-varnish had been removed.<sup>18</sup> The best solvent sequence was an initial padding with butyl cellosolve followed by pouncing the finish areas with a second application of the same solvent (necessary due to the resistance of the finish which has been attributed to an, as yet, unidentified component of the spirit varnish) within five minutes of the first.<sup>19</sup> Allowing the finish to dry thoroughly before applying the second solvent was found to minimize its effectiveness. The surface was rubbed firmly during the first application and pounced vigorously during the second with a moderately wet pad. Immediately after the first solvent application, a color change was evident and increased in depth within minutes. There was no change to the finely crazed pattern (i.e., texture) of the finish. The second application occasionally resulted in a slight liquification of the finish surface (or “hot spot”) which was left alone or feathered with a dry brush. Stubborn areas were brushed with a 25% solution of DMF in acetone. Brush applications were used only on the most resistant areas where more solvent was needed to reattach the finish, and it was applied with the understanding that there would be a change in the finish’s texture. Overvarnish and wax that had been trapped in low areas of original finish loss were later removed with swabs of cellosolve.

Reattachment of the original finish was most successful over thin undisturbed areas of original finish where its physical bond was most tenuous with the wood surface. As was discovered during the conservation of the sideboard table, the best chance to successfully reattach the finish occurred with the initial solvent application. Variables in the method of application which affected the success of the procedure included: heating areas of original finish just before applying the reattachment solvent which was observed to increase the rate of reaction; positioning the work surface horizontally which allowed for better solvent control and the use of greater pressure during solvent application; applying the solvent with a pad which facilitated the use of force during the procedure and enabled the second solvent application to follow within a short period of time; controlling the amount of solvent in the pad which ensured maintenance of an even surface texture; and selecting the pad’s covering materials to minimize lint and dust from sticking to tacky finish areas.

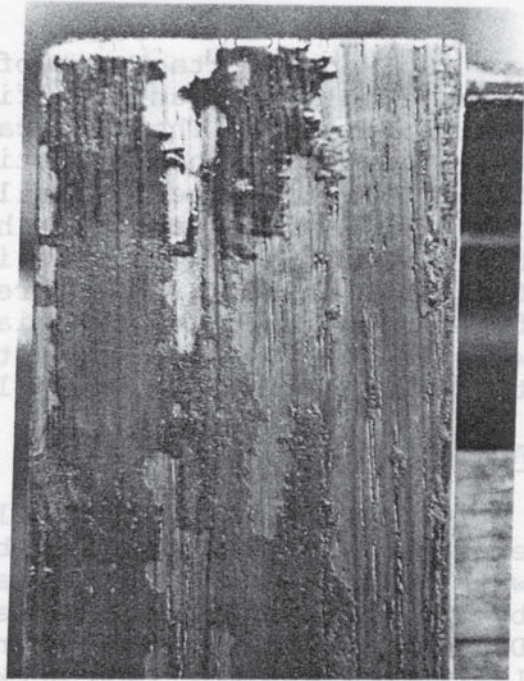
**Finish amalgamation with DMF (top half) versus finish reattachment with butyl cellosolve (bottom half).**

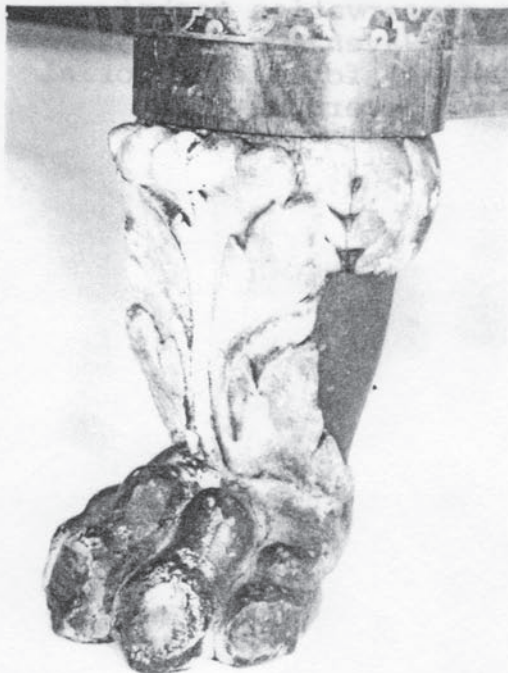
tion. The end grain of the front feet was discolored and slightly spongy as the result of moisture retention caused by the presence of salts left by what was identified as urine.<sup>5</sup>

Choice of a conservation treatment also had to address the discovery of the presence of salts in the wood of the front feet. With relative humidity above 60%, the feet smelled strongly of urine, the exposed wood surfaces felt wet and sticky, and the paint and gold layers also felt damp. Where urine had run down the glazed oil-gilt surface, the strata were especially dessicated and crumbling away from the substrate. After consulting with conservators, organic chemists, a wood scientist and an urologist, the feet were “dried out” by lowering the relative humidity to between 30% and 40%. The affected area was next treated with materials chosen for their ability to inhibit moisture from penetrating to the wood substrate, to consolidate the lifting strata and to provide a compatible interface with the proposed method for augmenting the losses.

**Gilt and painted Paw Foot.  
Before Conservation**

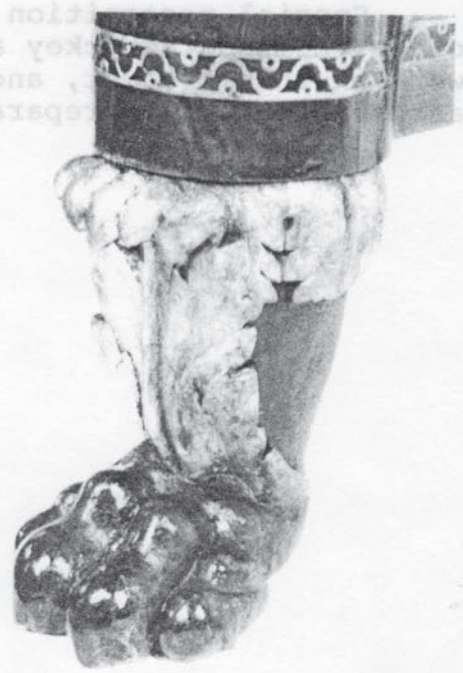
**Gilt and painted Paw Foot.  
After Conservation.**

After cleaning the feet with swabs of stoddard solvent to remove surface dust and dirt, three coats of a 15% solution of Acryloid B-72 in diethylbenzene were brushed over the surface and injected under lifting areas of paint.<sup>12</sup> Following each application, the surface was allowed to dry and was then pressed back to the substrate with a warm tacking iron. A wax mixture (9 parts beeswax/ 1 part carnauba/1 part microcrystalline: Multiwax X-145A) with the addition of dry powder pigments to approximate the surface color was applied hot with a brush to fill the most prominent losses. The fills were then shaped (micro- spatula), smoothed (fingernail and solvent cloth) and distressed (scalpel). 24k gold powder was lightly dusted over the wax, and, following a sealer coat of the same acrylic resin, inpainting proceeded with a series of tinted varnish glazes.<sup>13</sup> Any areas that were too glossy were abraded gently with fine steel wool, and a final coat of Renaissance wax was applied to all four feet.

Using the same technique, the leaves were stabilized with from one to three coats of a 15% solution of Acryloid B-72 in ethyl alcohol. Only obtrusively dark areas were cleaned with swabs of a very thin solution of shellac in denatured alcohol and were then recoated with the acrylic solution. With the addition of a small balsa wood wedge support to the front of the proper left leaf tip, wax (9 parts beeswax/1 part microcrystalline) was mixed to color, applied to fill the major losses, shaped, smoothed and distressed. After sealing the wax with a brush coat of 20% Acryloid B-72 in diethylbenzene, the most prominent fills were oil-gilded with 22k gold leaf over japanner’s quick size. The sharp edges of the new leaf were blended with a swab of stoddard solvent, and inpainting and toning then proceeded as described above. The end grain on the bottom of each foot was sealed in two steps: Butcher’s wax applied hot was readily absorbed into the wood and was followed by a hot mixture of beeswax and carnauba wax (3 parts/1 part) which was ironed-on to both penetrate and seal the wood’s surface.<sup>14</sup>
