# ACETONE-ROSIN TREATMENT FOR WATERLOGGED WOOD

by Brian R. Howard\*

A brief review and assessment of an Acetone-Rosin treatment of a waterlogged nineteenth century coffin from the First African Baptist Church Cemetery excavation; treated in 1985.

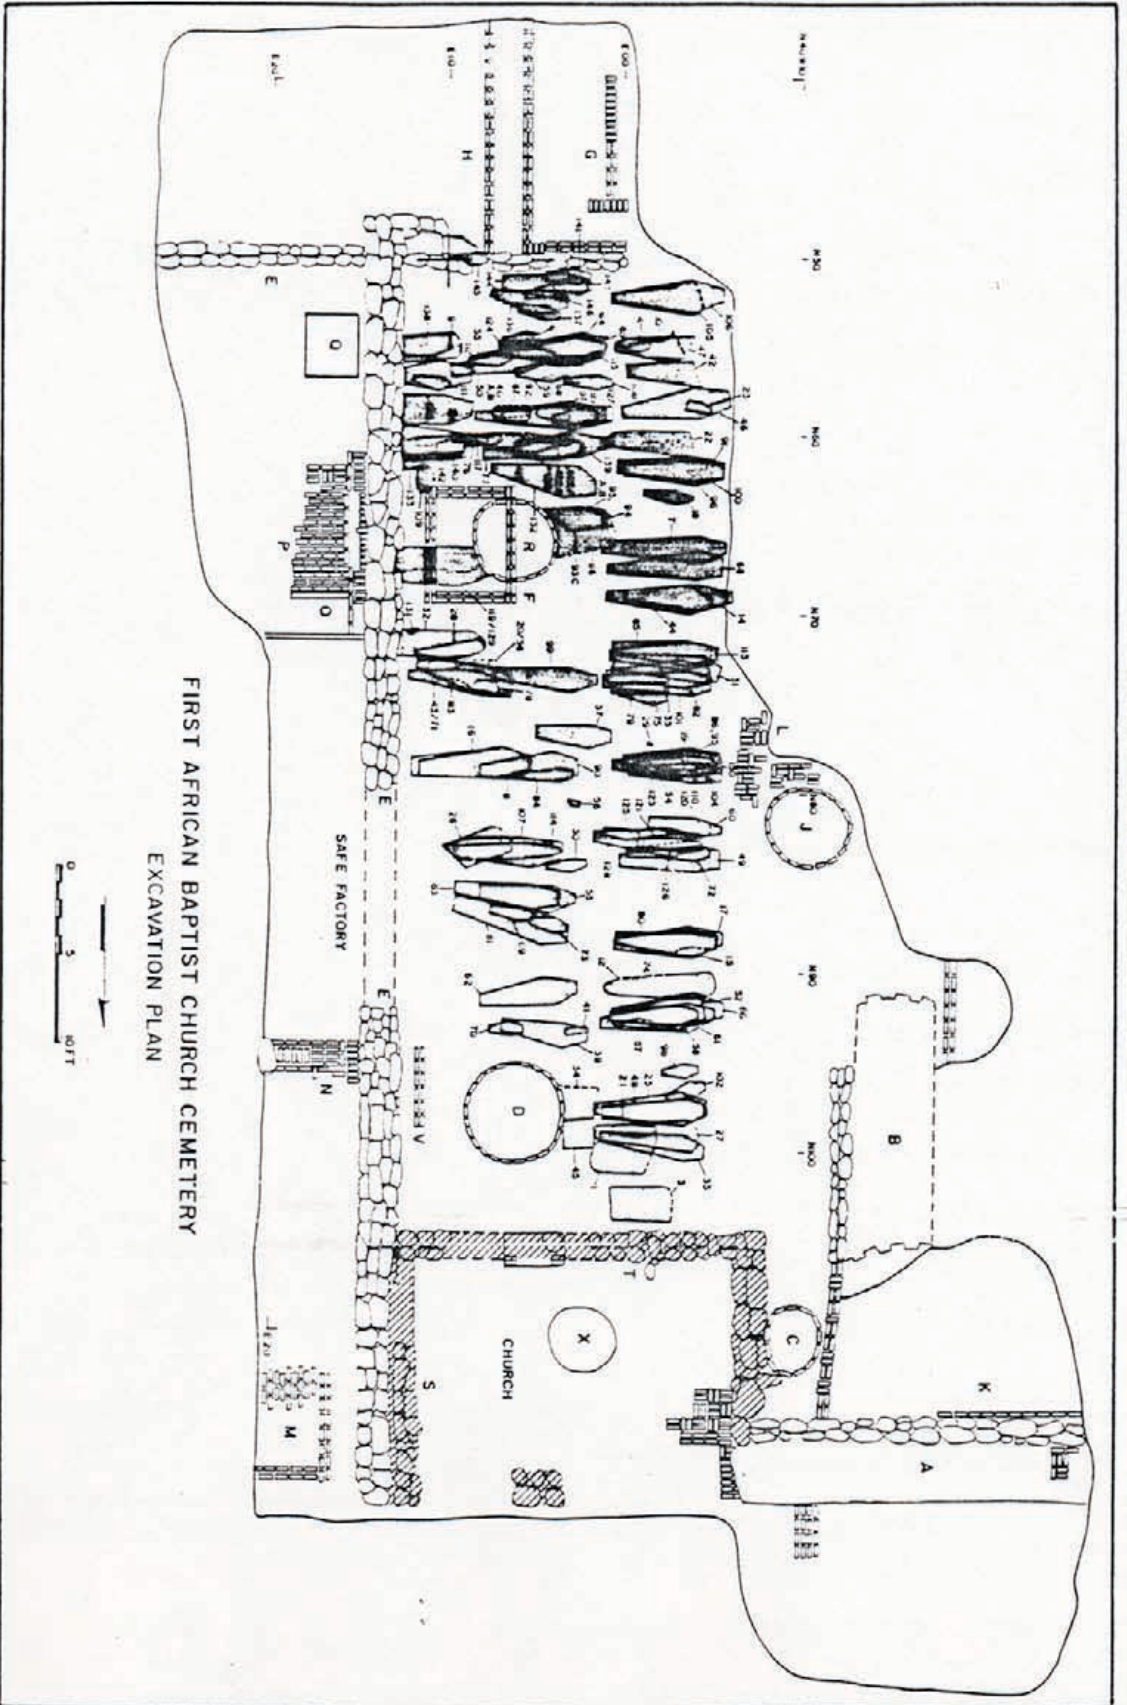
Site Plan Showing the Location of All Excavated Features  
 John Milner Associates

Certainly, the burial ground of the First African Baptist Church, was not nearly as crowded as that previously described; however, the site plan shows that multiple burials in a single grave pit existed. (See figure 1).
