COUNTERACTING WARPAGE IN WOODEN OBJECTS: TWO NEW APPROACHES

F. Carey Howlett, Conservator of Furniture, The Colonial Williamsburg Foundation, Williamsburg, VA 23187

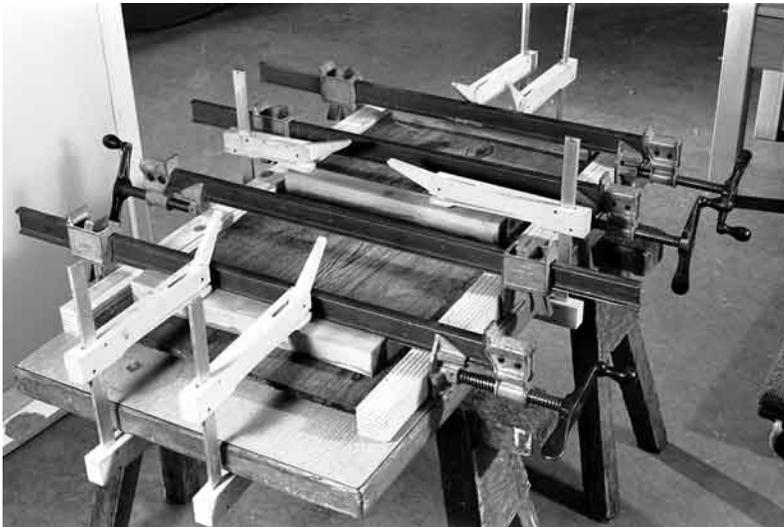
Figure 3. Inducing compression set shrinkage in the convex side of a warped yellow pine board (Case Study 1). With the water-saturated convex side facing up, cam clamps apply light downward pressure on the warp while optional bar clamps restrict cross-grain expansion.

their convex curves up. With the long cauls in position alongside the board's edges, three bar clamps were then placed across the assembly and lightly adjusted to hold the cauls against the board. *Note:* No force was used to tighten the bar clamps, as their purpose was solely to resist the impending expansion of the formerly convex surface, not to compress it in its relatively dry condition. (fig. 3)

5. The convex face was saturated with warm water. The three upper curved cross-battens were immediately positioned above their counterparts. Deep-throated wooden cam clamps were then applied with sufficient pressure to reduce the warp of the board to the shallower curve of the cross-battens (fig. 3).

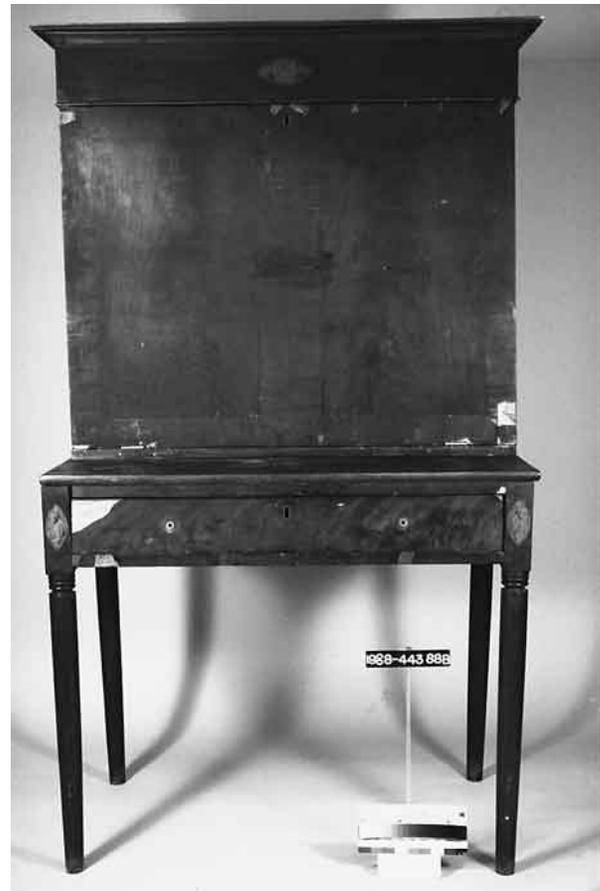
An early 19th century writing table and bookcase made in Richmond, Virginia entered the collection at Colonial Williamsburg in extremely deteriorated condition, with its worst problem a severely warped and split fallboard (*Fig. 4*). Because of severe structural failure associated with the warpage, the fallboard was an ideal candidate for an experimental warpage reduction treatment using glycol.

A large split (as much as 3 mm across) ran the length of the board at its mid-section, completely

Figure 4. Early nineteenth-century Virginia writing table and bookcase before treatment; fallboard dimensions: 64.8 cm. W X 48.6 cm. H X 2 cm. thick.

dividing it into two independent members and disrupting the face veneer. Several smaller splits ran from either end but stopped short of the center. On either side of the large split, the veneered face developed pronounced convex warps, and the shorter splits partitioned each half into smaller, less-pronounced convex divisions. A straight-edge placed across the entire width of the fallboard showed deflections as great as 6 mm.

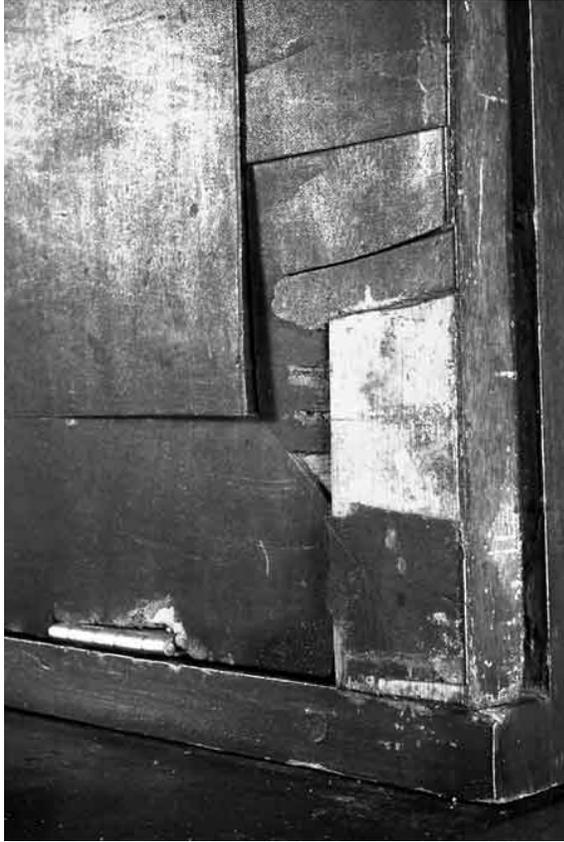
The severe warpage of the wide pine board overcame the restraint of the battens, splitting both of them. The lower end of one batten projected 6 mm from the surface of the fallboard (see *Fig. 5*). The other batten incurred a ten inch split near its midpoint which projected 4 mm above the adjoining surface. Because of these and other structural problems, veneer was fractured, detached, and

Figure 5. Close-up of a projecting batten and associated veneer damage on the warped fallboard in figure 4, before treatment.

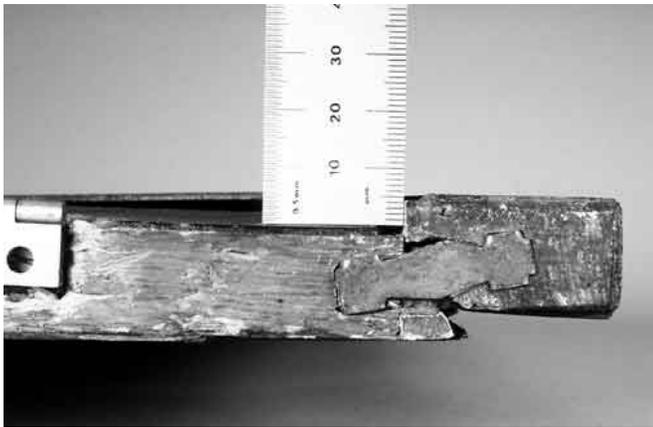
Figure 6. Edge view of the projecting batten in figure 5, significantly out of plane with the warped pine fallboard before treatment. A handyman made a vain attempt to realign the parts with a strap-nail.

missing in many areas. In addition, the deformation broke the hinges (old replacements) out of their mortises, rendering the fallboard entirely non-functional. Realignment of the structural members, repair of the veneer, and reattachment of the fallboard to the desk were impossible using standard techniques (*fig. 6*).

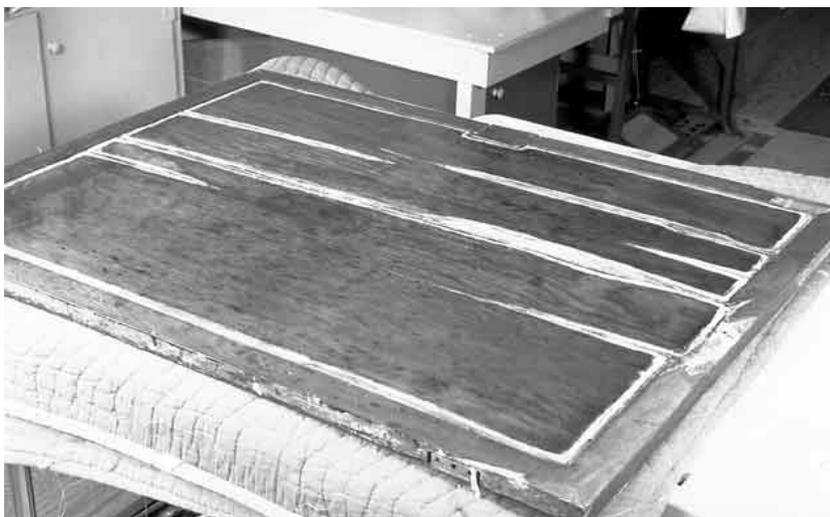
Figure 7. Treating the writing surface of the fallboard with a glycol/water solution (Case Study 3). Paraffin dams prevent the solution from wetting the veneer edgebanding or entering the splits.

4. The towels were removed and a 25% solution of DPG in water was applied in a thin layer over the entire writing surface. The surface was again covered with plywood and polyethylene sheeting, and the treatment checked twice a day for the following month. Small amounts of solution were added as necessary, and water alone was added on several occasions to prevent the return of the warp (*fig. 7*).

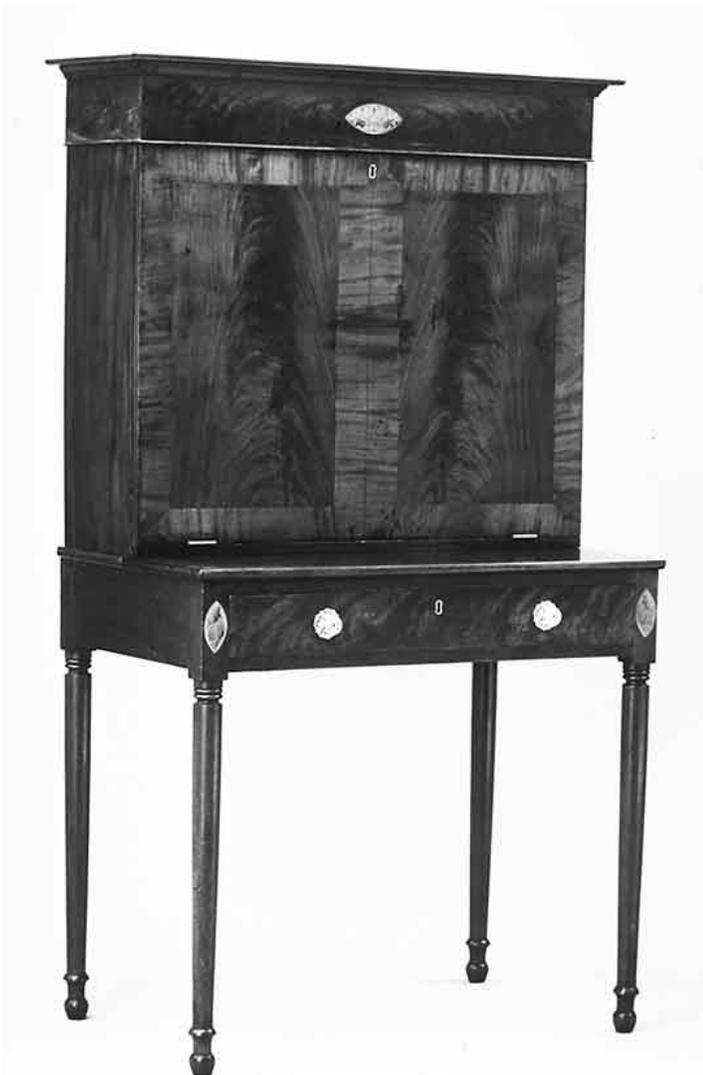
Since 1990, the writing table and bookcase has been on exhibit in the Dewitt Wallace Decorative Arts Gallery at Colonial Williamsburg (see Fig. 8). Its condition appears stable more than five years after treatment, though slight increases in warpage are apparent in some areas, and the widths of splits on the writing surface (which had narrowed significantly after treatment) have widened slightly. These changes are probably an indication of the evaporation of dipropylene glycol, and the fallboard will eventually be retreated with less volatile polyethylene glycol.

Figure 8. The writing table and bookcase (Case Study 3) on exhibit following treatment. The object is exhibited closed at all times: the treated writing surface on the interior remains bare to permit monitoring.

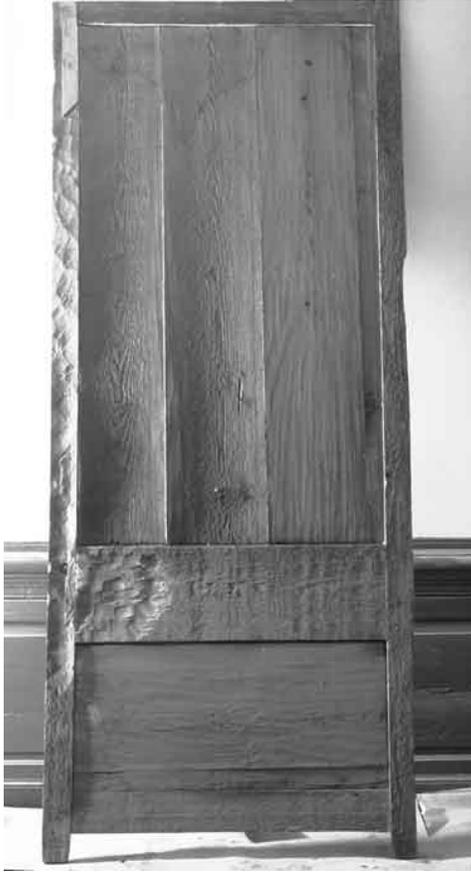
When Colonial Williamsburg's Brush-Everard House was closed for renovation of its mechanical systems in early 1995, a section of warped and damaged yellow pine raised panelling from the house's parlor was removed for repair. The floor-to-ceiling painted panelling, covering a side of the chimney breast projecting into the room, exhibited severe warpage on two of the boards comprising a large panel above the wainscot. The warpage, convex on the painted face of the boards, apparently resulted from compression set shrinkage of the reverse (*fig. 9*), probably brought about by periodic dampness associated with the chimney.

Figure 9. *The reverse side of the warped architectural woodwork removed from Colonial Williamsburg's Brush-Everard House (Case Study 4). Raking light reveals significant warpage to boards in upper panel.*

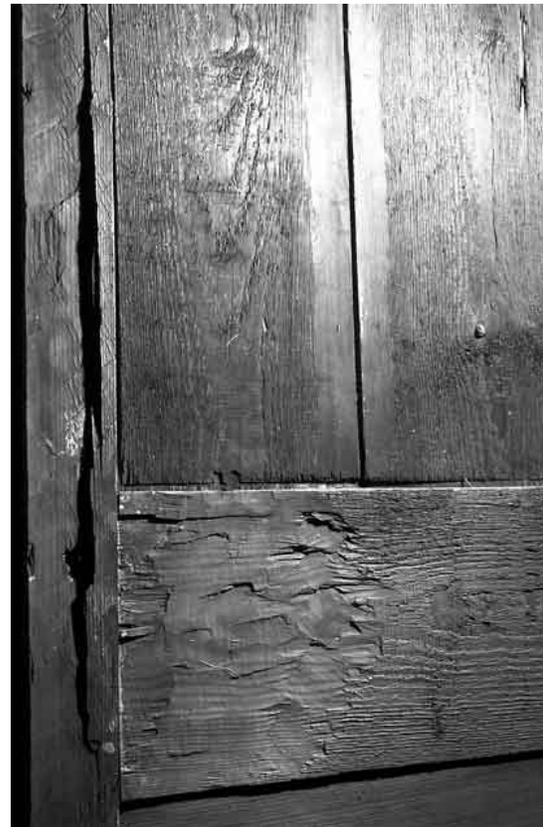
The force of the panel's warpage broke through the backside of the supporting frame, where a stile and a rail were already weakened by original adze-chopped clearance for the brick chimney (*fig. 10*). Previous attempts to repair or disguise this damage included an 8 mm putty fill in the resulting gap on the front face of the woodwork (*fig. 11*). Because of the frame damage and the unsightly fill, the following treatment was carried out to reduce the warpage of the painted panels. This treatment utilized polyethylene glycols 300 and 600 (Sigma Chemical Co., P.O. Box 14508, St. Louis, MO 63178) to ensure long term effectiveness.

Figure 10. *A close-up of damage on the reverse caused by the force of the warping panel (Case Study 4). The stile and rail were initially weakened by early adze cuts which provided chimney clearance for the panelling.*

8. While the warped boards were undergoing treatment, repairs were made to the damaged stile and rail. The uneven areas of greatest weakness on the reverse of each were reinforced with a carefully fitted 5 mm pine backing.

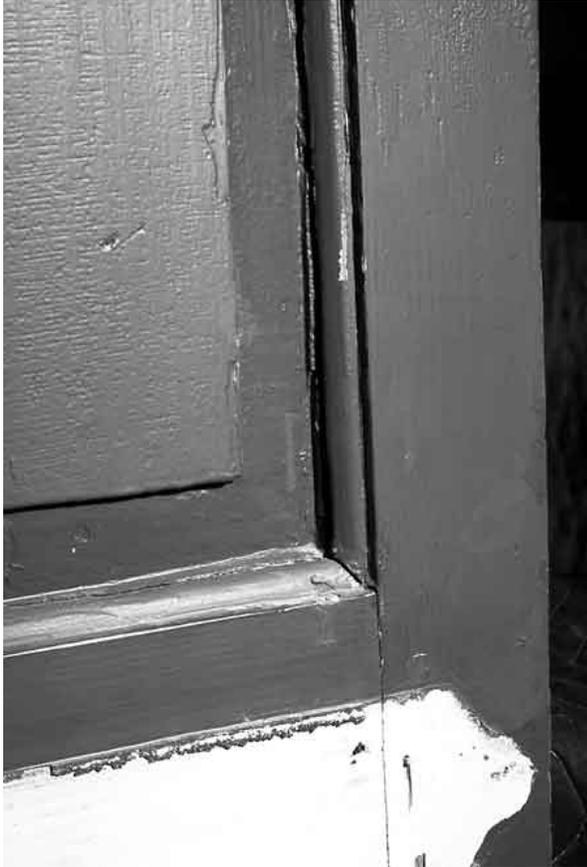
Figure 11. The face of the painted panel opposite the damage illustrated in Figure 10. A large, tapered putty fill bridges the gap between the warped panel and the rail.

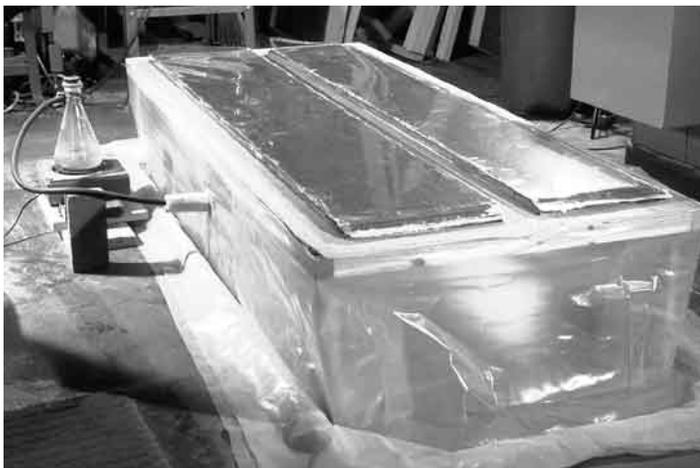
Figure 12. Beginning treatment: swelling the concave sides of the warped boards from the panel with steam using a humidity table (Case Study 4).

3. In order to swell the concave rear surfaces of the boards, a humidifying table was constructed of plywood and polyethylene sheet (Fig. 12). The boards were placed concave side down above slightly undersized cut-outs in the plywood top, and steam was injected into the tented table. After approximately two hours, the boards exhibited very slight reverse warpage.

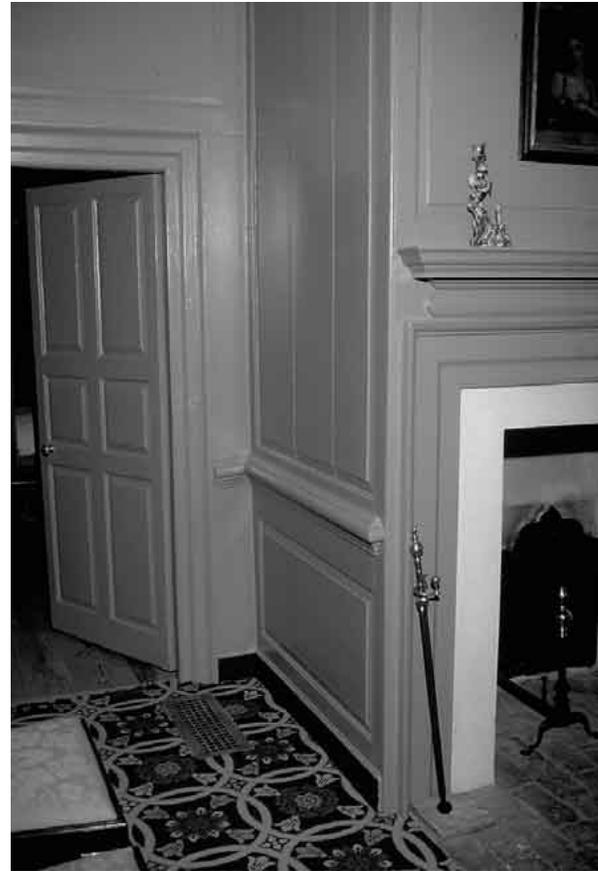
Figure 13. A view of the treated panelling, reinstalled on the left face of the parlor chimney breast at the Brush-Everard House (Case Study 4).

9. After three days of stability—with warpage no greater than 1.5 mm—the panelling was reassembled. No top coating was applied to the treated surface. However, prior to reinstallation at the Brush-Everard House, the entire assembly was backed with Tyvek sheet (available at building supply stores), which serves as a dust barrier and slows moisture transpiration.
