THE REPRODUCTION OF THE ROYAL COAT-OF-ARMS OF KING GEORGE III OF ENGLAND

Mark Kutney, Asst. Conservator, and Philippe Lafargue, Sr. Conservator, Tryon Palace Historic Sites and Gardens, 610 Pollock St., New Bern, North Carolina, 28560

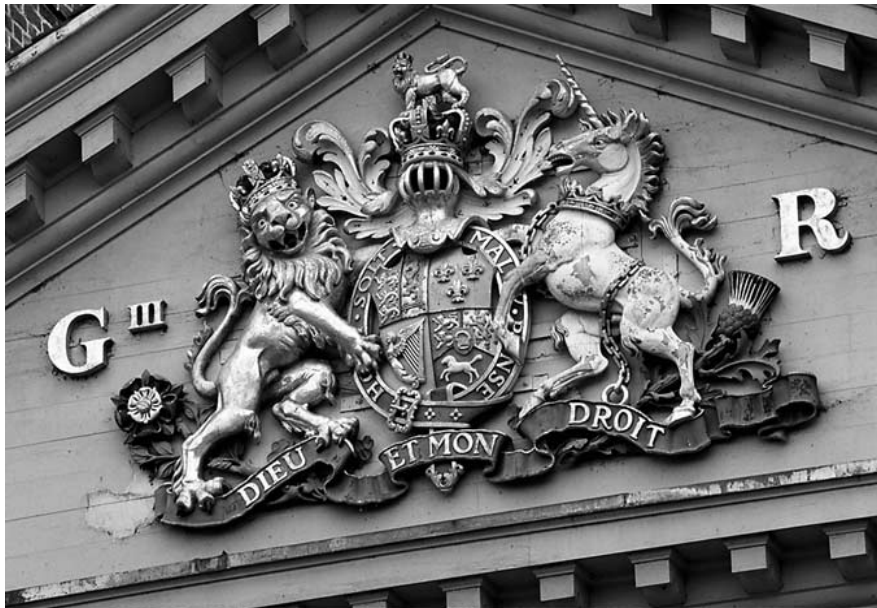
Figure 2. Coat-of-arms original to the building just prior to 1993 restoration

The condition of the coat-of-arms in February of 1993 included large cracks at almost every joint in its laminated construction, the polychrome surface was at an advanced stage of flaking and was powdery in many areas, and there were losses in the substrate-the largest being about the size of a brick.

After equilibrating in the tent for a month and a half, we began to consolidate the joints. Conserv 100, a wood consolidant, was introduced into all the joints. This was followed by Conserv 200, a flexible epoxy with an optional thixotrope. The first several applications of the epoxy were ap-

plied as a liquid to maximize penetration. Thixotrope was added for the final application in order to match the profile of the carvings. The flexible epoxy should allow the wood at the joints to expand slightly without causing irreversible cellular compression, which had caused the cracks to form in the past.

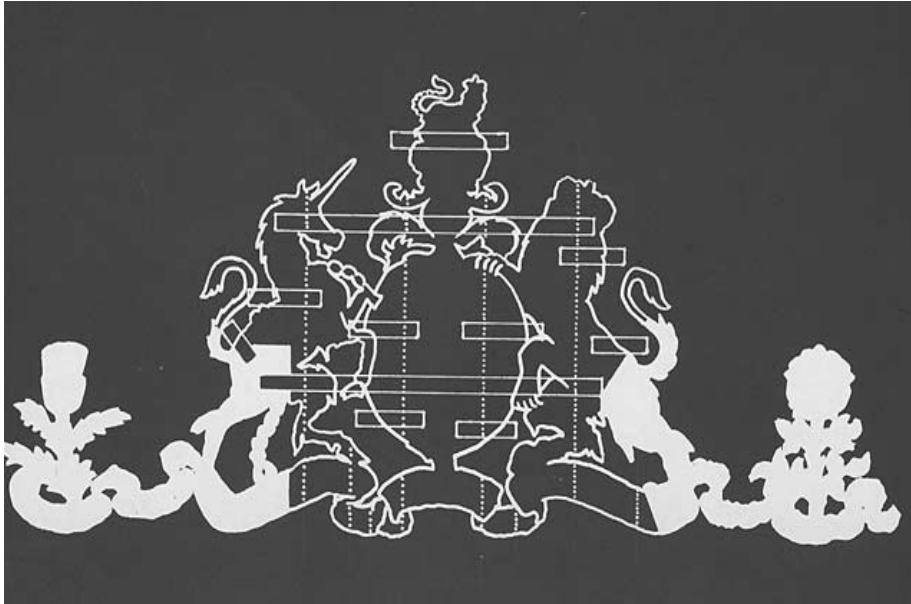
The mounting system of the original played a very big role in causing the extensive cracking of the substrate. This system is made up of eleven bronze bars of various lengths placed at right angles to the joints and grain of the wood, with numerous screws attaching the bars across the back. (*fig. 3*)

The right and left outer extremities were backed with plywood, as part of the original construction, to make them less susceptible to damage while handling. The cross-grain construction combined with exposure to changing weather had caused compression shrinkage of the wood, resulting in the cracks at all the joints and several losses.

Fig. 3 Diagram of coat-of-arms showing bronze mounting bars (horizontal rectangles), plywood backing (solid white areas), and joints in wood (vertical dotted lines).

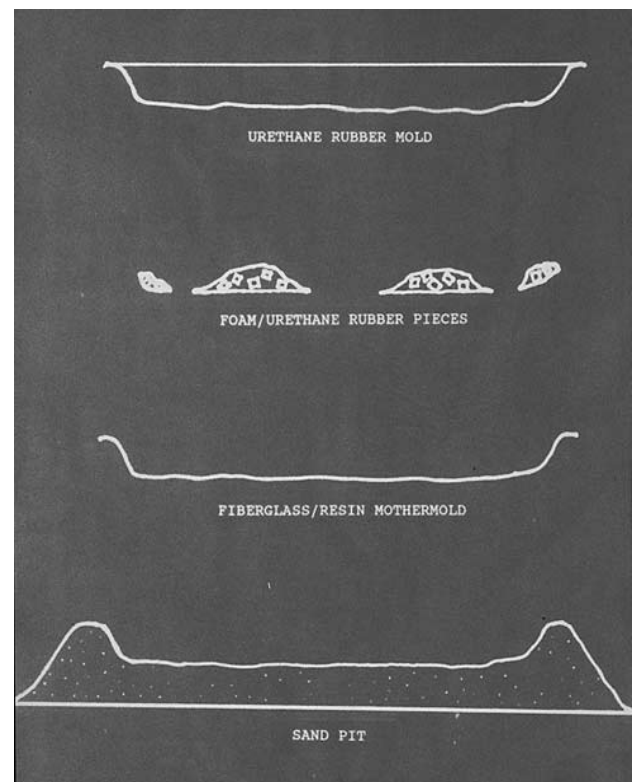
Fig. 4 Diagram of mold layout for casting reproduction.

The reconstruction of the mold began with laying out a very large sand pit in order to support the odd shape of the fiberglass shell. The foam/urethane rubber pieces were then situated on the fiberglass shell in their appropriate locations. Some of these pieces were worked into the large rubber mold first and then the large rubber mold laid on top of the fiberglass shell. (fig. 4)

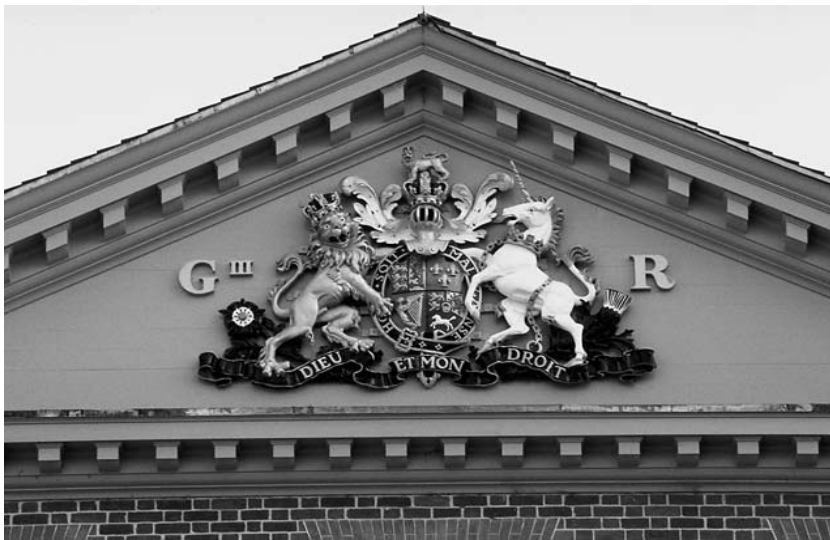
Figure 5. Glass reinforced polyester reproduction.

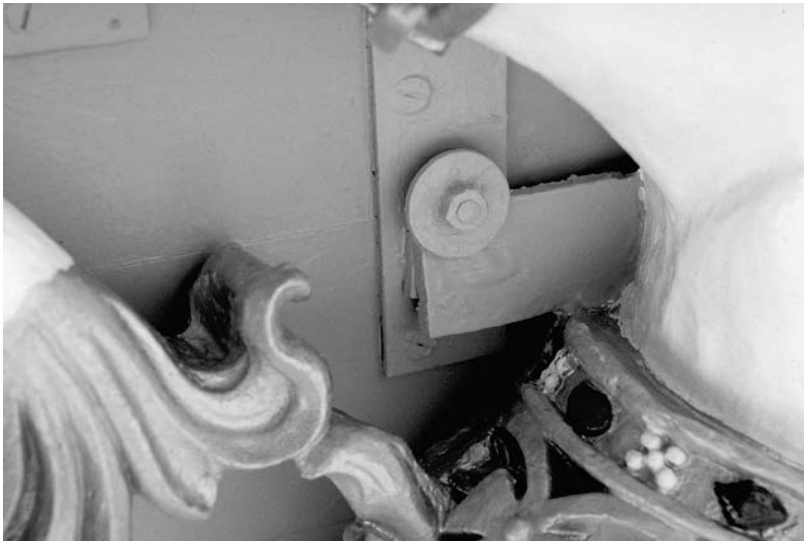
The physical difference between the original and the reproduction was probably most evident when trying to match up the 11 mounts to the original holes in the building. A few of them did not line up and were not fully load bearing (*fig. 6*). Fortunately, because of the lighter weight of the reproduction, a fewer number of mounts were required.

Figure 6. Closeup of a mount on reproduction which did not properly line up.

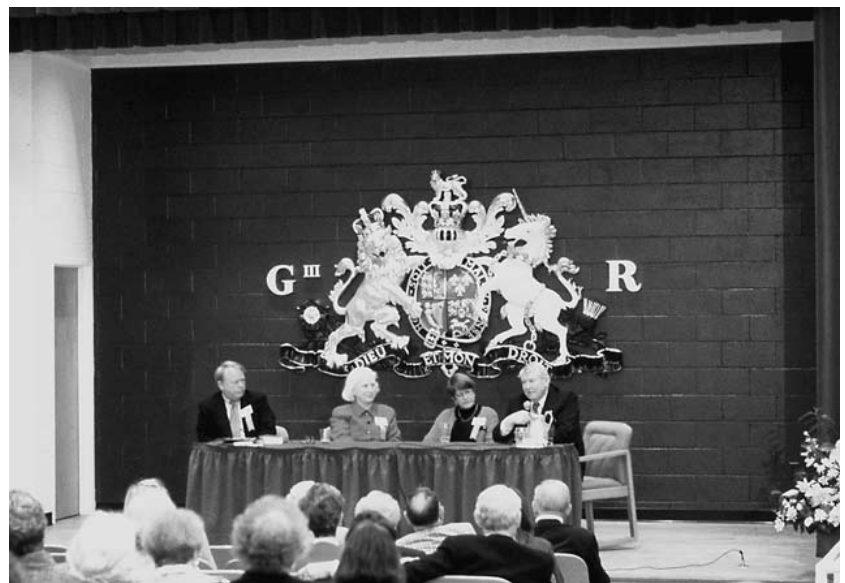
Figure 7. Original coat-of-arms in its new location.

The coat-of-arms that was original to the reconstruction is now displayed in a prominent place in the visitors center. Even though we have separated the object from its original location we have not altered the nature of the original, it is accessible to any visitor (fig. 7), it is protected from the harsher outdoor environment, and the option remains to return the 1957 coat-of-arms to the front of the building.
