A Study of the Materials and Environment at Russel Wright's Dragon Rock

Susan L. Buck, Conservator, SPNEA Conservation Center

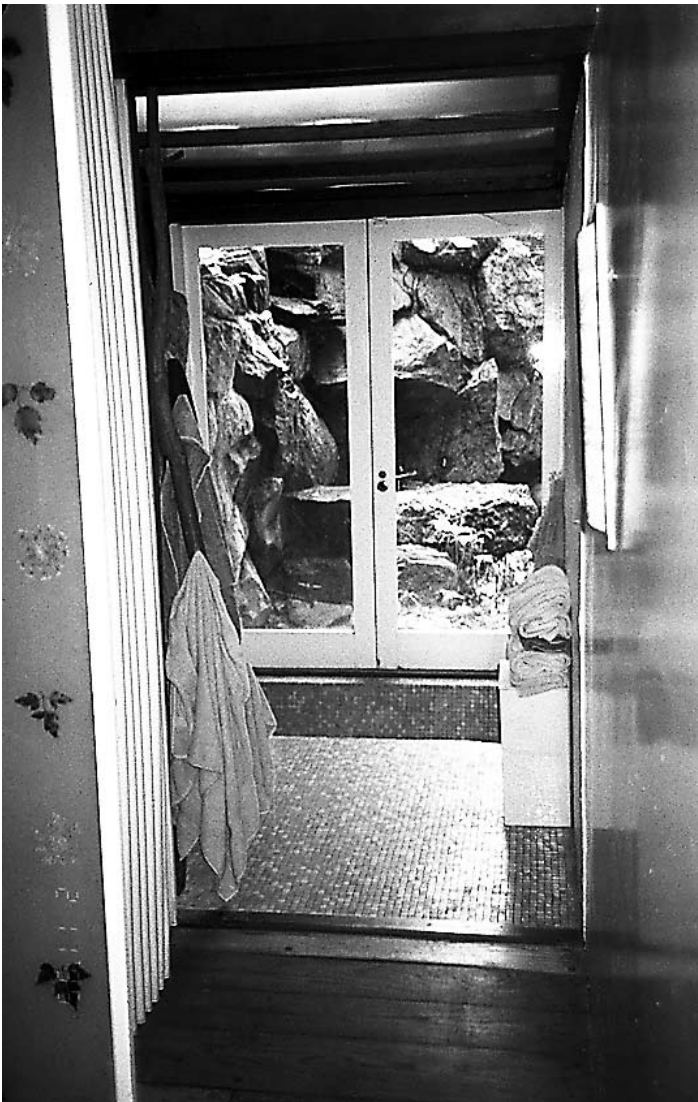
Figure 1. Sliding door panels, like this one leading into the Harem Bathroom, incorporate fragile plant materials from the site.

There is a very marked example of chronic light exposure when the sliding door in the Harem Bathroom is pulled completely closed. The butterflies sandwiched between the plastic at the leading edge of the door are embrittled, pale and faded from this outer edge to about one and half feet in. However, the butterflies sandwiched between the plastic panels at the inside section of same door are still brilliantly colored and remarkably intact. It appears that this door is most often left in a partially closed position which has caused the significant damage to the butterflies on the leading, exposed edge of the door.

4. Investigate methods to reduce the RH levels in the studio and to increase air circulation, to limit mold growth in this space.
5. Leave the panel with the butterflies in the fully retracted position as much as possible to limit light damage and vibration.

6. Investigate conservation methods to reattach and stabilize the fragile butterflies.
7. Develop guidelines for the care and maintenance of all finished surfaces. This would include designating the types of materials for use on woodwork (paste wax coatings only), restricting refinishing and repainting work in both the house

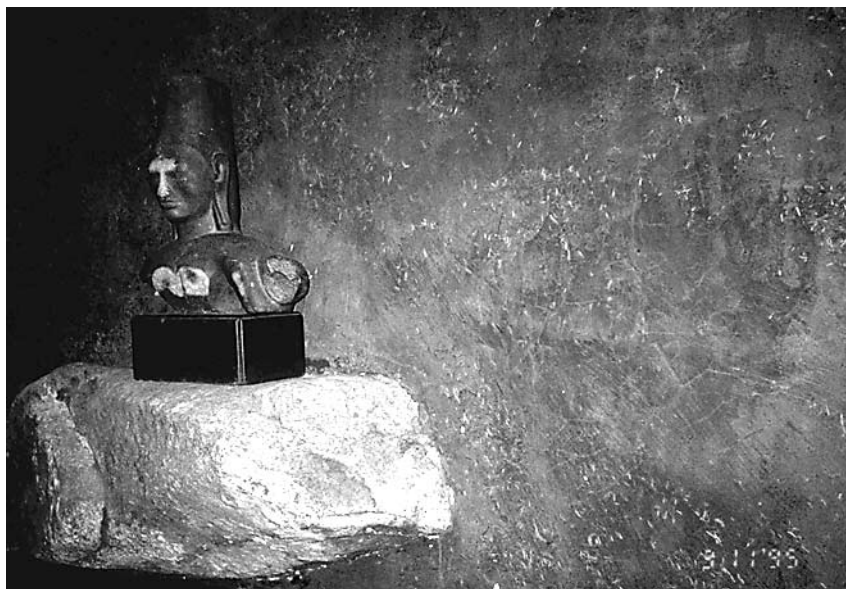
Figure 2. Russel Wright created textured green plaster walls in the living room by pressing pine needles into the pigmented plaster while it was still wet.

The green wall paints in the living room were identified as plaster colored with stable pigments, including lampblack, yellow ochre, and iron oxide. The green plaster also contains pine needles which were pressed into the plaster before it had set. The combination of lampblack and yellow ochre produces an optical green which is generally a darker, more olive green color. These are all stable pigments, in use since antiquity. The living room samples were analyzed with FT-IR microspectroscopy and confirmed to be plaster with pigments (based on the presence of double peaks for CaSO_4 and CaCO_3 and the absence of peaks for any organic binders), as described by Wright.

One sample was taken from an area of efflorescence on the west wall where salts have been deposited on the surface by water wicking out through the plaster substrate and the textured green plaster. This water carries soluble salts from the plaster which then dry on the surface leaving a powdery white deposit. The plaster substrate and the green plaster finish layers are particularly friable in this area.

1. Investigate and correct the sources of moisture traveling through the living room green plaster and the stucco-like paint in the hall.
2. Determine the best methods for shielding the most vulnerable areas of the house and studio from excessive visible and UV light exposure. Install UV blocking materials as soon as feasible, and install light-reducing shades where possible.

3. After the moisture problems in the walls have been identified, test alternative methods for consolidation of the flaking plaster and peeling stucco-like paint in the living room and hallways.

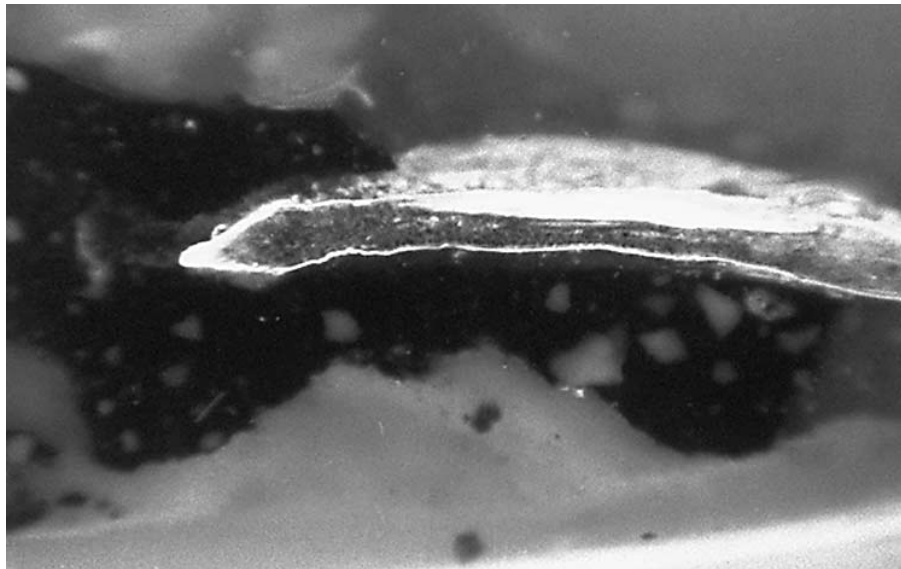
Figure 4. This cross-section shows a pine needle partially embedded in the green plaster above a more traditional white finish plaster. Above: UV light. Right: Visible light.

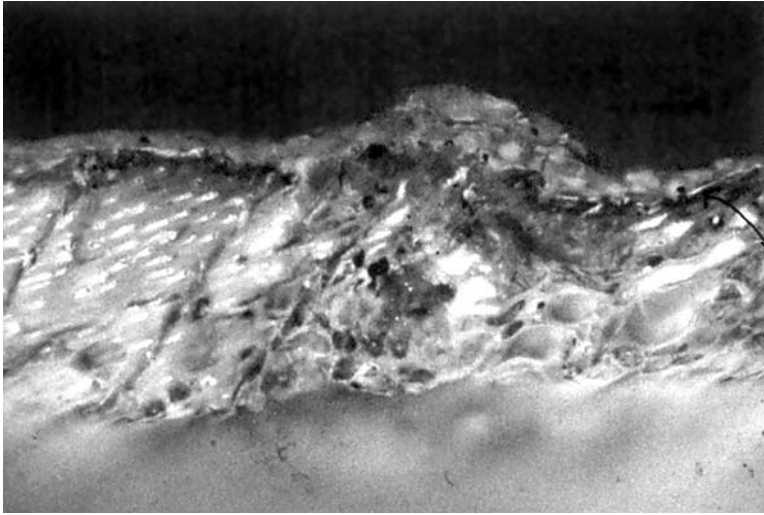
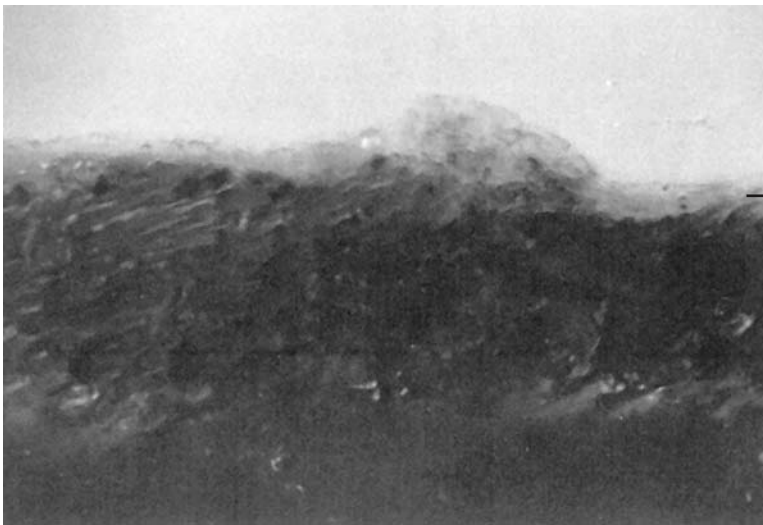
The studio woodwork has the same type of slightly pigmented/flatted synthetic resin found on the woodwork in the main entry, the main hall, the Harem Bathroom and on the top of the kitchen table. However, this flatted varnish is the second generation in the studio as there are remnants of an earlier sealant or plant resin varnish coating trapped in the fibers of the wood. The Wrights moved into the completed studio while work on the house was progressing, so this second matte finish layer was perhaps applied at the same time Wright was applying woodwork finishes in the house. Or, perhaps he first tested out this coating in the studio before using it in the house.

May be remnants of an earlier varnish coat (bright white auto-fluorescent material)

Clear finish coat with pigments and flatteners suspended in it.

Figure 5. A synthetic varnish with flatteners was used on the wood surfaces in the studio and house to create a natural, matte appearance, but still provide a protective, washable surface. Top: UV light, bottom: visible light
