# Loss Compensation of Lacquer on Two Chinese Tables

Melissa H. Carr and John M. Driggers, Robert Mussey Associates, Inc.

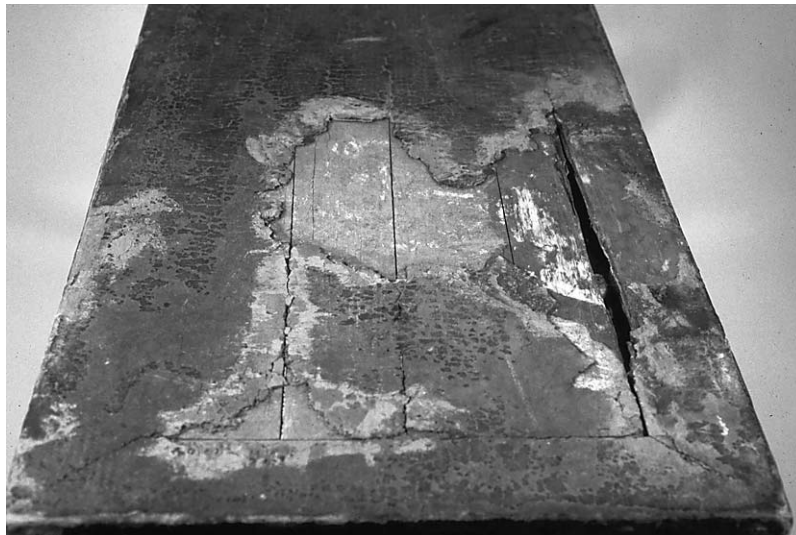
*Figure 2: Damaged top of black lacquer table.*

Except for metal rings on the ends of the legs, the black table was completely covered in a uniformly black lacquer without decoration. The lacquer, which was originally smooth and glossy, was now heavily crackled and dull, with major losses on the table top and lower ends of the legs. At one end of the table top the roughly 200 square inches of loss extended through the surface lacquer, the thick ground layer underneath and the woven fiber (ramie) liner sitting atop the wood substrate. (*fig. 2*) Moreover, the wood itself was eroded away in a small area allowing one to look through the top to the floor below. Obviously the damage was extensive, thought by the curator to have been caused by water dripping on the table top over a long period of time.

Ultimately we chose to compensate for the ground losses first, matching their surface appearance to the surrounding exposed original ground. Then, if possible, we would replicate the surface lacquer over the original ground and the replacement ground to produce a relatively uniform old, undamaged surface. If efforts to replace the surface lacquer did not succeed, at the very least the final surface would be a convincing representation of a much less damaged surface. Our methods are described below.

The profiles of the irregular edges of the losses were transferred to the replacement casts with carbon paper and tissue paper. These paper patterns were glued to the casts and cut on a back bevel with a jeweler's saw. The casts were then detailed for profile and thickness, abraded on the back, and adhered with hide glue. To further obscure the border lines the black cutting dust was brushed into them while the hide glue was still damp.

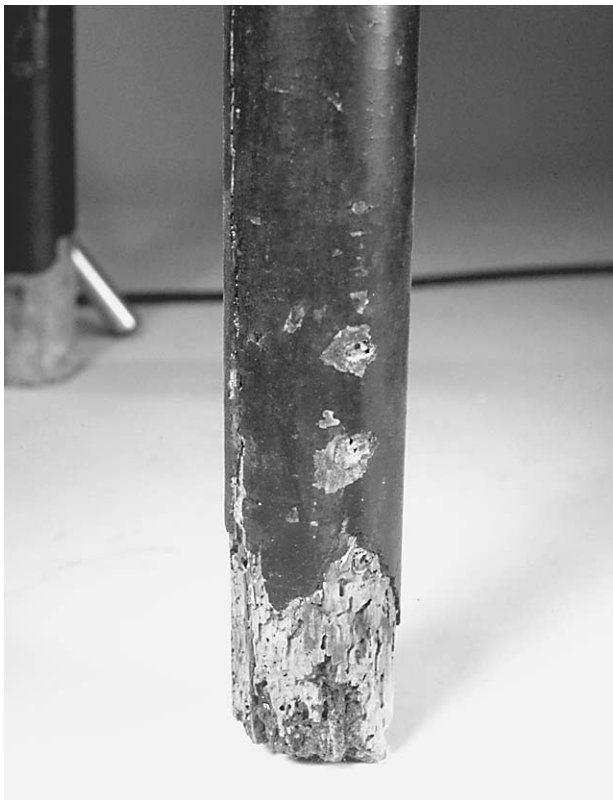
While the losses across the table top were substantial, the losses to the feet were equally impressive (or dismaying) in their own way, as were previous efforts to repair/obscure them. (*fig. 3*) This type of damage to the lower end of table legs is common because of moisture wicking up the legs from condensation on the cool stone floors of traditional Chinese dwellings. The erosion of the lacquer and the wood substrate extended from three to six inches up the legs.

*Figure 3: Typical damaged leg of black lacquer table.*

the exposed wood and adjacent lacquer were consolidated with two applications of 20% Acryloid B-72 in acetone. Paste wax was applied as a barrier coat on the adjacent lacquer, and the cylindrical wooden substrate was reformed with a bulked epoxy and trimmed to an offset approximately equal to the thickness of the film of synthetic surface lacquer to be applied.

The surface quality of the lacquer on the legs was entirely different from the heavily crackled top. A separate curved silicone mold was taken from an intact area above the losses and used to cast an extremely thin smooth film for each leg. These casts were then individually fitted and scribed to the irregular edge of the original lacquer.

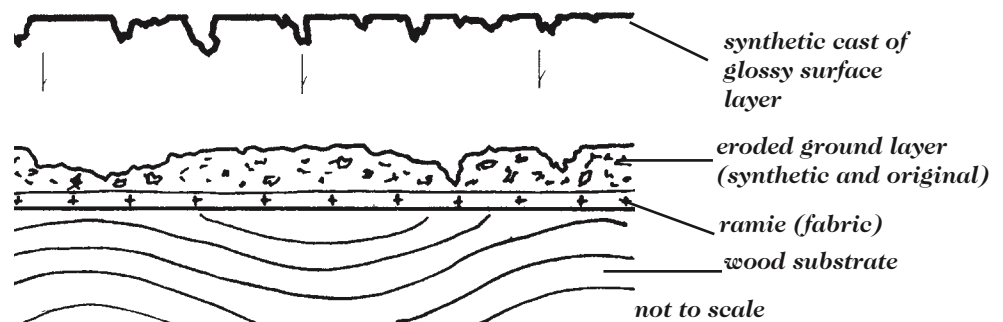
film and the very even glossy side of the synthetic lacquer film. (fig. 4) The dilemma became one of how to adhere the two uneven surfaces while preventing them from telegraphing their irregularities to the glossy show side. In fact, when the first thin film was laid down this is exactly what happened.

When a less flexible film was laid down in an effort to mask the uneven ground, the irregularities elevated the film above the adjacent surfaces. Efforts to level the underside of the thinner film and/or the ground with inert fill similarly lifted the film. Further efforts to flatten the film over the ground with heat and pressure caused losses in the fine detail of the glossy surface. These and other tests of different materials and application methods eventually led to the conclusion that while each had the potential to solve a part of the problem, none solved it entirely.

Figure 4: Original and synthetic lacquer layers

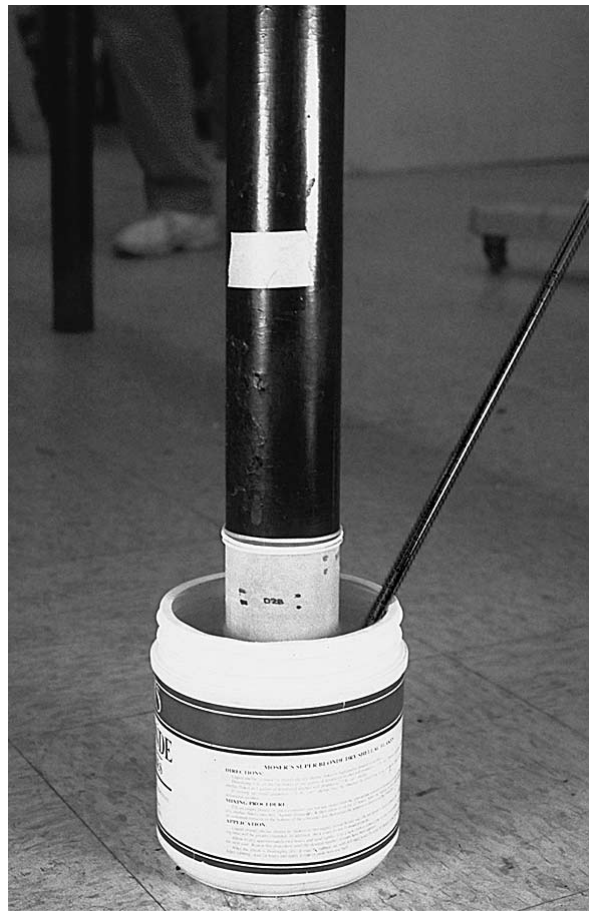
*Figure 5: Activation of sheet BEVA 371 to adhere synthetic film to leg.*

Adhering the casts required an acceptable adhesive and good visibility to monitor slippage. Sheet BEVA 371 emerged as the adhesive of choice but not without some adjustments to the method of heat activation. Activating it with a Teflon iron produced distortion and dimensional changes in the film, and adhered sections would release when the iron was applied to an adjacent area. The ideal system would hold the cylindrical film in position with perfectly even pressure around the leg, heat the entire film evenly and simultaneously to 140° F, and at all times be translucent to monitor shifts in position. As serendipity would have it, three condoms provided perfectly even pressure and a waterproof casing while the leg was suspended in a bucket of water heated to the melting point of the BEVA. (*fig. 5*)

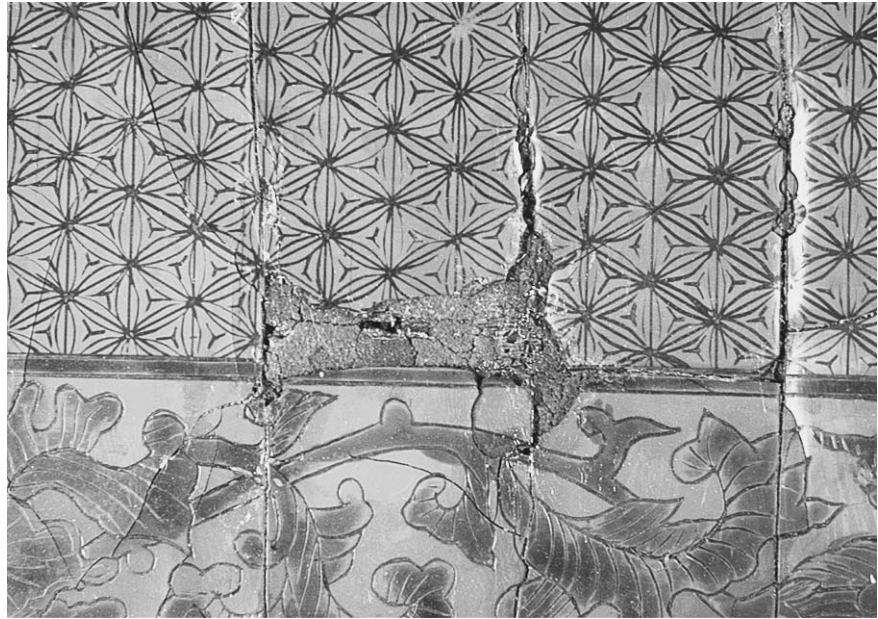
Unlike the black lacquer table, the surface of the red table was highly decorated with an incised design of peonies, birds, butterflies and geometric shapes toned with pigments and gold powders, but not heavily cracked. (*fig. 6*) Relatively speaking the losses were much smaller; the largest measuring one inch across as compared to eighteen inches on the black table. Further distinguishing the two was the quality of the losses. On the black table there were tremendous variations in the degree of damage, with large areas of damaged but original surface. On the red table the losses were small but complete, penetrating cleanly to the wooden substrate. Our strategy was to level the losses in

*Figure 6: Shallow loss on red lacquer table.*

the ground layer with a fill material and then apply a thin film or skin to take the place of the lost lacquer surface. Losses in the decorative paint and gold were replaced separately by a paintings conservator.

be colored similarly to the color of the table because the filler acted much like a bole does in gilding, helping to impart color and depth to the very thin films that would be placed on top of it. After drying, the mounded filler was compressed with plexiglass cauls and then leveled with a felt block and a small amount of methyl ethyl ketone (MEK). The MEK softened the acrylic binder so that the fill could be leveled to the surrounding area by light rubbing with the felt block; it did not affect the original lacquer surface.

Finally, the liquid acrylic mixture was brushed onto silicone molds to form a thin film. When dry, the film was removed, trimmed to size and adhered to the underlying fill after activating the acrylic binder with MEK. All of the films were polished with an agate burnisher to bring up the sheen slightly and provide an appearance of hardness similar to the original lacquer.

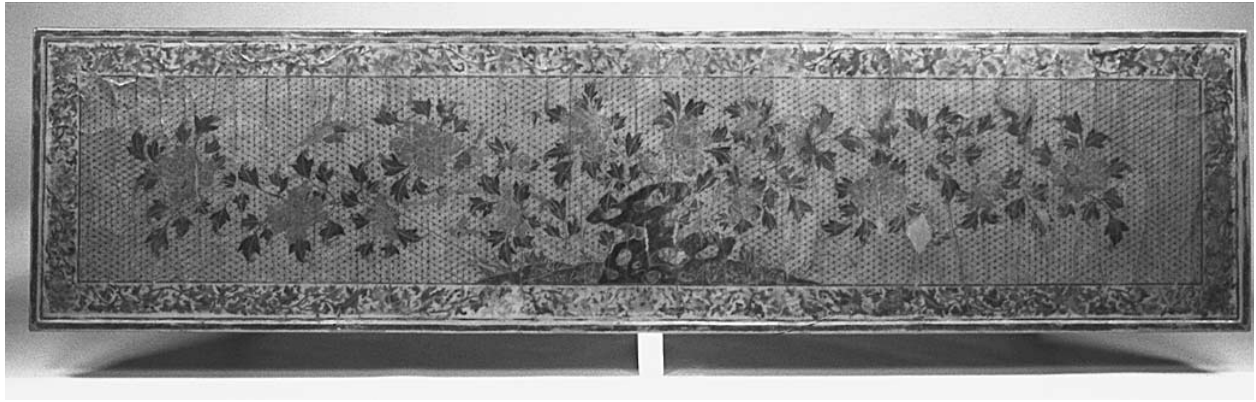
Figure 7: Red lacquer table after treatment.

From the client's perspective the treatment of the red table was more successful: the apparent damage was eliminated and the loss compensation was virtually invisible. (*fig. 7*) Conversely, the treatment of the black table was less successful: the apparent damage was significantly decreased but not eliminated, and the loss compensation was detectable by the careful eye. (*fig. 8*)

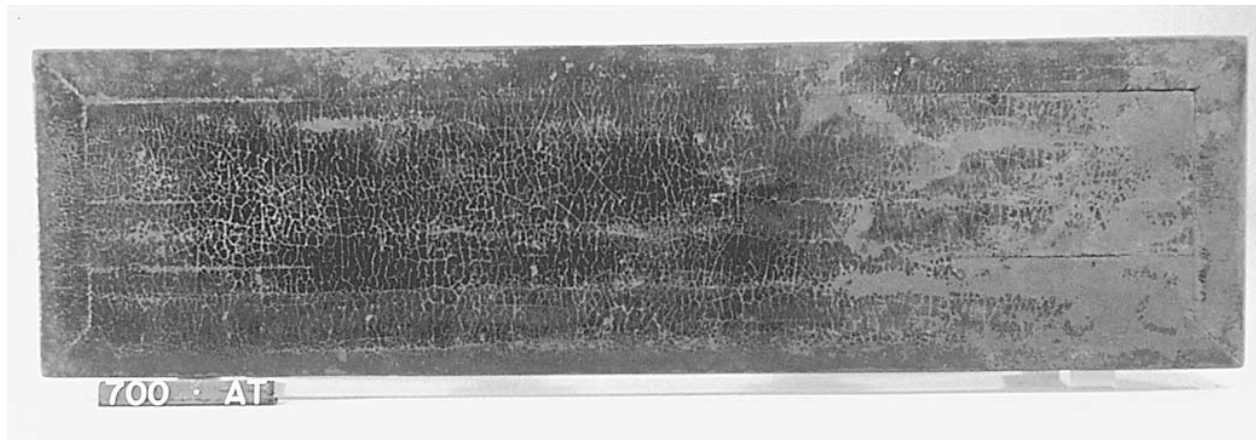
Figure 8: Black lacquer table after treatment.
