Loss Compensation of Lacquer on Two Chinese Tables

Melissa H. Carr and John M. Driggers, Robert Mussey Associates, Inc.

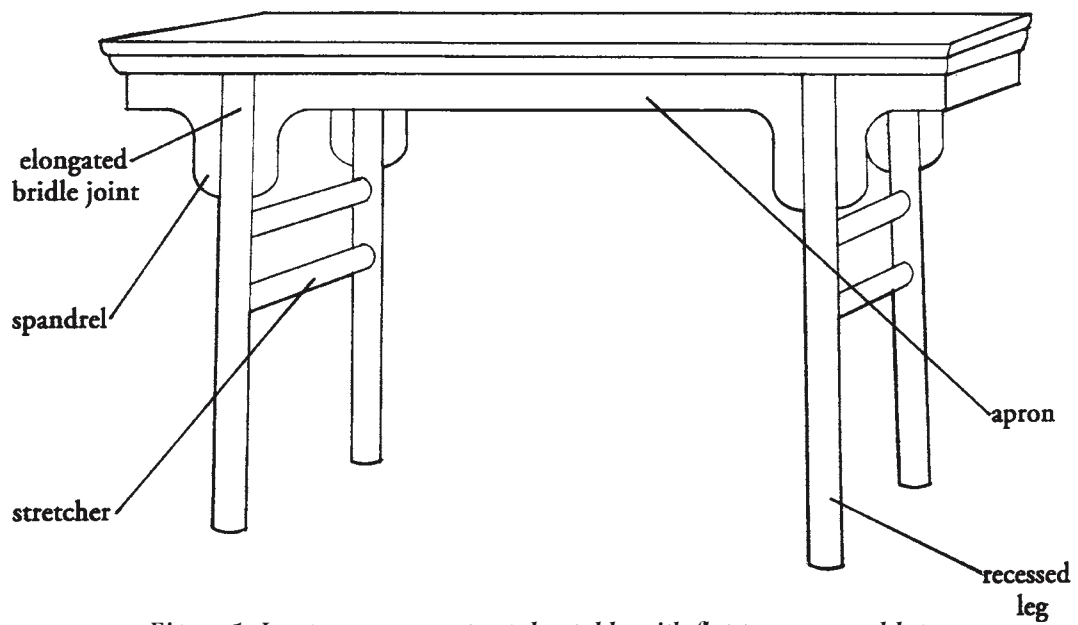
Figure 1: Long, narrow, rectangular table with flat top, recessed legs and elongated bridle joints.

The tables were quite similar in dimension and form. Classic representatives of the late Ming Dynasty period, they are characterized in the literature as long, narrow rectangular tables with a flat top, recessed legs and elongated bridle joints. (*fig. 1*) In this style the top is flat rather than having turned-up ends, and the legs are recessed from the sides and ends of the top rather than flush. The elongated bridle joint characterizes the connection between the apron, spandrels and legs.

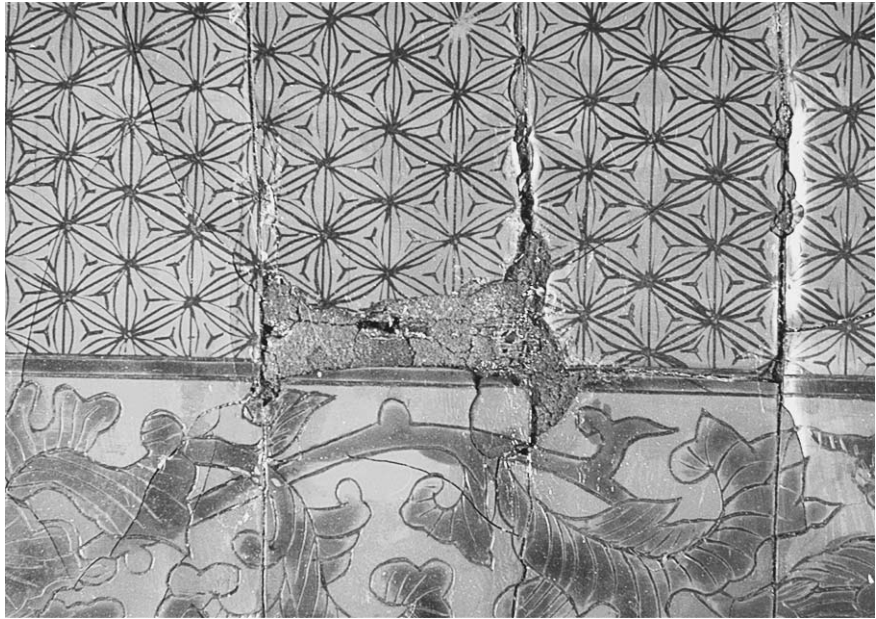
Unlike the black lacquer table, the surface of the red table was highly decorated with an incised design of peonies, birds, butterflies and geometric shapes toned with pigments and gold powders, but not heavily cracked. (*fig. 6*) Relatively speaking the losses were much smaller; the largest measuring one inch across as compared to eighteen inches on the black table. Further distinguishing the two was the quality of the losses. On the black table there were tremendous variations in the degree of damage, with large areas of damaged but original surface. On the red table the losses were small but complete, penetrating cleanly to the wooden substrate. Our strategy was to level the losses in

Figure 6: Shallow loss on red lacquer table.

the ground layer with a fill material and then apply a thin film or skin to take the place of the lost lacquer surface. Losses in the decorative paint and gold were replaced separately by a paintings conservator.

An acrylic emulsion bulked with phenolic micro balloons was used as the fill material. During early tests we found that it was essential that the filler

be colored similarly to the color of the table because the filler acted much like a bole does in gilding, helping to impart color and depth to the very thin films that would be placed on top of it. After drying, the mounded filler was compressed with plexiglass cauls and then leveled with a felt block and a small amount of methyl ethyl ketone (MEK). The MEK softened the acrylic binder so that the fill could be leveled to the surrounding area by light rubbing with the felt block; it did not affect the original lacquer surface.

Finally, the liquid acrylic mixture was brushed onto silicone molds to form a thin film. When dry, the film was removed, trimmed to size and adhered to the underlying fill after activating the acrylic binder with MEK. All of the films were polished with an agate burnisher to bring up the sheen slightly and provide an appearance of hardness similar to the original lacquer.

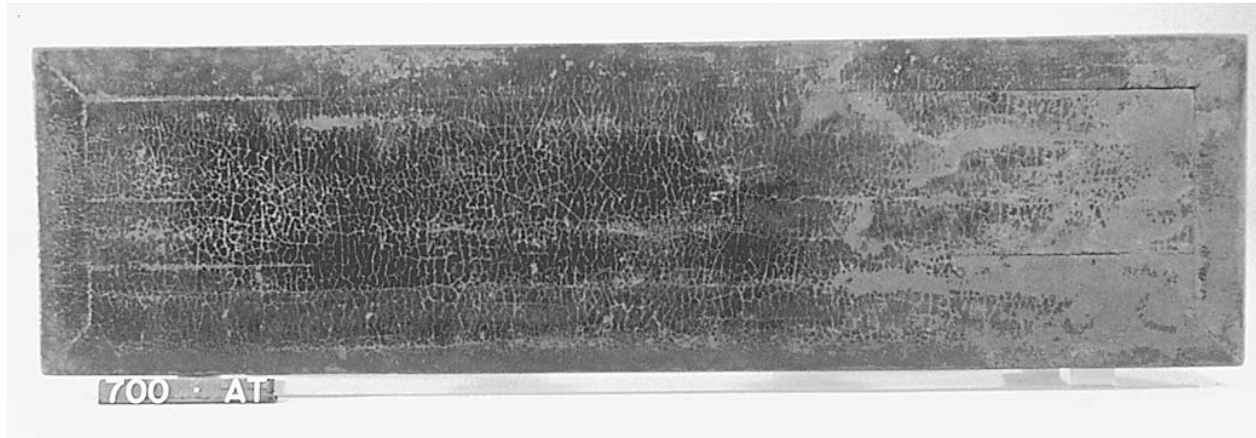
Figure 8: Black lacquer table after treatment.

From the client's perspective the treatment of the red table was more successful: the apparent damage was eliminated and the loss compensation was virtually invisible. (*fig. 7*) Conversely, the treatment of the black table was less successful: the apparent damage was significantly decreased but not eliminated, and the loss compensation was detectable by the careful eye. (*fig. 8*)
