Treatment of a Labyrinth: Addressing Decay and Losses in a Large Outdoor Wood Sculpture Located in a Public Place

Hugh Glover, Conservator of Furniture and Wooden Objects, Williamstown Art Conservation Center, Williamstown, Massachusetts.

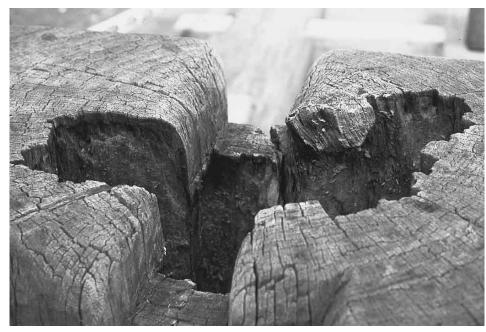
Figure 3: Area of decay in the top of one large center block.

spreading at an ever increasing rate and infecting other components. It is possible that the brown rot had been present since the trees were felled or seasoned. Presumably, it has spread from the most affected parts, which are the centers of the large blocks (*fig.3*), which all include the trees' center or pith.

The extensive losses due to decay in seven of the large vertical blocks (*fig. 3*) were addressed. Fills were placed within the decayed openings to restrict rainwater (and trash) and to reinforce the fragile edges. The fill method was designed to be strong, safe and durable, to allow for seasonal movement of the host, to be removable, and to avoid the use of tropical woods (New York State policy now prohibits the use of tropical woods for public works).

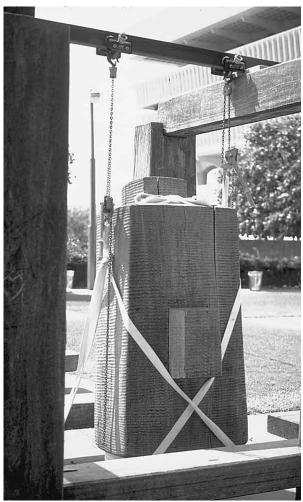
Figure 4: A large center block between arches (1 of 8) showing the lifting equipment.

The eight large blocks set between paired arches had been secured to the ground with short anchored rods and a bedding adhesive, used between the wood, the rods and the concrete. Decay in the top of seven blocks was beginning to meet decay rising from the bottom, and central cavities had formed. With lifting gear suspended from a steel I beam that rested on the convenient overhead lintels (*fig. 4*), each block was raised and lowered to a horizontal position. (*fig.5*) Most of the soft rotted wood was extracted from the cavities and old bedding adhesive was removed. To help ventilation and drainage of water through the blocks, a hole was drilled through each center, boring from the depth of the decay at each end to meet in the middle.

While the blocks were in the horizontal position, four 3/4" lead feet were nailed beneath the corners of all eight blocks, to lift the end grain from pooling water. The blocks were then repositioned onto their new feet. It was not necessary to add feet beneath the many low structures as these already stand on neoprene blocks. Only the tall posts of the arches now remain standing on the concrete (the posts of the tower are embedded in the concrete with steel collars).

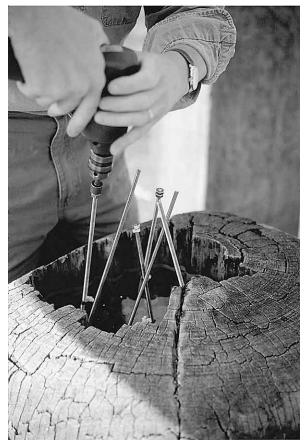
Figure 6: Installing stainless steel all-thread rods to locate the Lexan support table.

The Lexan was secured into place with lengths of stainless steel all-thread rod that passed through angled holes tapped in the Lexan (*fig. 6*) and into the walls of the cavities below, to form several variously angled legs. (*fig. 7*) Lower ends of the rods were pointed to penetrate the wood inside the cavity and their upper ends were slotted to enable screwing them flush to the Lexan's surface.

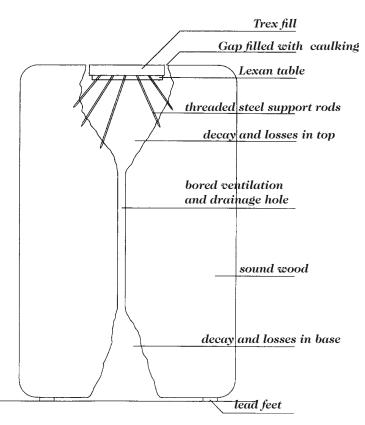
Figure 7: Diagram (not to scale) of cross-section view of a typical center block (≈ 6 ft. h. x 3 ft. w.) showing the decay and the arrangement of the fill and feet.

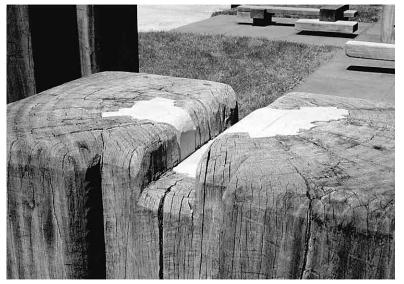
Figure 8: A completed fill showing the Trex insert before its surface color has oxidized.

A Mylar tracing of each opening was transferred onto Trex which was cut with a bandsaw to provide an 1/8" gap around the opening. The larger Trex inserts were formed by adhering smaller pieces with an epoxy resin. The Trex was lowered into place to rest on the Lexan table and secured with latex/silicone caulking around the perimeter. Excess material was leveled with edge tools. (*fig. 8*)

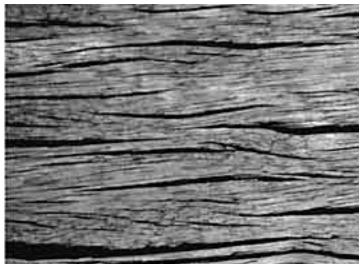
focused on the primary timber elements that Figure 9: A small Trex fill after its surface has oxidized.

Several small horizontal cavities (smaller than a hand) were filled with Trex alone. After routing a firm base and installing borate rods into internal holes, the shaped Trex was dropped in and secured with caulking against the walls. (*fig. 9*) Another fill method had been installed by others several years ago; here, pigmented epoxy resin had been poured directly into one area of decay. All three fill methods are being monitored for durability and any secondary consequences.
