# Treatment of a Labyrinth: Addressing Decay and Losses in a Large Outdoor Wood Sculpture Located in a Public Place

*Hugh Glover, Conservator of Furniture and Wooden Objects, Williamstown Art Conservation Center, Williamstown, Massachusetts.*

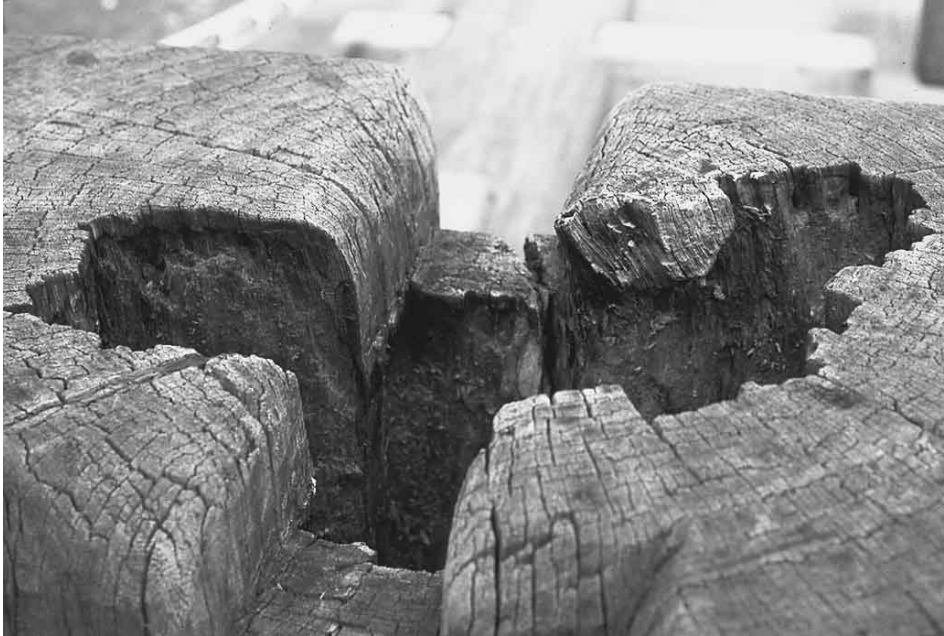
**Figure 3:** Area of decay in the top of one large center block.

spreading at an ever increasing rate and infecting other components. It is possible that the brown rot had been present since the trees were felled or seasoned. Presumably, it has spread from the most affected parts, which are the centers of the large blocks (fig.3), which all include the trees' center or pith.

The extensive losses due to decay in seven of the large vertical blocks (fig. 3) were addressed. Fills were placed within the decayed openings to restrict rainwater (and trash) and to reinforce the fragile edges. The fill method was designed to be strong, safe and durable, to allow for seasonal movement of the host, to be removable, and to avoid the use of tropical woods (New York State policy now prohibits the use of tropical woods for public works).

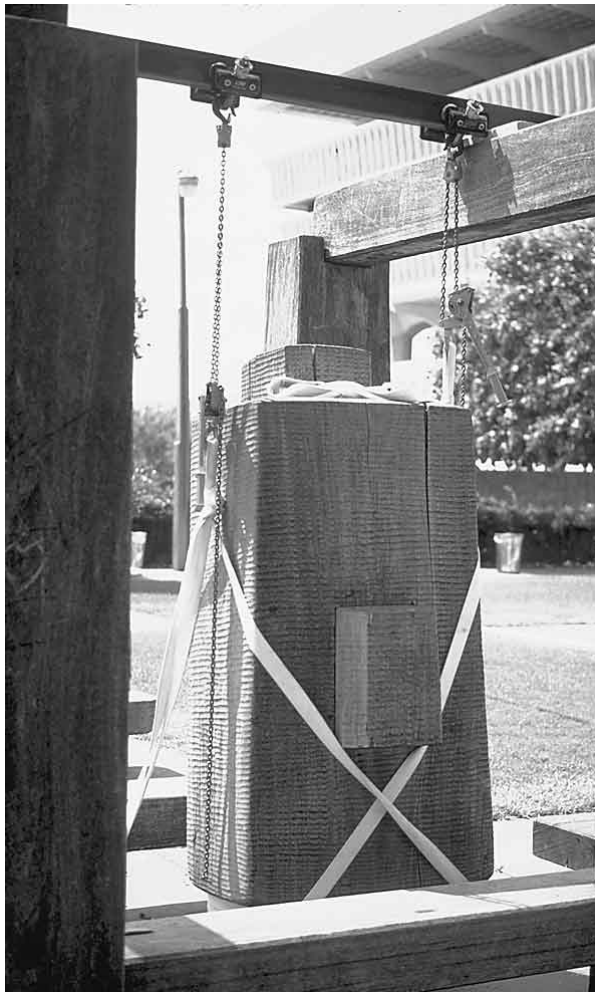
*Figure 4: A large center block between arches (1 of 8) showing the lifting equipment.*

The eight large blocks set between paired arches had been secured to the ground with short anchored rods and a bedding adhesive, used between the wood, the rods and the concrete. Decay in the top of seven blocks was beginning to meet decay rising from the bottom, and central cavities had formed.

With lifting gear suspended from a steel I beam that rested on the convenient overhead lintels (fig. 4), each block was raised and lowered to a horizontal position. (fig.5) Most of the soft rotted wood was extracted from the cavities and old bedding adhesive was removed. To help ventilation and drainage of water through the blocks, a hole was drilled through each center, boring from the depth of the decay at each end to meet in the middle.

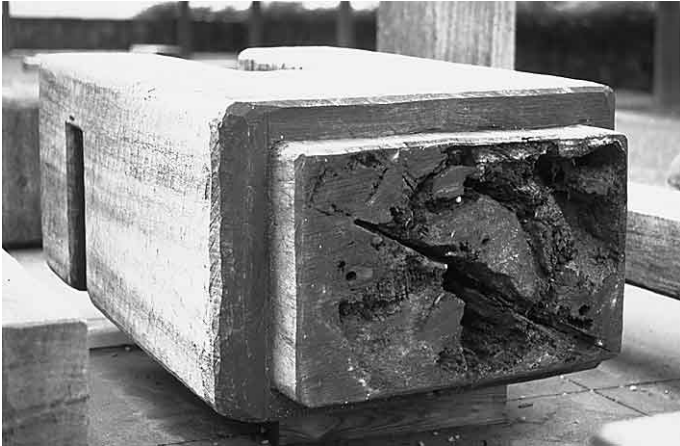
*Figure 5: View of the decayed base of one center block.*

While the blocks were in the horizontal position, four 3/4" lead feet were nailed beneath the corners of all eight blocks, to lift the end grain from pooling water. The blocks were then repositioned onto their new feet. It was not necessary to add feet beneath the many low structures as these already stand on neoprene blocks. Only the tall posts of the arches now remain standing on the concrete (the posts of the tower are embedded in the concrete with steel collars).

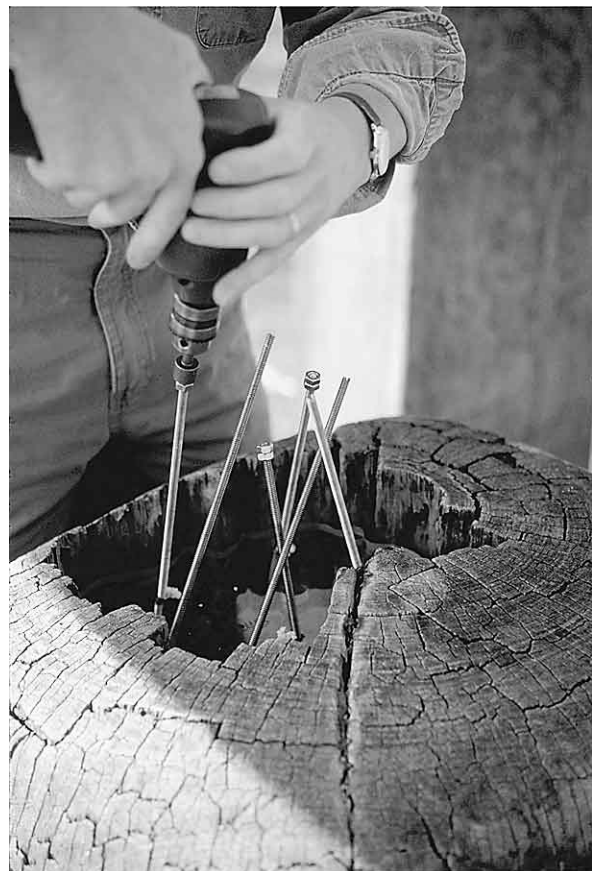
*Figure 6: Installing stainless steel all-thread rods to locate the Lexan support table.*

The Lexan was secured into place with lengths of stainless steel all-thread rod that passed through angled holes tapped in the Lexan (*fig. 6*) and into the walls of the cavities below, to form several variously angled legs. (*fig. 7*) Lower ends of the rods were pointed to penetrate the wood inside the cavity and their upper ends were slotted to enable screwing them flush to the Lexan's surface.

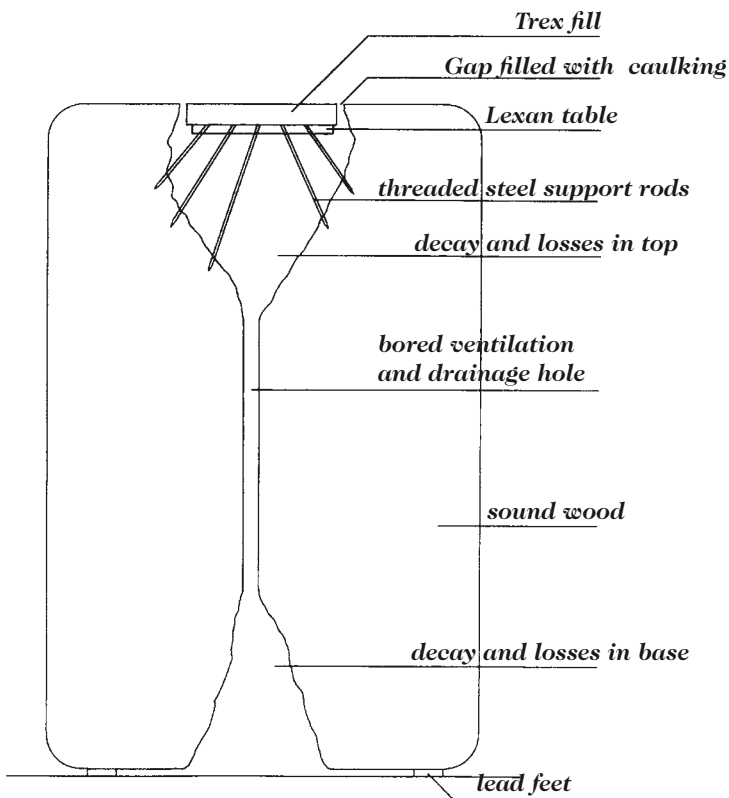
**Figure 7:** Diagram (not to scale) of cross-section view of a typical center block (≈ 6 ft. h. x 3 ft. w.) showing the decay and the arrangement of the fill and feet.

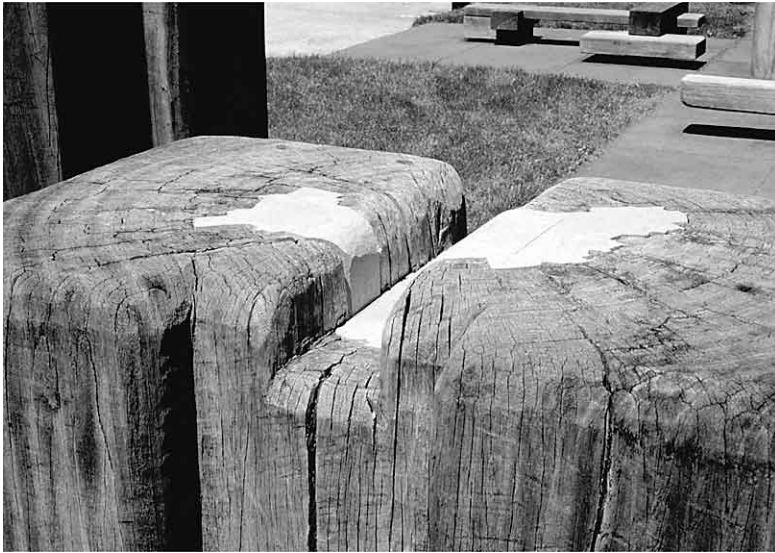
*Figure 8: A completed fill showing the Trex insert before its surface color has oxidized.*

A Mylar tracing of each opening was transferred onto Trex which was cut with a bandsaw to provide an 1/8" gap around the opening. The larger Trex inserts were formed by adhering smaller pieces with an epoxy resin. The Trex was lowered into place to rest on the Lexan table and secured with latex/silicone caulking around the perimeter. Excess material was leveled with edge tools. (*fig. 8*)

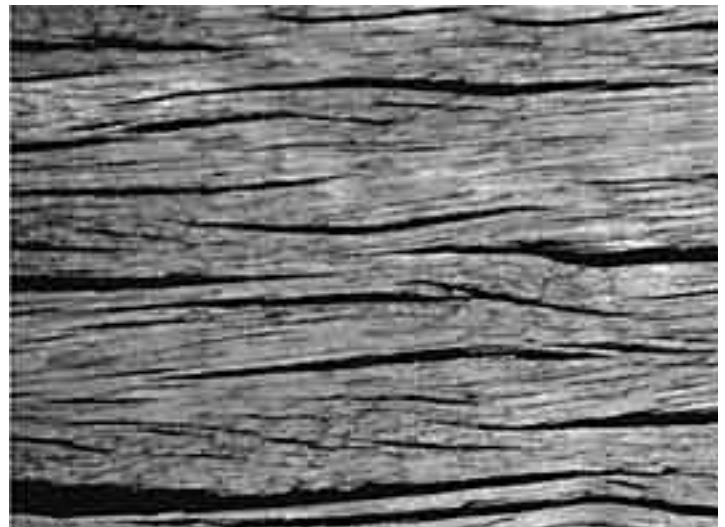
*Figure 9: A small Trex fill after its surface has oxidized.*

Several small horizontal cavities (smaller than a hand) were filled with Trex alone. After routing a firm base and installing borate rods into internal holes, the shaped Trex was dropped in and secured with caulking against the walls. (fig. 9) Another fill method had been installed by others several years ago; here, pigmented epoxy resin had been poured directly into one area of decay. All three fill methods are being monitored for durability and any secondary consequences.
