Up a Creek Without a Paddle: The History and Conservation of an 1870s Birch Bark Canoe

by Daniel Kurtz

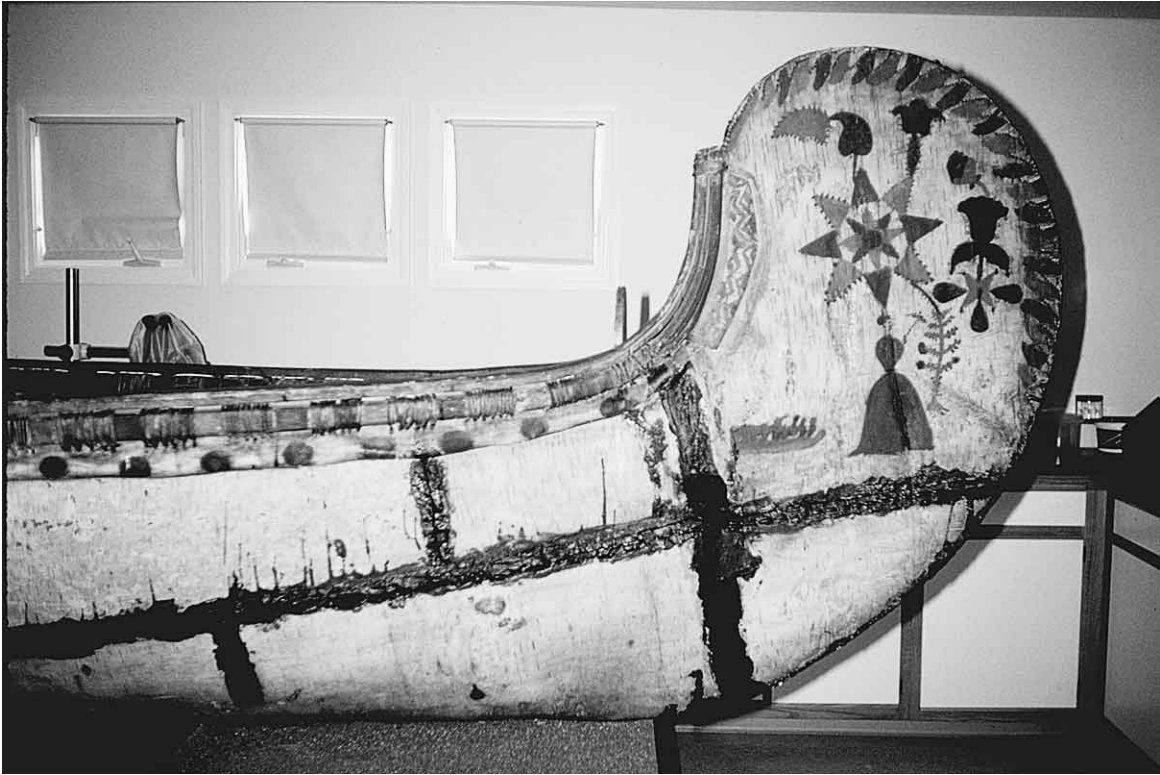
Figure 1: Multicultural iconography: proper right prow, bow end. (after treatment)

This canoe is decorated with paintings that combine Western and Native American iconography. There is an interesting juxtaposition of cultural designs. Images of a woman with a parasol (*fig. 1*), an American flag, stylized flowers and stars, a hand, a bird (all reminiscent of Pennsylvania Dutch iconography), a peace pipe, a fish, and Indians hunting with bows and rifles can be found on the prows of this canoe.

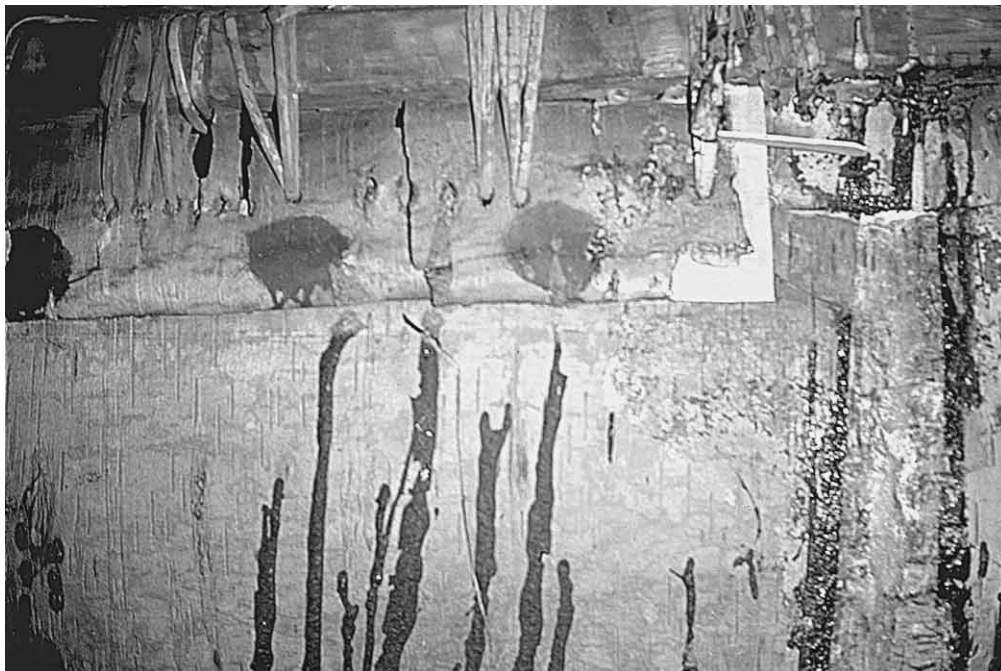
The majority of the lashings which held the bark to the gunwales were missing. An estimated 40% of the lashings, made up of as many as three different materials, remained. The original spruce root lashings had become significantly embrittled to the point that fewer than 10% of the original were extant. Those areas which did have original root lashings were insecure as the lashings no longer had the strength or flexibility to support the bark. Several additional materials were used to replace the lost lashings. These included a dif-

ferent variety of root and wicker caning. (*fig. 3*) Only the caning, which was different in color and texture than the original remained strong enough to lend adequate structural support. These cane lashings were found to be stable in all areas where they held the thwarts in place.

Figure 3: Missing and previously replaced lashings.

The missing lashings and areas where the lashings were too brittle to provide sufficient support to the bark were replaced using a substitute material. Three sheets of plain white blotting paper were toned with Liquitex acrylic paints then laminated using the Rhoplex. Strips of the appropriate width were then cut and wrapped around the gunwale through the original lashing holes to simulate the original lashings. The replacement lashings were then toned with Liquitex to match the remnants of original lashings. This material proved to be quite flexible and surprisingly strong. It provided a good

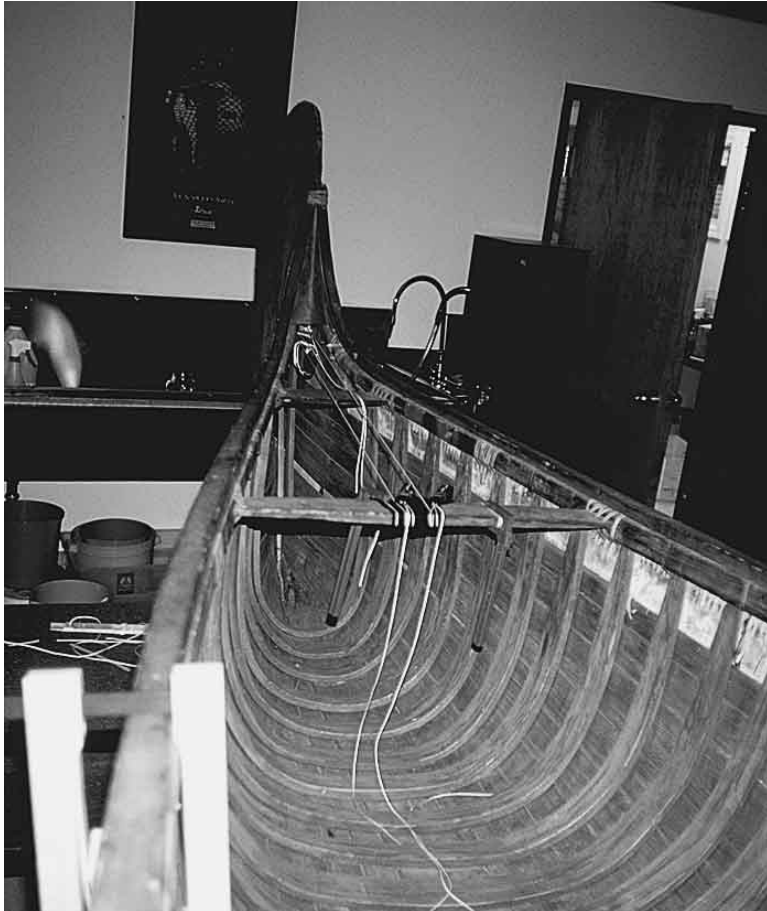
Figure 4: Tying up bow during structural repairs.

Structural repairs to the bow involved removing the end cap, and tying thin nylon cord around the structural wooden elements to replace the degraded twine. Two pieces were used in each of three areas: along the top, at the bottom, and in the center of the prow. All the cords were pulled taut and clamped to one of the thwarts to achieve the best possible positioning of the bow end. (*fig. 4*) The top two cords were then fished under the ribs just under the gunwales to the first thwart where they were tied off using extant holes from the original lashing of the bark to the gunwales. The bottom two cords were run under the ribs along the bottom center of the canoe and tied off to a small board tacked to the side of the third rib. The center two cords were used to simulate the original construction of the canoe by pulling them taut through the holes in the end cap and pegging them in place. The stern, which had not split off as

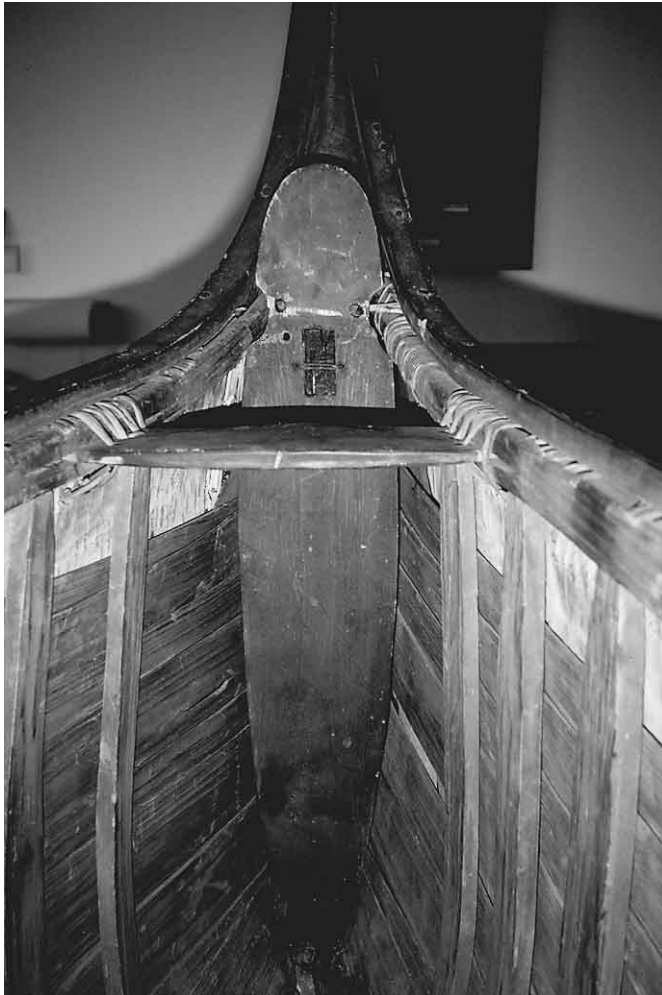
Figure 5: Bow end after treatment.

had the bow, was structurally reinforced by tying two cords around the structural elements of the prow in the center. This was possible as the large loss allowed access to the prow. The cords were then pulled taut and fed through the end cap holes and pegged, again in simulation of the original construction. The cords were then toned to look like twine, using Liquitex acrylic paints. (*fig. 5*)

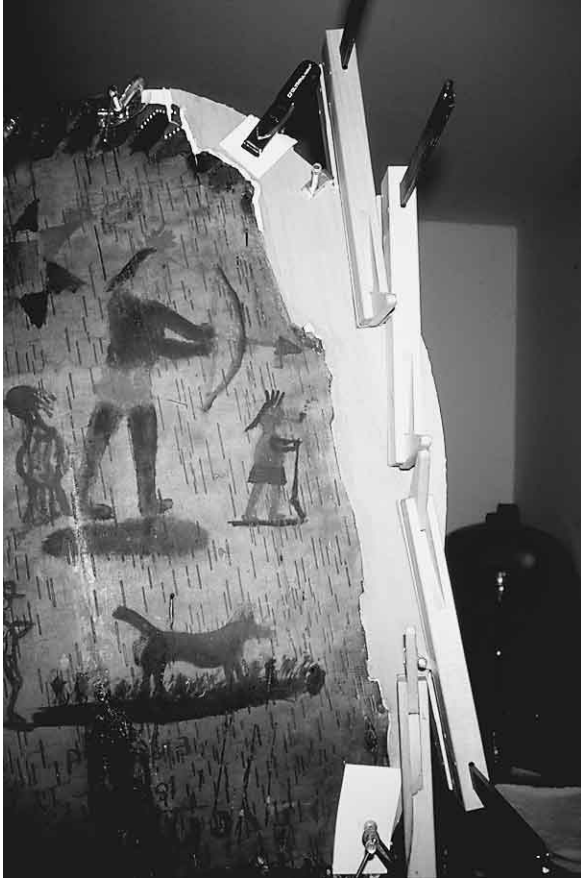
Figure 6: Attaching mat board fill to proper left prow, stern end.

Losses in the birch bark were filled with 100% cotton rag four-ply mat board toned with Liquitex acrylic paints. After any cracks in the area were mended, the losses were backed with Japanese tissue bandages spanning horizontally across the loss, adhered with diluted Rhoplex. These bandages were made large enough to allow for the natural expansion and contraction of the bark. The mat board was then cut to fit and thinned with a scalpel to the appropriate thickness. The fill was then inserted and adhered to the Japanese tissue using the Rhoplex. In areas where the cracks remained evident after application of the fill, the join was covered using either toned Japanese tissue or thinned, toned mat board. The large loss to the stern, port side prow was filled using toned mat board cut to the shape of the loss. (*fig. 6*) It was then joined using strips of Japanese tissue to back the repair. The fill was then covered with toned Japanese tissue which was applied over the join and over the prow end to secure the fill in place. Texture was added to the mat board fills using a variety of tools such as spatulas, awls, and screwdrivers. All fills were inpainted to match the surrounding areas with Liquitex acrylic paints. (*fig. 7*)

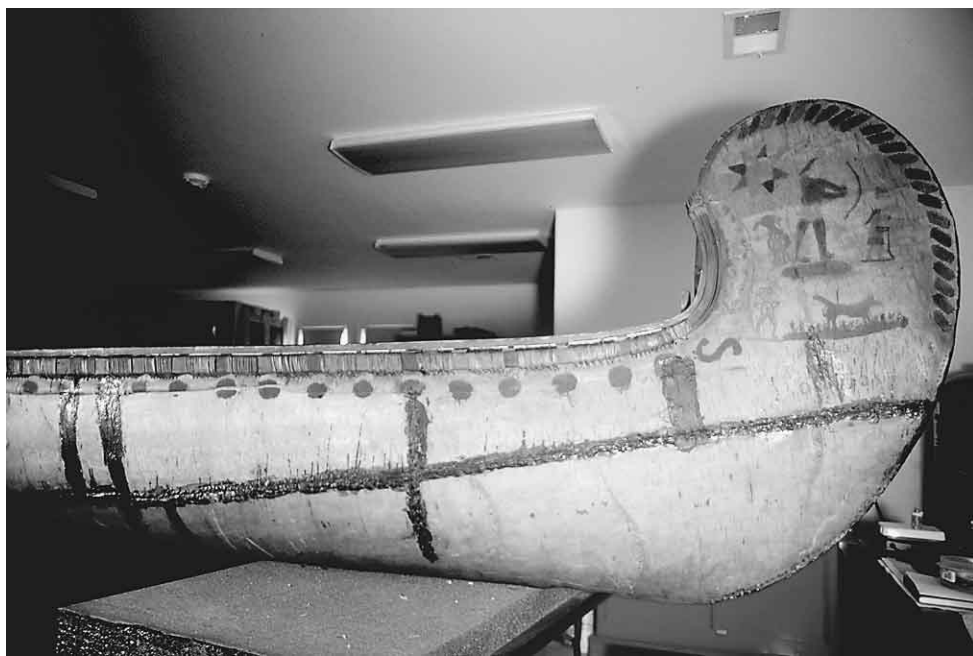
Figure 7: Proper left prow, stern end (after treatment).

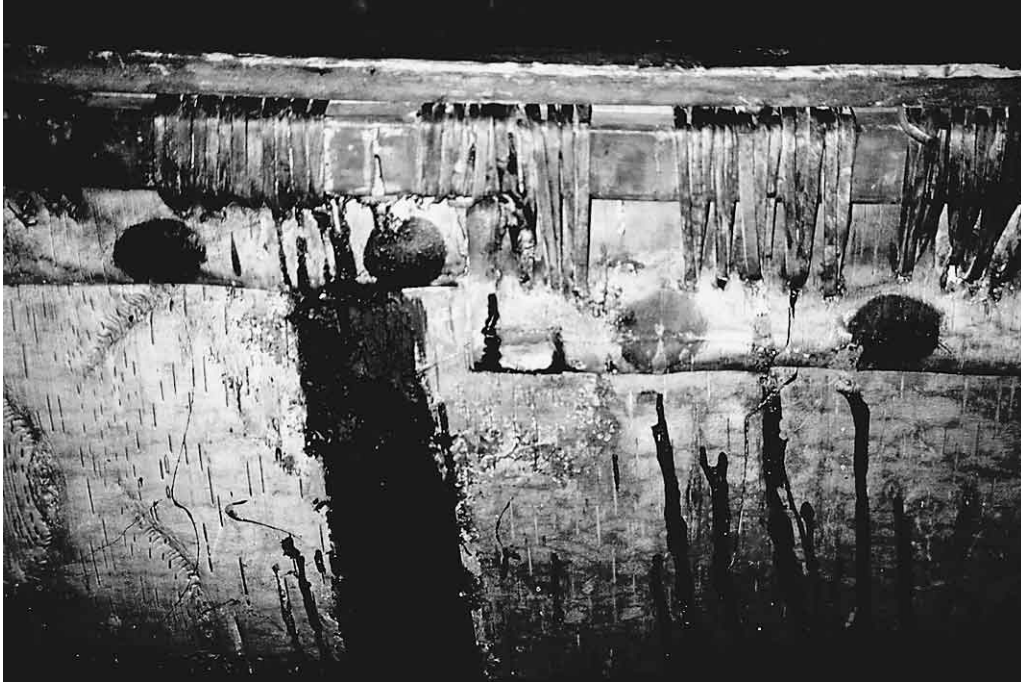
Figure 8: Replaced and toned lashings, bark, and pitch.

simulation of the original but can be easily distinguished upon close inspection. As much of the remaining original lashings as possible were kept intact and consolidated as needed using Rhoplex. The stable, earlier replacement lashings were also toned with the Liquitex. (fig.8)
