Up a Creek Without a Paddle: The History and Conservation of an 1870s Birch Bark Canoe

by Daniel Kurtz

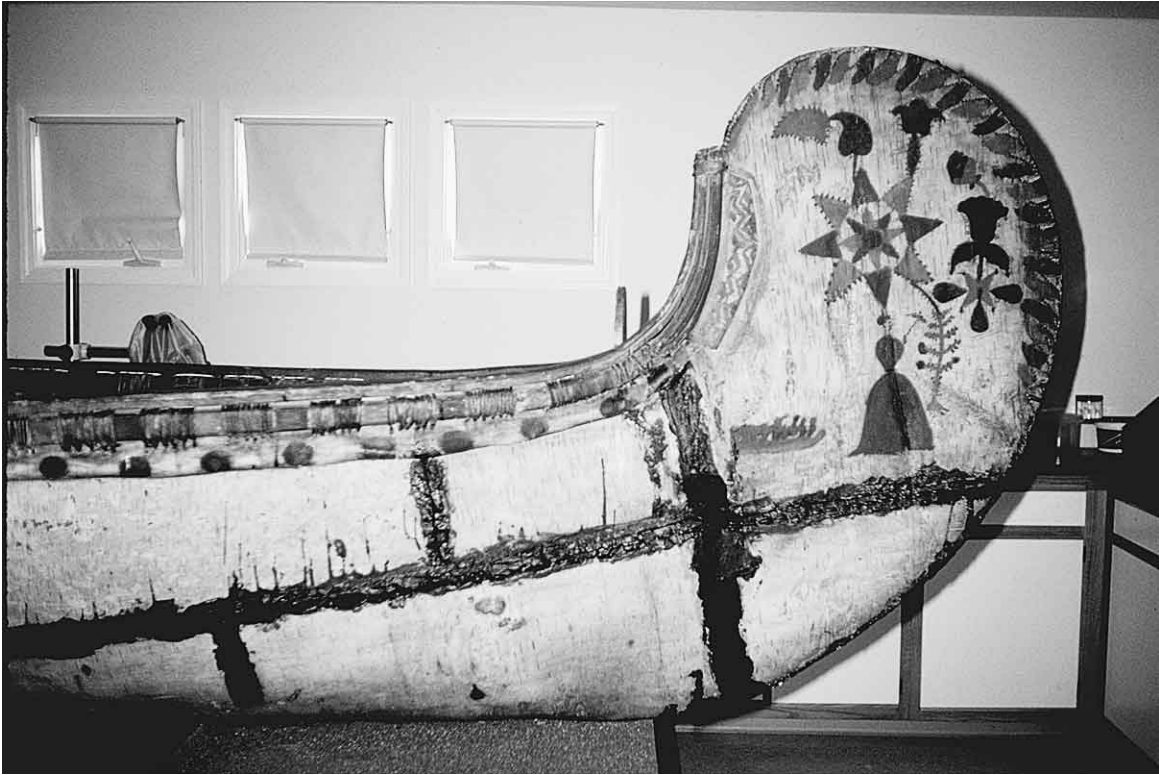
Figure 1: Multicultural iconography: proper right prow, bow end. (after treatment)

This canoe is decorated with paintings that combine Western and Native American iconography. There is an interesting juxtaposition of cultural designs. Images of a woman with a parasol (*fig. 1*), an American flag, stylized flowers and stars, a hand, a bird (all reminiscent of Pennsylvania Dutch iconography), a peace pipe, a fish, and Indians hunting with bows and rifles can be found on the prows of this canoe.

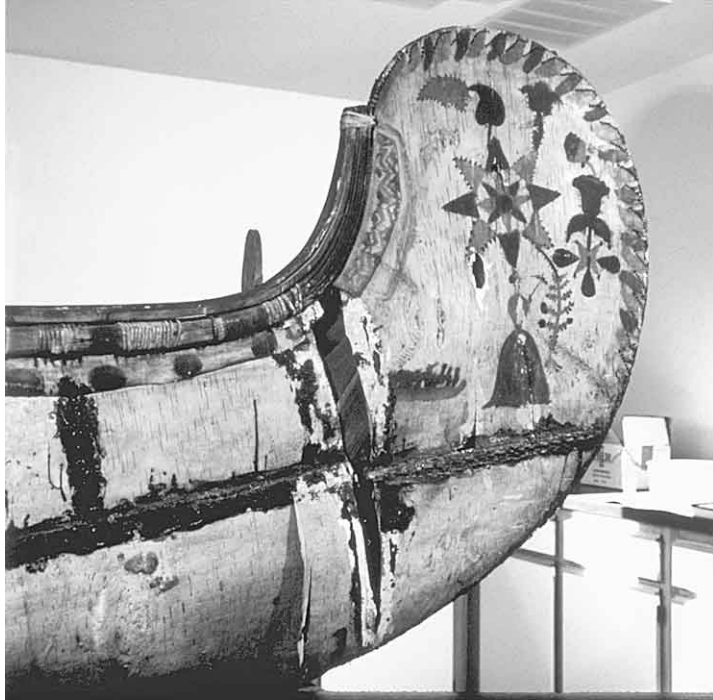
Figure 2: Structural damages: proper right prow, bow end. (before treatment)

The main concerns with this canoe were the various structural problems. The twine which was used to wrap the prow on both the bow and stern ends had become extremely brittle and had failed in several places. The lack of support for the bow had caused it to sag as much as five inches, resulting in the failure of the bark seams nearest the bow end on both sides. The bow was found to be loose and at risk of becoming wholly detached. (*fig. 2*) At the stern, the twine was still connected to the end cap at one point but was not affording much support overall. Small splits had begun to form at the bark seams though they had not opened up enough to cause the end to sag.

Structural repairs to the bow involved removing the end cap, and tying thin nylon cord around the structural wooden elements to replace the degraded twine. Two pieces were used in each of three areas: along the top, at the bottom, and in the center of the prow. All the cords were pulled taut and clamped to one of the thwarts to achieve the best possible positioning of the bow end. (*fig. 4*) The top two cords were then fished under the ribs just under the gunwales to the first thwart where they were tied off using extant holes from the original lashing of the bark to the gunwales. The bottom two cords were run under the ribs along the bottom center of the canoe and tied off to a small board tacked to the side of the third rib. The center two cords were used to simulate the original construction of the canoe by pulling them taut through the holes in the end cap and pegging them in place. The stern, which had not split off as

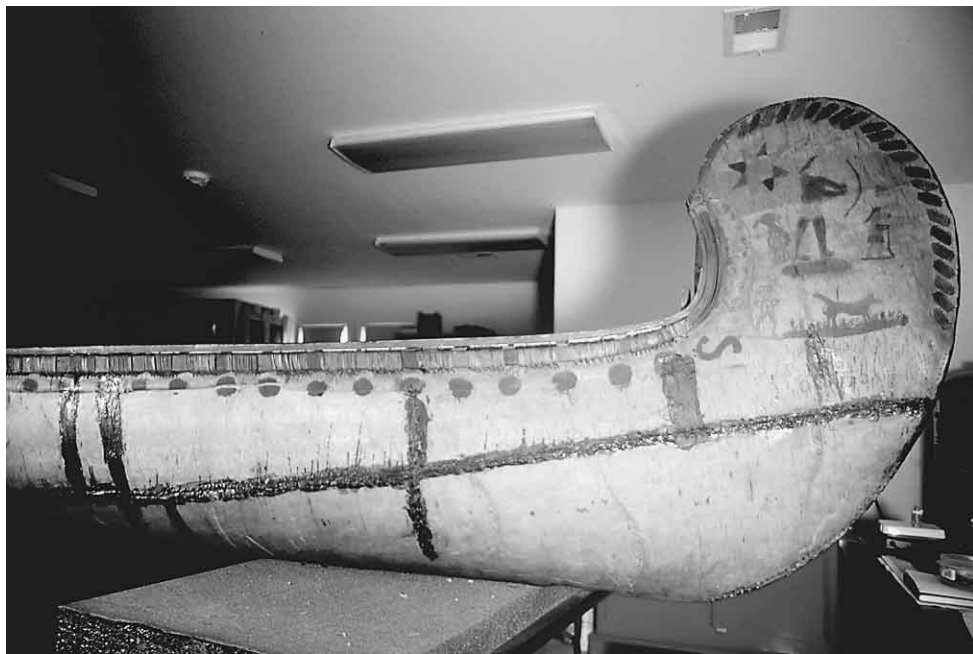
Figure 7: Proper left prow, stern end (after treatment).

Losses in the birch bark were filled with 100% cotton rag four-ply mat board toned with Liquitex acrylic paints. After any cracks in the area were mended, the losses were backed with Japanese tissue bandages spanning horizontally across the loss, adhered with diluted Rhoplex. These bandages were made large enough to allow for the natural expansion and contraction of the bark. The mat board was then cut to fit and thinned with a scalpel to the appropriate thickness. The fill was then inserted and adhered to the Japanese tissue using the Rhoplex. In areas where the cracks remained evident after application of the fill, the join was covered using either toned Japanese tissue or thinned, toned mat board. The large loss to the stern, port side prow was filled using toned mat board cut to the shape of the loss. (*fig. 6*) It was then joined using strips of Japanese tissue to back the repair. The fill was then covered with toned Japanese tissue which was applied over the join and over the prow end to secure the fill in place. Texture was added to the mat board fills using a variety of tools such as spatulas, awls, and screwdrivers. All fills were inpainted to match the surrounding areas with Liquitex acrylic paints. (*fig. 7*)
