# After the deluge: The conservation of two Chinese chests

Kathy Z. Gillis, Assistant Objects Conservator, Virginia Museum of Fine Arts, Richmond, Virginia

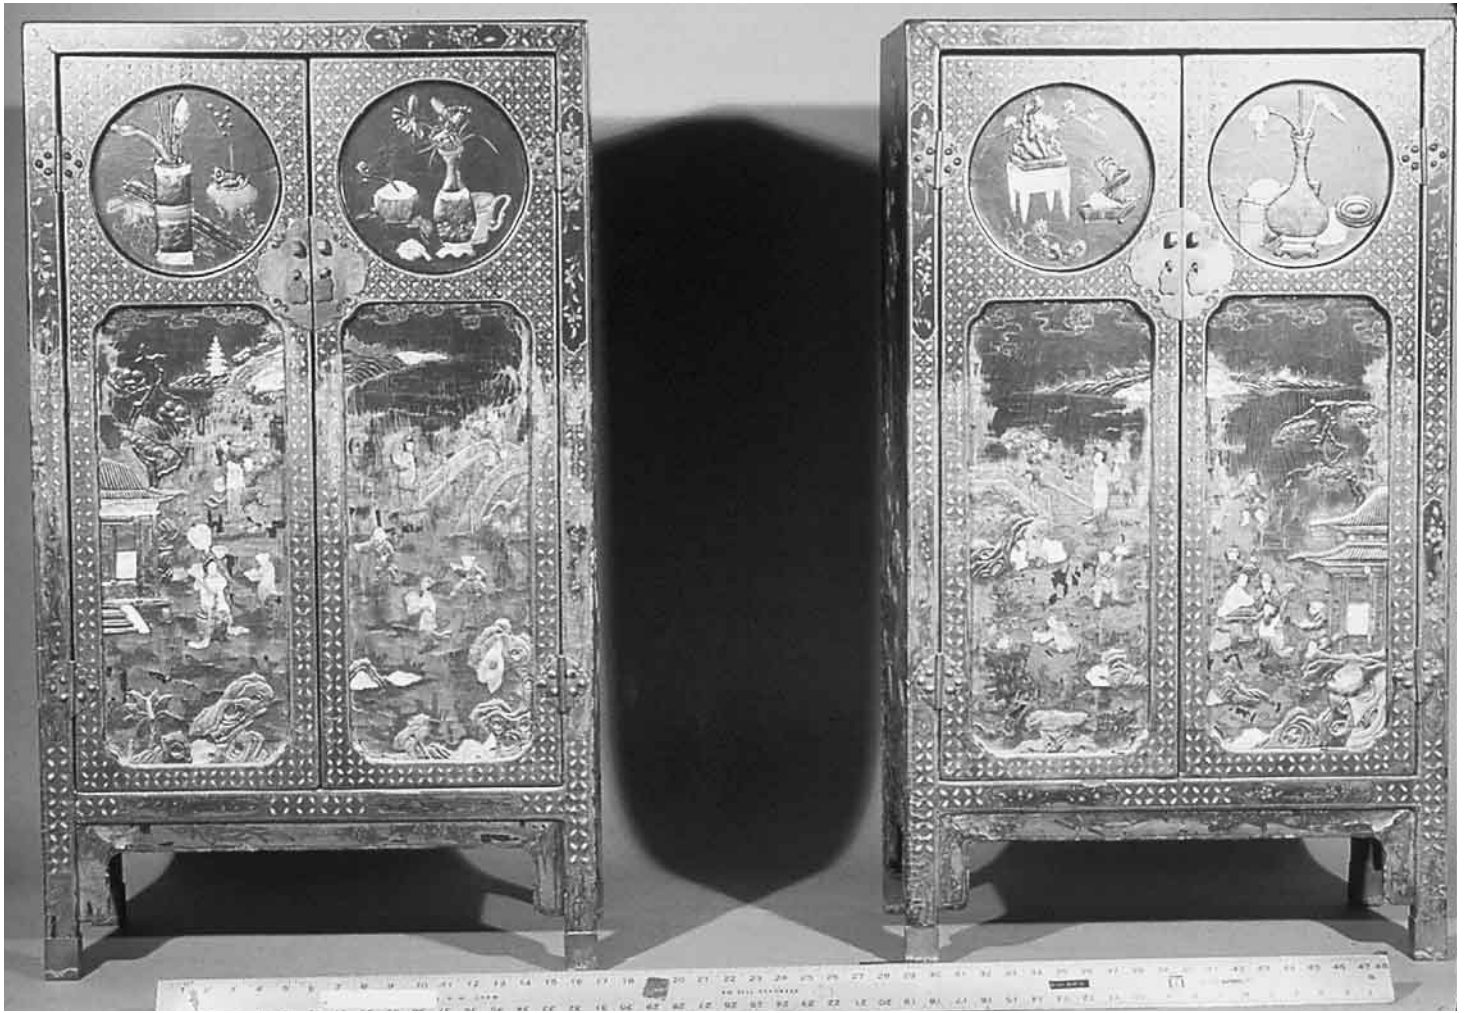
*Figure 1: Before treatment, Chest "A" and Chest "B"*

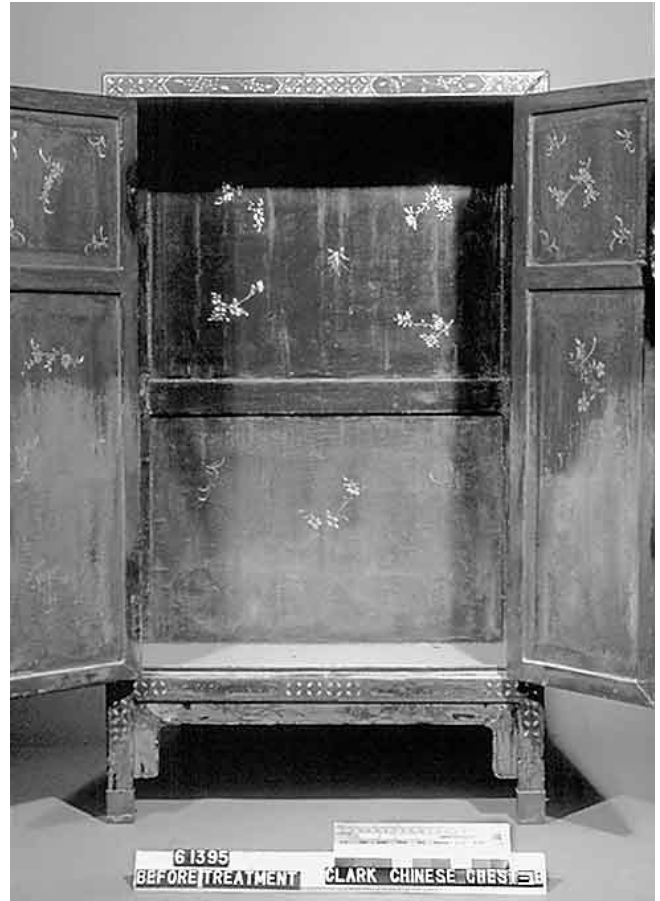
Both the exterior and interior surfaces were affected. (*fig. 2*) On the interior, the coating was blooming, but not actively flaking. The exterior varnish, however, was delaminating from the lacquer. Surprisingly little damage was evident in the wooden structure under the lacquer. The lacquer coating seemed to act as an excellent water barrier. The wooden and ground components under the lacquer were only damaged in areas where there was previous structural damage to the legs of one of the chests.

Figure 2: Before treatment, Interior, Chest “B”

The interior coating and the back of the chests responded more easily to testing for resolubilization and evening out, and therefore did not necessitate complete removal. This option was preferred on the interior, since the décor was on top of the varnish. A 50:50 solution of acetone and ethanol was used for this resolubilization. Some severe areas of blanching inside the chests were removed by swabbing with pure acetone. These areas fortunately did not hold any decoration (fig. 6).

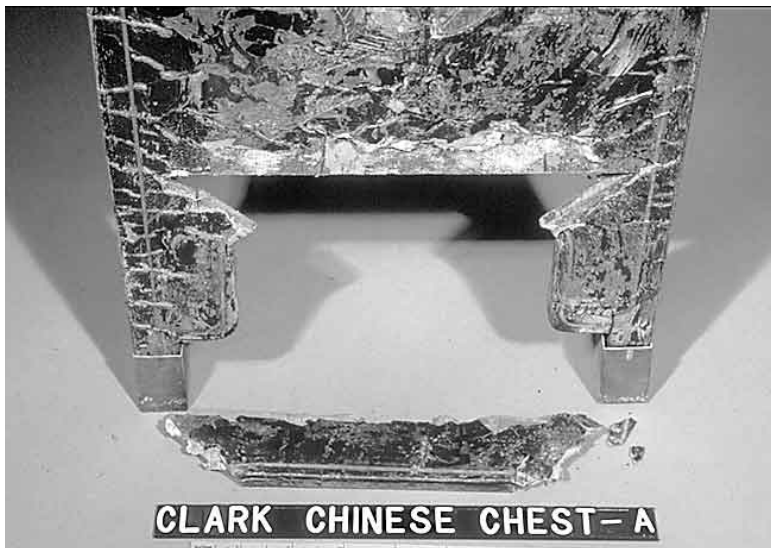
This was the case for one of the patients (Chest “A”) where a portion of the material between the proper left legs had been detached. (*fig. 3*)

*Figure 3: Before treatment, structural damage to Chest "A" proper left side.*

The detached piece from the bottom proper left side of Chest "A" was reattached to the chest using hot hide glue and Acryloid B-72 acrylic resin in acetone. Loose pieces of wood around the legs and the top front moldings on the interiors of both chests were secured using hot hide glue. Areas of flaking lacquer, areas of loss, and areas adjacent to losses were consolidated using solutions of Acryloid B-72 acrylic resin in acetone. The concentrations of resin-to-solvent varied from 20% to 30%.

The losses around the detached piece were filled using a wax-resin mixture (polyvinyl acetate AYAC, ethylene acrylic acid copolymers A-C 540 and A-C 580, and an antioxidant, Irganox 1076). This fill material had been used with good results and undergone testing over a number of years by John Burke, Chief Conservator at the Oakland Museum, as well as other conservation professionals. A barrier coat of polyvinyl acetate AYAC was applied to the surfaces to be filled. The fill material had good adhesion to the barrier layer, was easily sanded with acetone, produced a sheen similar to the lacquer, and was easy to control. Color matching proved to be the biggest challenge, since dry pigments had to be added to the wax-resin mixture during its preparation. Since the color of the lacquer was not completely uniform, it was difficult to achieve a match that was suitable in all areas of loss. The wax resin was heat-set into place and

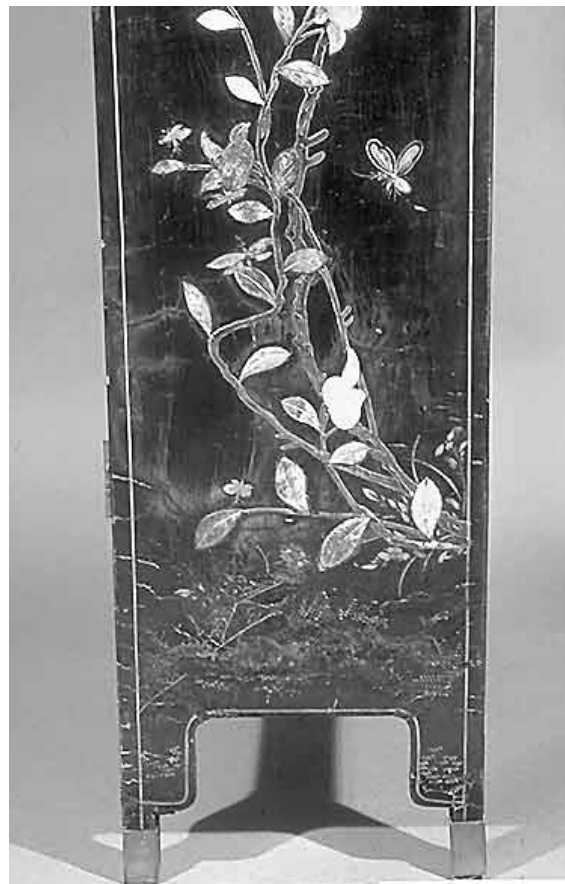
*Figure 4: After treatment, area of loss on Chest "A"*

solvent-polished using acetone on cotton swabs. Additional smaller areas of loss on both chests were filled using this mixture and/or pigmented wax. (fig. 4) Subsequent to this treatment, information about this fill material was published in the Spring 1997 *Journal of the AIC*, in an article by Susanne Gänsiecke and John W. Hix, entitled "A Translucent Wax-Resin Fill Material for the Compensation of Losses in Objects."

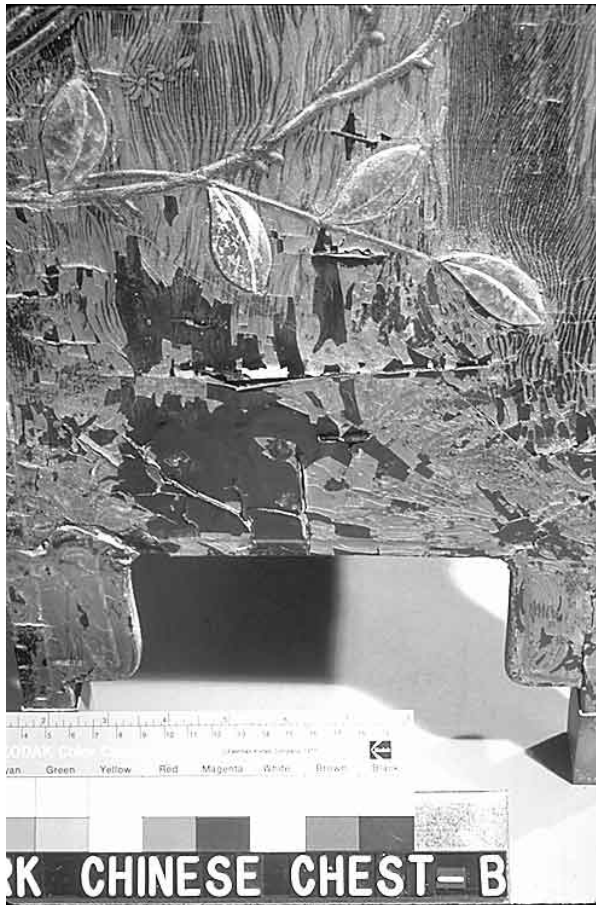
The exterior varnish layer, which was actively flaking, was soluble in acetone, fluoresced yellow-green under ultraviolet (UV) illumination, and burned rapidly, indicating the likelihood of a cellulose nitrate-based coating. Under UV examination, it was also apparent that the existing coating had been sprayed on, without removing the hard-

**Figure 5: Detail of flaking varnish, Chest "B"**

Although testing was carried out for the feasibility of resolubilizing the varnish, in many areas, the varnish was literally falling off in large sheets. (fig. 5) Much of the varnish, therefore, could be easily removed mechanically, and wooden applicators, microspatulas, and Teflon spatulas were used in this phase of the treatment. On the exterior of the chests, varnish that did not pop off easily was removed using acetone on cotton pads and swabs. The coating on the upper third of the chests, where the varnish had not been affected by the water, was also removed using acetone. This was done

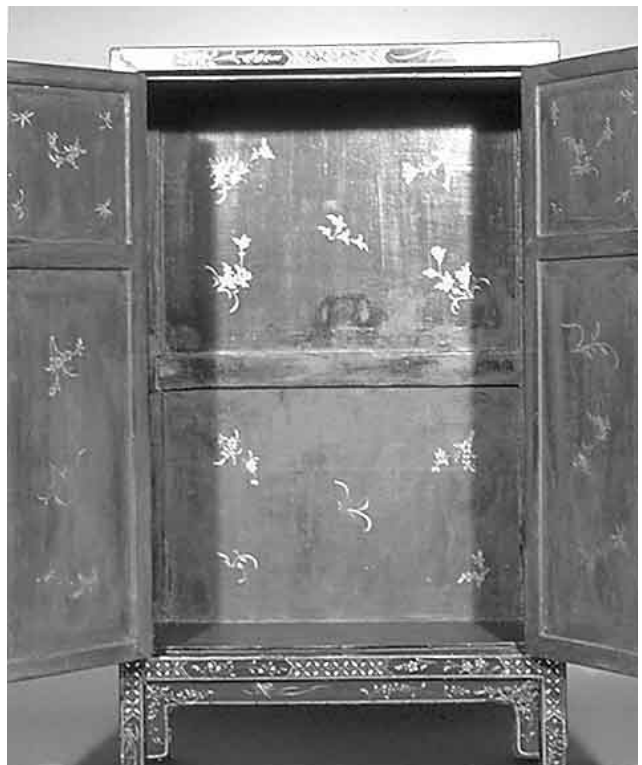
**Figure 6: After treatment, Interior, Chest "A"**

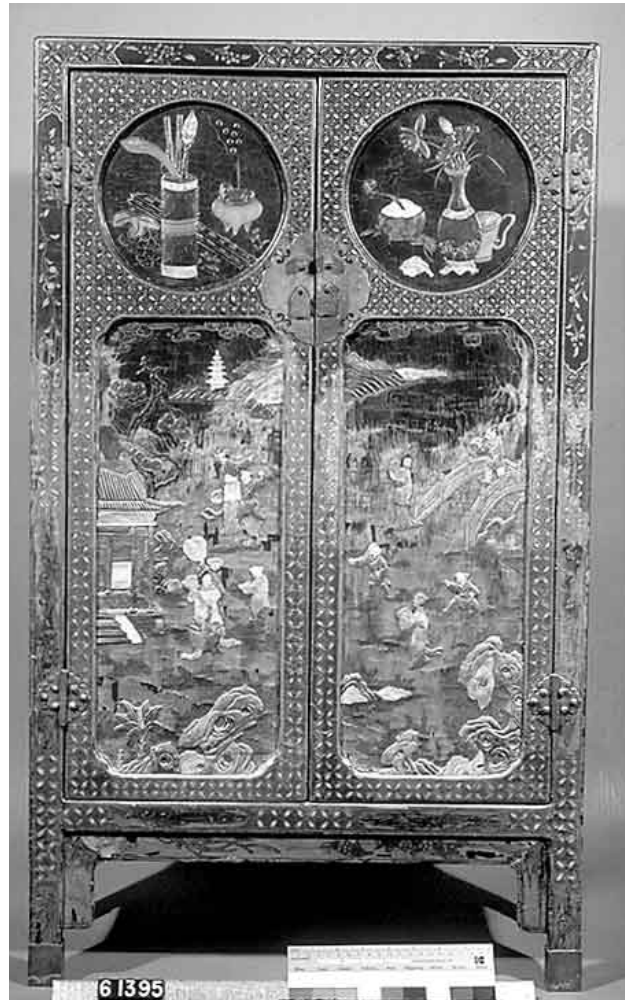
Figure 7: Before treatment, Chest “B”

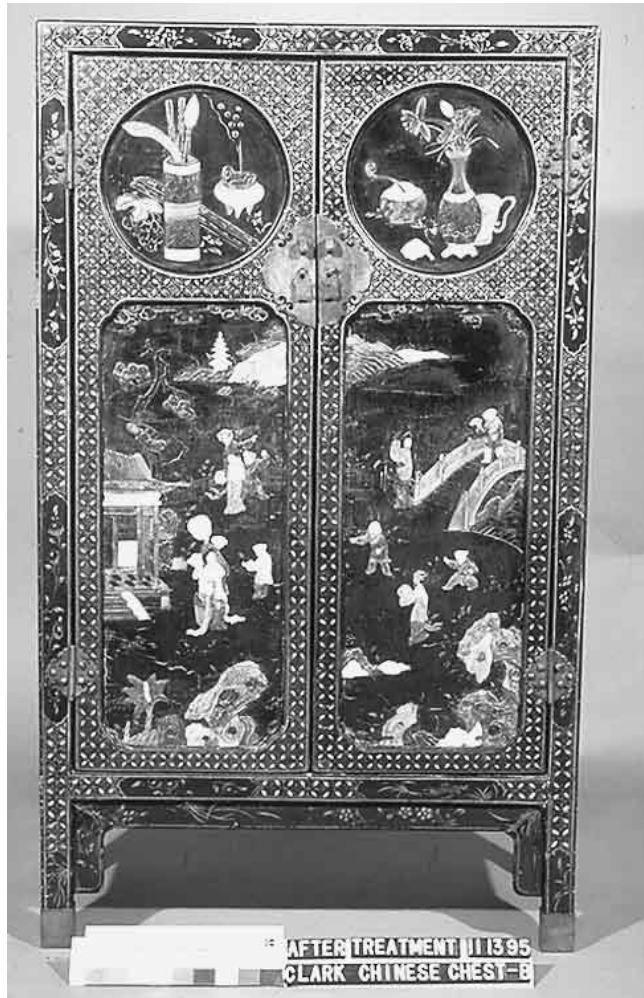
The areas that had not experienced flaking varnish on the upper third of the chest did not change appreciably in appearance as a result of the treatment. The remaining areas, however, did change. (figs. 7 & 8)

Figure 8: After treatment, Chest "B"

sen was polycyclohexanone resin (Larapol K-80) in Stoddard and toluene. Irganox 1076 was added to this mixture to hinder cross-linking of the resin. This coating could be brushed over the exterior lacquered surfaces providing a thicker coating than the previously sprayed varnish. Larapol was also applied to any interior surfaces where blanching varnish had been removed. We wanted a coating that could be removed with solvents other than acetone so that the coating we had applied could be distinguished from the acetone-sensitive coating that had been resolubilized on the interior. In addition, all exterior surfaces were then waxed using Renaissance Wax to add an additional moisture barrier.
