Wood Conservation in Cuba: Treatment of a Chinese Altar in La Habana Vieja

Elisabeth Cornu, Fine Arts Museums of San Francisco with

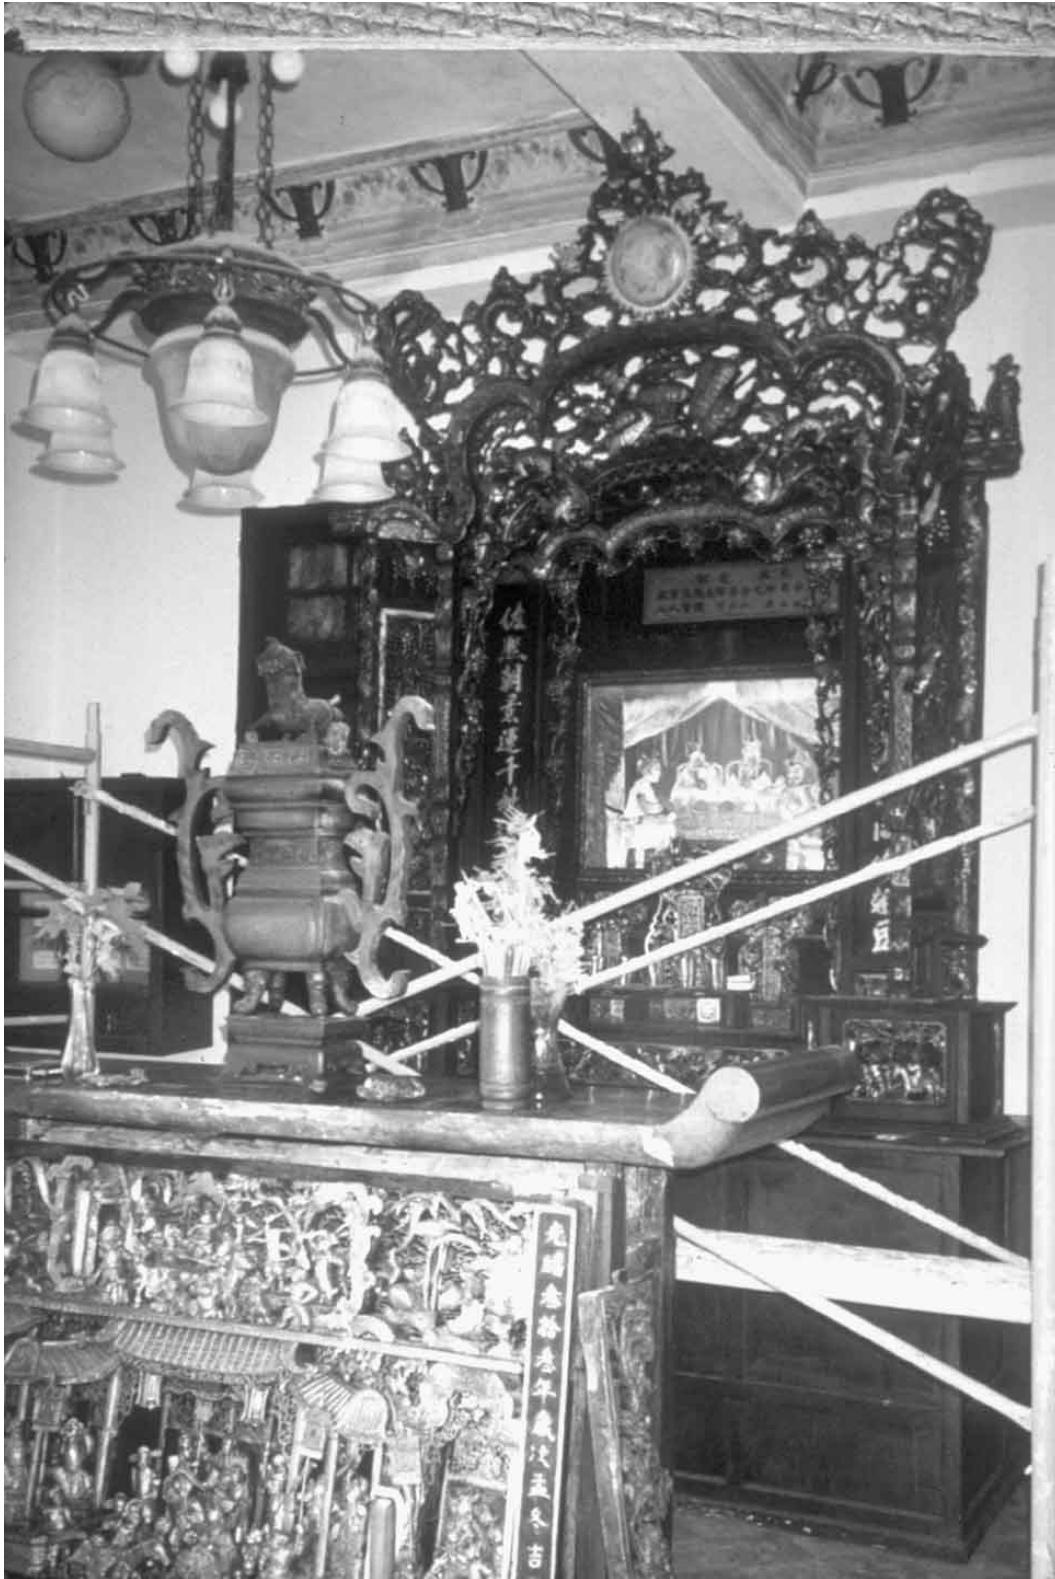
Altar before treatment—lower wood panel is detached due to insufficient ceiling height.

restored approximately ten years ago. Some of the original gilded layers had been covered with a synthetic varnish with bronze powder. In some areas where the gold leaf had worn off, exposing the original red lacquer, a thin layer of synthetic dark brown paint was present. Many joins of the panels, originally built to be disassembled, were fixed with nails and screws, causing cracks and degradations of the wood due to the oxidation of the nails.

– Restoration of structural damages. The support table in the lower section was the most structurally damaged element. Wood loss from termite activity had affected its stability and caused the collapse of some of the joints. The table supporting the heavy ceremonial objects was in danger of breaking apart. It was decided to replace the structure of the table which had originally been fabricated in Cuba, and so Alejandro Villalon Yee built an exact reconstruction. The mortise and tenons joints were restored and all elements

of the table could now once more be easily assembled, thereby recovering the original portable function of the Altar.

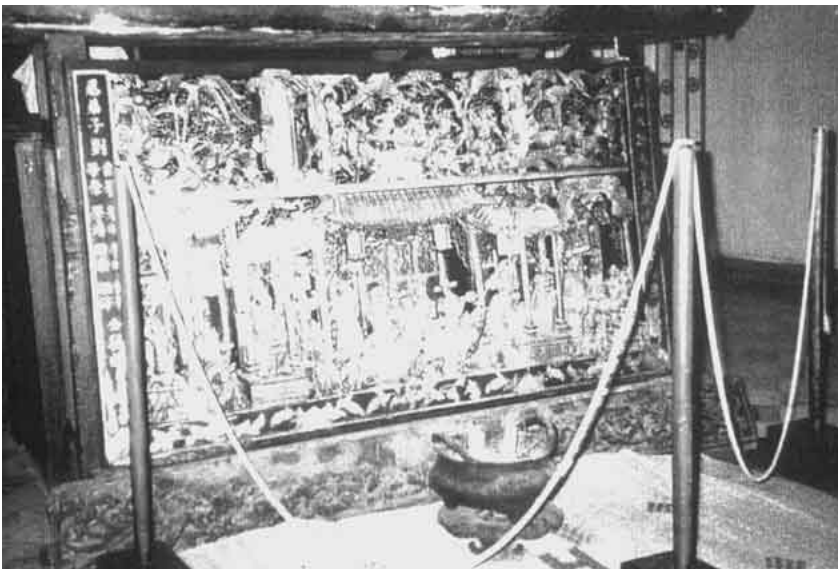
Lower panel shows carving of the battle of the gods, and an incense burner.

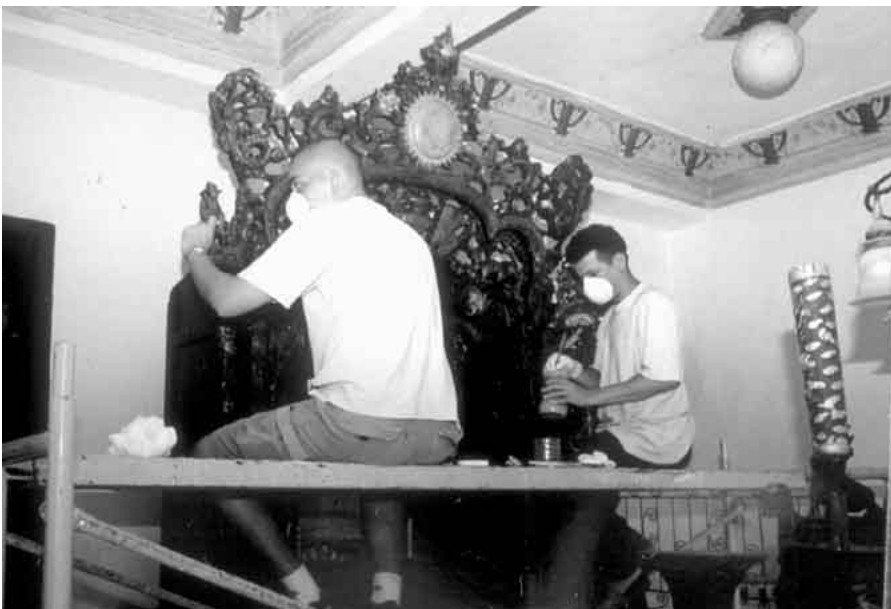
Cleaning process—Amaury Mexias Torres and Alejandro Villalon Yee at work.

- Mechanical cleaning, intended to remove dust and residue of earlier termite activity from the surface, was carried out using brushes and a vacuum cleaner.
- Chemical cleaning. Mechanical cleaning techniques were not able to fully remove the dirt, soot and grease from the gilded and pigmented surfaces of the Altar. A solvent mixture (ethyl and benzyl alcohol and acetone) in Carbopol 934 was found to be the most effective. This was applied carefully and the treated areas were cleaned of all remnants of the solvent gel with mineral spirits. Over a period of several months the decorative elements of the Altar were successfully cleaned. In the other parts of the Altar a different cleaning technique was applied: synthetic enzymatic solutions and solutions including mild detergents in mineral spirits successfully removed less stubborn surface dirt.
