# “There is a house that is no more a house” Conservation of the Painted Wall Paneling in Shelburne Museum’s Stencil House

*Nancie Ravenel, Objects Conservator, Shelburne Museum*

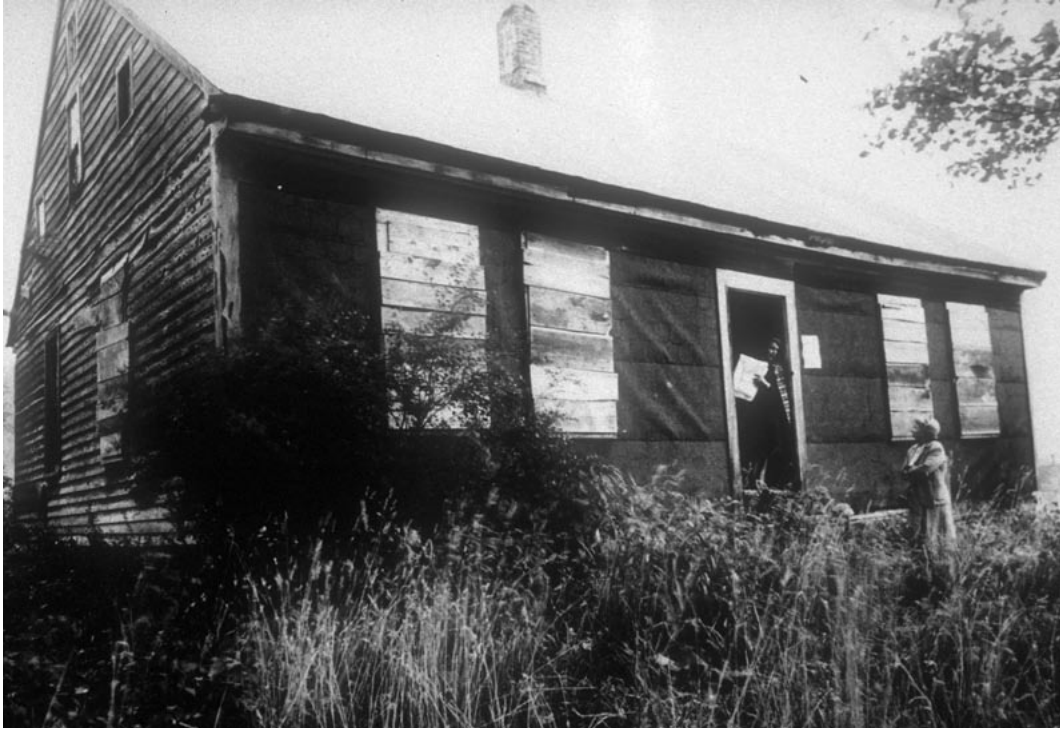
Figure 1. Exterior of the Stencil House in Columbus, NY, 1952.

When the painted wall paneling from the Stencil House came to Mrs. Webb's attention in 1952 it was covered by about five layers of wall paper (figs. 1 & 2). And rather than the house itself, it was really these painted walls that grabbed her interest. In a letter dated October 1952 to American Decorative Arts scholar Nina Fletcher Little, Mrs. Webb writes:

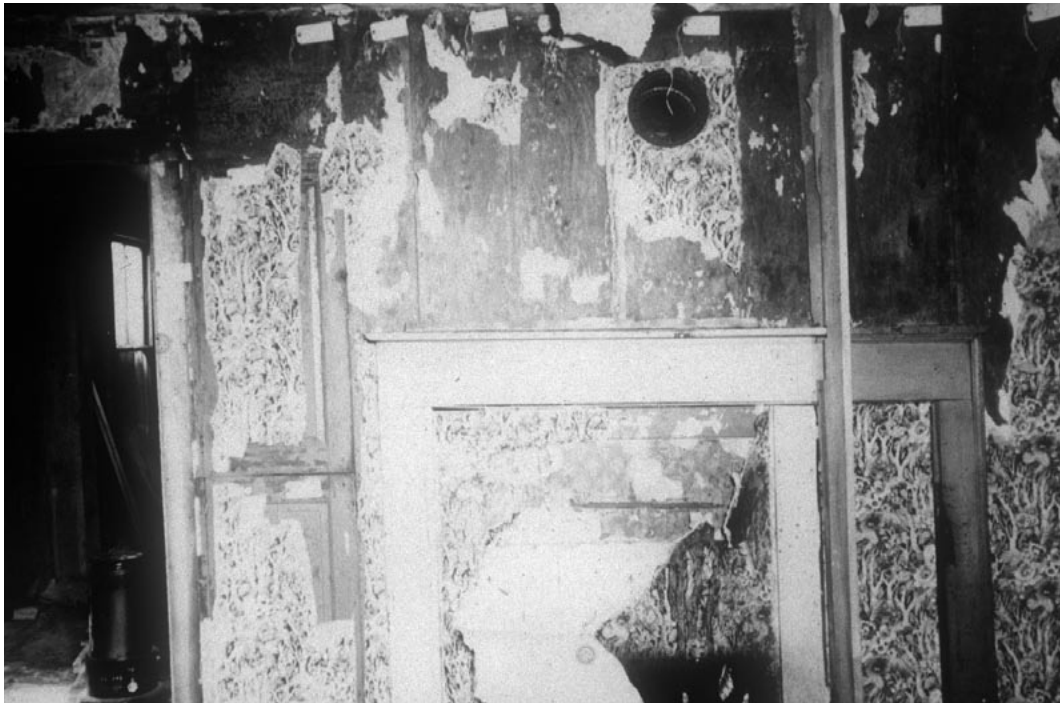
Figure 2. Stencil House dining room before disassembly in Columbus, NY, 1952.

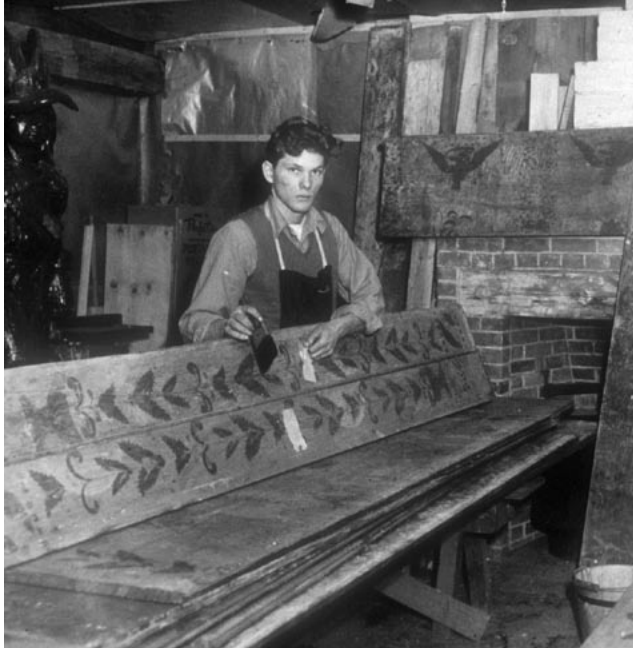
Figure 3. Alan Munro working on Stencil House paneling, circa 1954.

After the house arrived in the 1950s, Alan undertook most of the work on the painted wall paneling in the parlor (fig. 3). It appears he also worked in the front hallway, but probably did not work in the dining room. Generously, he described his methods of removing the wall paper and incorporating new wood boards with the old.

He described the Stencil House work to Letitia as a “dirty, dusty, lousy job.” His system for incorporating new boards into the old was to first coat them with a protein glue based gesso to give them the right textural feel, then to apply an oil-based paint. The appearance of age, the old hand-worn appearance Mrs. Webb so desired, was provided by a layer of varnish followed by paste wax on to which rottenstone, raw umber dry pigment, and pumice were worked into the surface.<sup>4</sup>

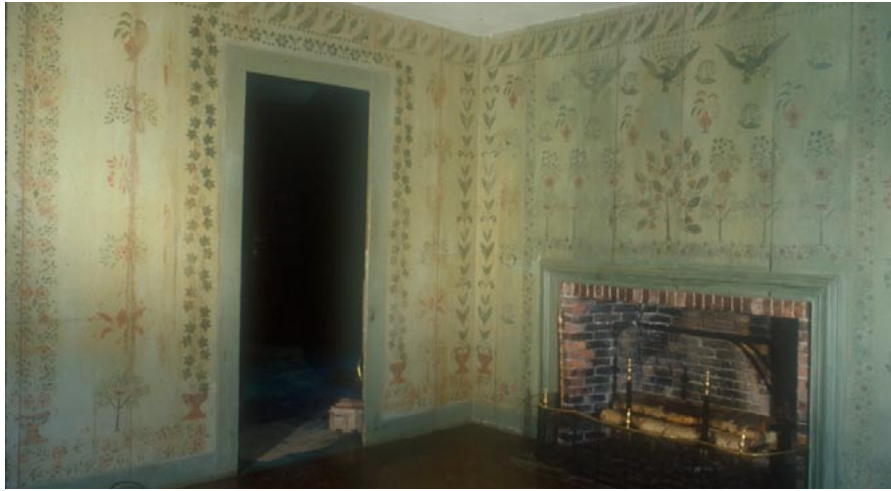
By 1990 Alan’s varnish had unevenly discolored in the parlor and the front hallway, and the painted surfaces in the dining room were cracking and shearing off the wood paneling (figs. 5&6). For more specificity of what was done to the walls,

Figure 5. View of two parlor walls, 1990.

To support our observations, cross sectional samples were taken throughout the house and stained with fluorescent dyes to indicate the media in the layers. There was a good deal of original paint visible under the varnish and wax layers that had been applied by Alan Munro in the parlor and front hallway. Samples from the parlor and front hallway show a priming layer of glue, topped with a distemper paint, followed by the varnish that Alan described applying. In the front hallway and parlor, the discolored varnish was removed and overpaints were reduced creating a more unified appearance to the walls.

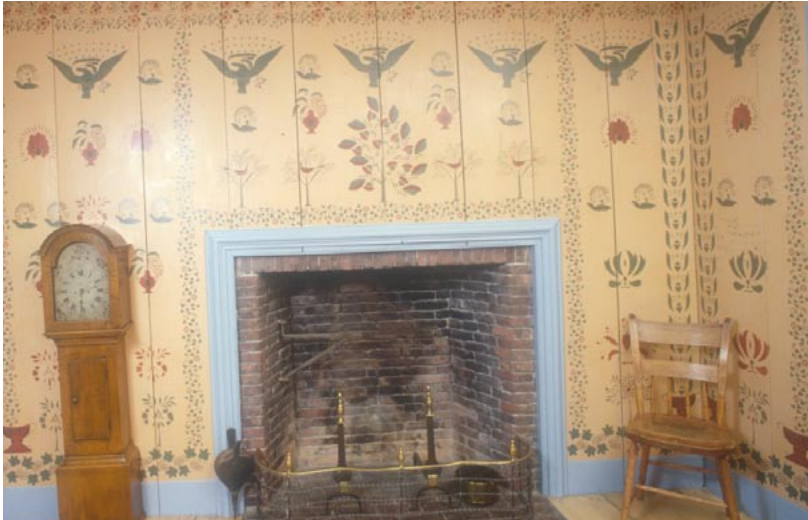
Figure 7. Fireplace wall in dining room after repainting, 2000.

After the dining room walls were documented as they existed, the flaking paint resulting from the 1950s restoration was mechanically stripped. Where gesso was not present, the surfaces were coated with an isolating layer of Acryloid B72 prior to repainting. Finally the stencil-painted decoration on those walls was recreated using the salmon color discovered in the analysis as the background color and repeating the stencil pattern applied in the 1950s (fig. 7).
