# Adirondack Rustic Architecture and Regional Watercraft: Case Studies of Artifact Use at the Adirondack Museum

*Doreen L. Alessi, Conservator and Collections Manager, Adirondack Museum*

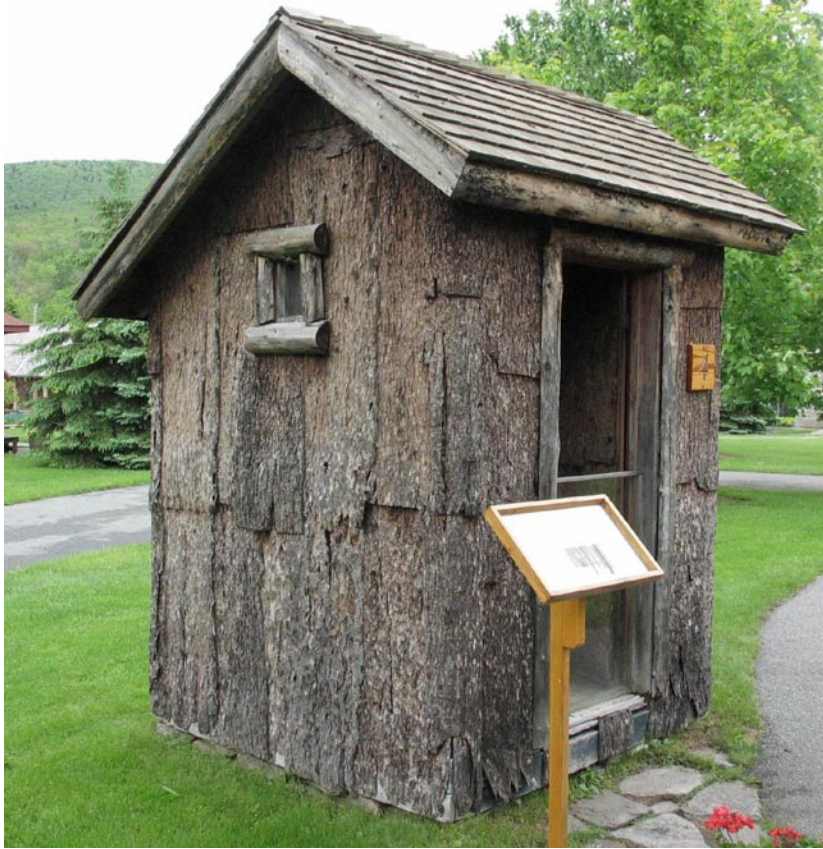
Figure 1. Rustic privy with spruce bark siding and half-log trim, present condition.

The rustic outhouse, (fig. 1) or privy, was built in 1905 and was used at an Adirondack camp until the 1950s. It was moved to the museum in 1961. It is a plank structure with a cedar shingle roof measur-

ing roughly 6' to a side and 9'9" in height. The siding is made of large overlapping sheets of bark that are tacked along the perimeter edge.

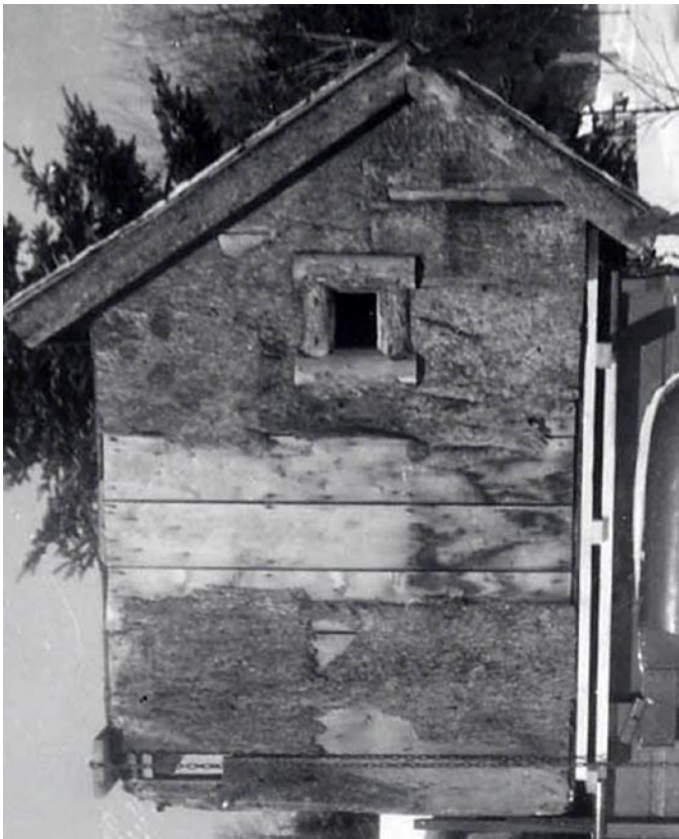
Figure 2. Rustic privy on truck bed, arriving at museum in 1961 (image has been rotated 90 degrees for easier comparison).

Much of the bark exterior of the privy had been lost due to weathering and biological degradation. (fig. 2) Bark has a finite lifetime once it is removed from the tree. Photographic evidence suggests that the use expectancy for spruce bark as siding ranges from 5 to 15 years, depending on the quality of bark and the degree of protection. The two main philosophies regarding bark preservation are:

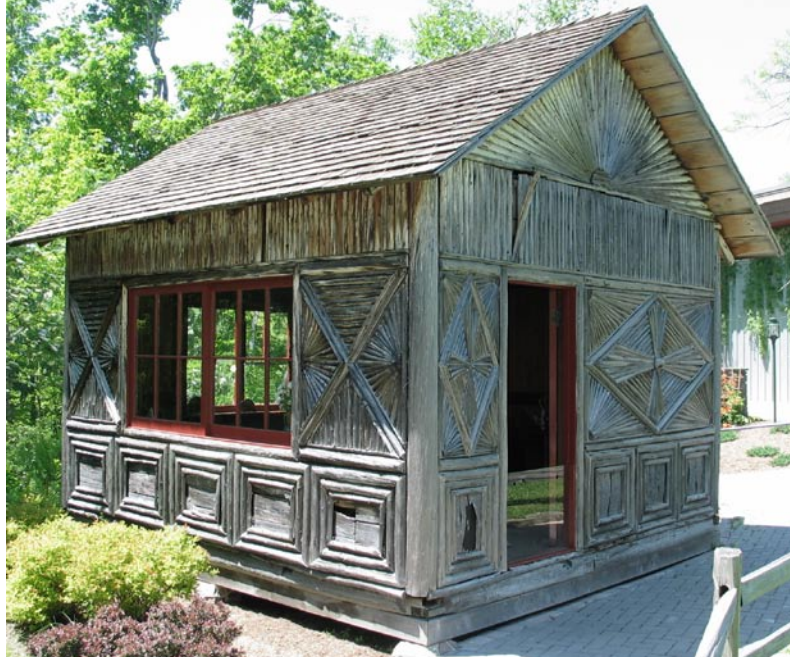
Figure 3. Sunset Cottage, showing pole mosaic with spruce bark inset panels, present condition.

A second rustic structure is Sunset Cottage, a 12' x 15' one-room cabin built ca. 1880. (fig. 3) It is named for the pole design in the gable ends, and is called the finest surviving example known of Adirondack mosaic pole work. Exterior decoration consists of hundreds of half-round bark-covered cedar poles, approximately 1.5 to 2.5 inches in diameter, set to form panels in various symmetrical geometric patterns. On three sides, pole patterns

frame inset panels made of flat sheets of spruce bark. The poles are face-nailed with small cut nails to rough board sheathing, which is nailed to a conventional stud wall framing. A tarred felt material was used between the poles and the sheathing.

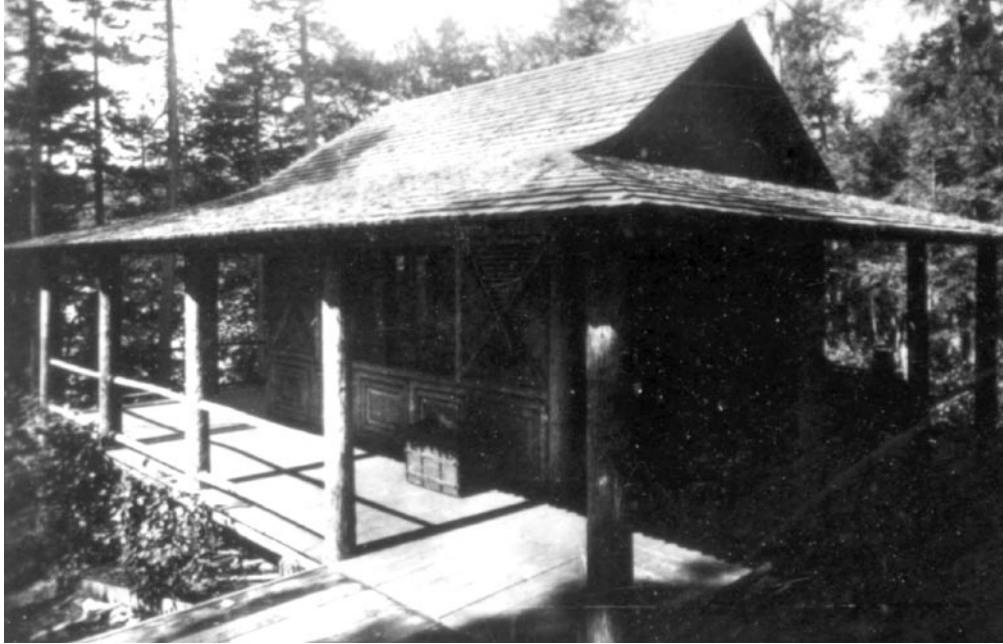
Figure 4. Sunset Cottage at Camp Cedars, original configuration, ca. 1934.

Sunset Cottage had two prior sitings before it was moved to the museum. (fig. 4) Two photos from 1930s insurance documents show the cottage in its original location at Camp Cedars, where it had a porch on three sides, and stood on a hillside on posts. The porch had been removed when the cottage was relocated to Deerland Camp, where it stood on footings by the shore of a lake for forty years. During that time, the cedar shingle roof was replaced with asphalt shingle, and the roofline was slightly altered with the removal of the porch. Sunset Cottage was moved to the museum on a flatbed in 1996. Little was known about its original configuration until after it was installed at the museum. Very few physical clues remain as to how the original porch was constructed and connected.

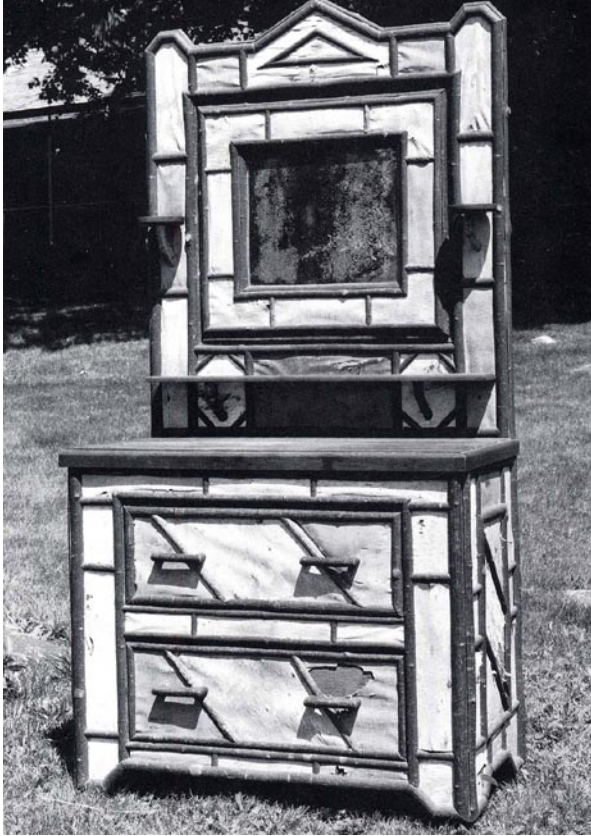
Figure 5. Rustic dresser with applied birch bark and spruce twig trim, before treatment (note loss on bottom drawer front).

A dresser decorated with applied birch bark and spruce twig trim suffered a large loss on the proper left panel of the bottom drawer front. (fig. 5) The loss was filled using mulberry paper toned with acrylics and scored to mimic the appearance and texture of birch bark. (fig. 6) It is adhered at the edges to the reverse of the birch bark with Aytex-P wheat starch paste.

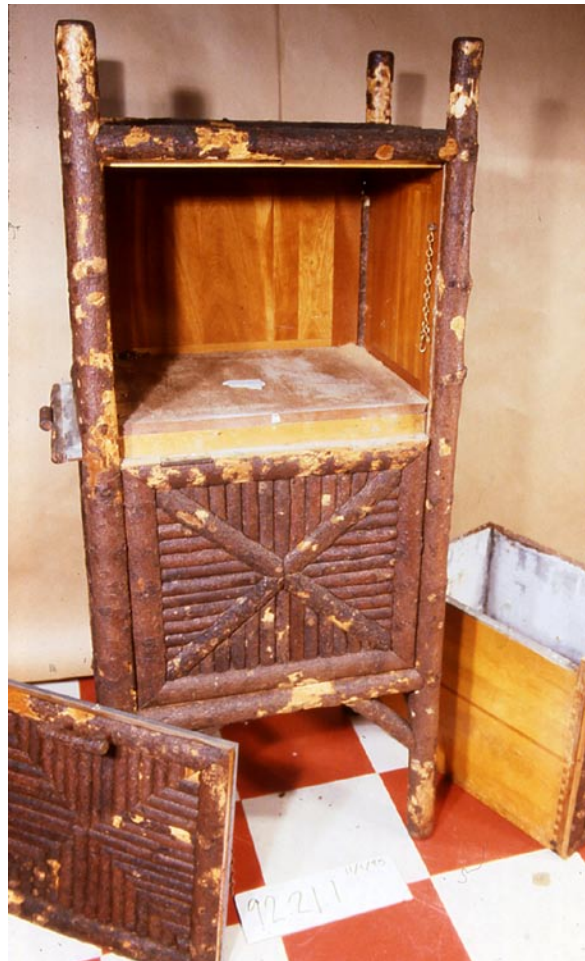
Figure 7. Rustic cellarette with upper door removed, showing numerous bark losses before treatment.

A rustic cellarette (fig. 7) made of unpeeled spruce poles had a prior (now inactive) infestation of powder post beetles resulting in large areas of powdery frass and areas of bark that were not attached securely. Numerous bark losses left the light-colored frass or bare wood visible. It required consolidation, followed by visual compensation of bark loss so it could be exhibited.

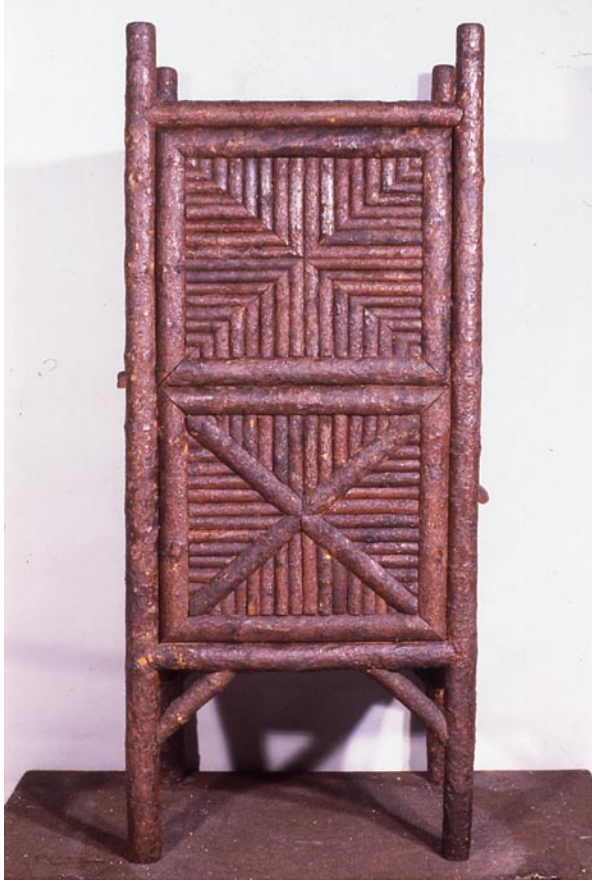
Figure 8. Rustic cellarette, after treatment.

The frass beneath the bark was consolidated using B-98 in ethanol with repeated application by syringe until the remaining bark was securely at-

tached. (fig. 8) Losses were filled with a homemade material made of shredded rag paper, microballoons, and ground pigment in 35% B-72 in 50/50 acetone/ethanol. When applied with a spatula, the resulting surface satisfactorily matched the texture of the surrounding bark. It was inpainted to blend with the natural color variations in the surrounding bark. This technique can be adapted for different colors and textures of bark, including bark with a fibrous nature such as cedar.

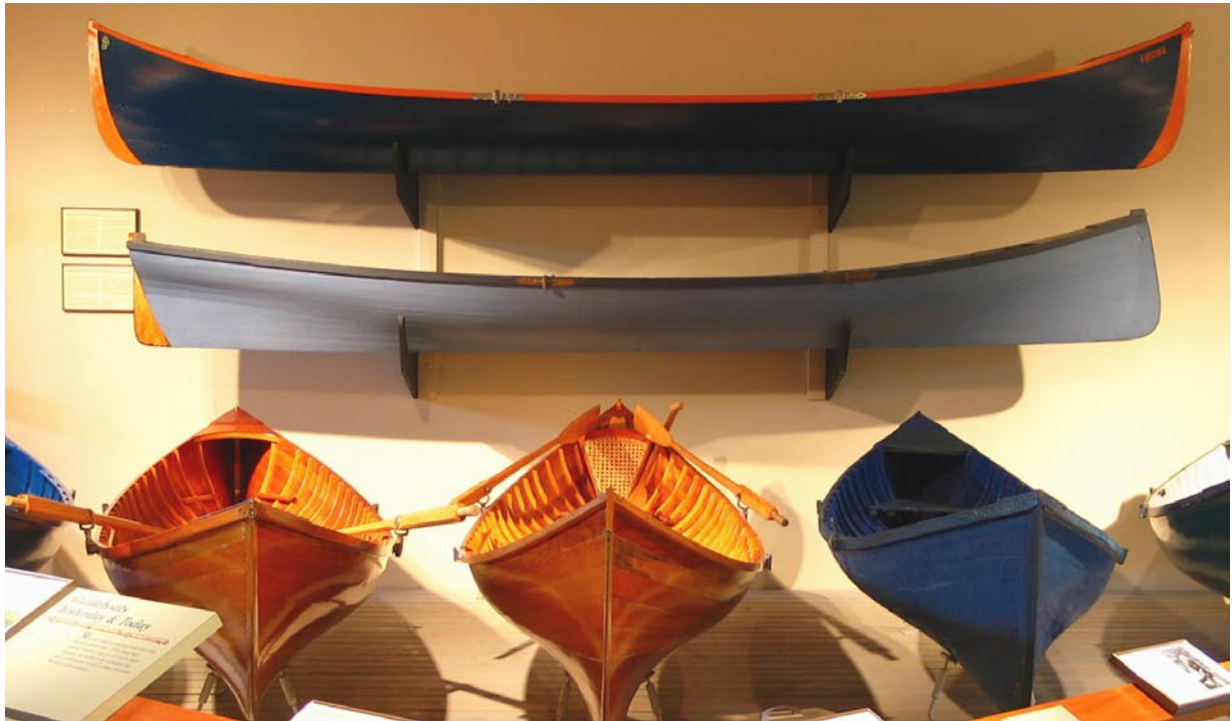
Figure 9. Guideboats on exhibit at the Adirondack Museum: the graceful, lightweight rowing craft can carry large loads swiftly and easily.

The guideboat is a highly refined, smooth-skinned rowboat that is extraordinarily lightweight, capacious, and fast. (fig. 9) It is elegant looking, with a distinctive profile that curves gracefully from a high stem down and out at the center and up again to a high stern. The development of this specialized regional watercraft was influenced by the ruggedness of the terrain, the lack of good roads, and the availability of waterways.

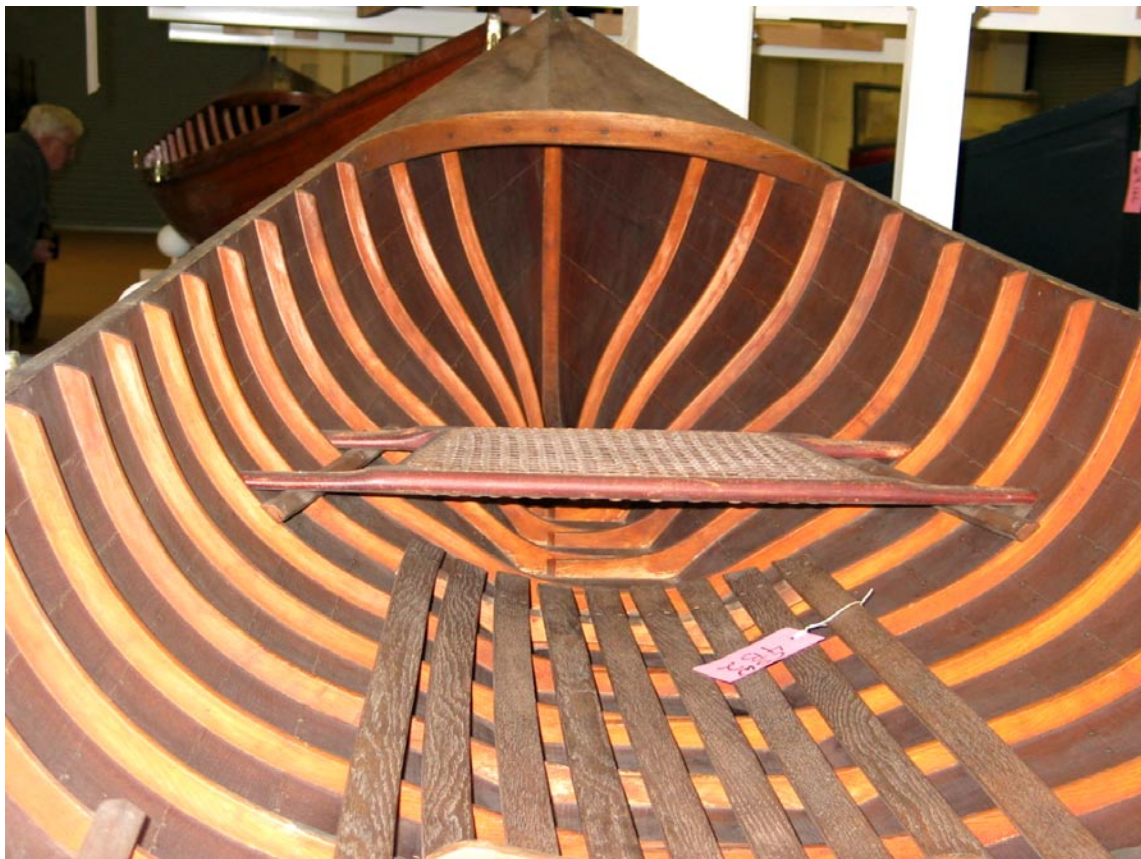
Figure 10. Interior of a guideboat, showing the flat bottom, sawn spruce ribs, and complex curves.

Ribs are sawn from the naturally curving root of a spruce tree. (fig. 10) Root wood is denser and stronger than ordinary lumber and can therefore be

cut to finer dimensions, saving weight. The builder tries to match the curve of the grain to the pattern of the rib. The stiffness of the ribs supports the sides of the boat, making cross braces or thwarts unnecessary, and is another key to its lightness.
