# Mid-Century Frank Lloyd Wright: Preserving the Price Tower and Gordon House Interiors

*Pamela Kirschmer, Conservator, Fine Art Conservation, Waterford, New York*

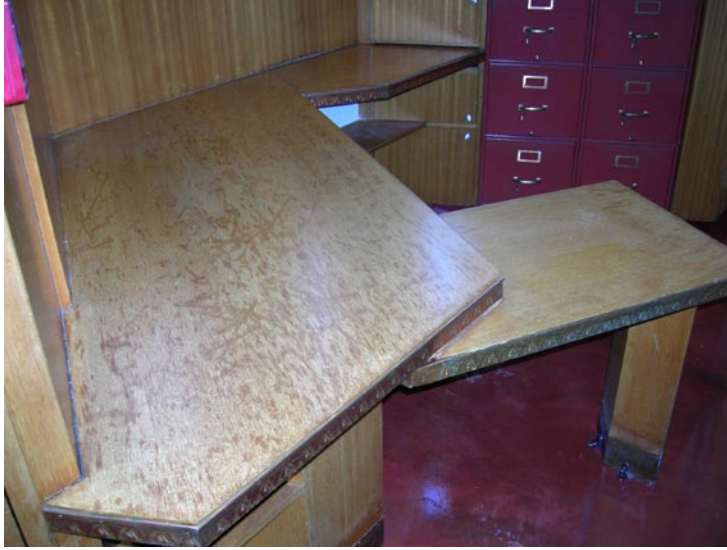
The clear finish found in the Price office has faded and cracked, with lifting in some areas. It appears that there have been attempts at consolidation and some areas have been refinished. Ultraviolet light is the leading cause of degradation for modern plastic materials.<sup>16</sup> Thermal degradation will occur from exposure to visible and long-wave ultraviolet light causing nitrate groups to break off.<sup>17</sup> Photochemical absorption of UV light reduces the viscosity and length of the molecules causing yellowing, embrittlement and softening. Humidity changes can also cause degradation. The cellulose nitrate absorbs moisture readily, causing hydrolysis. The finish shrinks and cracks and is unable to expand and contract as the wood changes dimensionally in response to fluctuations in relative humidity.<sup>18</sup> In the office, the finish and the wood itself have

Figure 3. Price Tower secretary's office, 19th floor, before treatment.

bleached due to light exposure. Low humidity, low temperature and continual air exchange as well as UV filters are recommended to preserve cellulose nitrate finishes and natural colorants in wood. Other areas of the interior, as well as freestanding furniture, appear darker. This may be due to refinishing or from the oils used as plasticizers in the finish that can darken with age and exposure to humidity changes. In the dark, cellulose nitrate can decompose releasing acidic nitrogen dioxide. This accelerates as acidic products accumulate and aids in further hydrolysis of nitrate as well as the cellulose chains themselves.<sup>19</sup> Desks from Price Tower that were kept in a barn at Starview Farm, the property where Carolyn and Harold Price Jr.’s home was located as well as residences for the Price Srs.’ and their son Joe, had been exposed to extreme environmental changes. They are quite dark, but they appear to have their original finish.

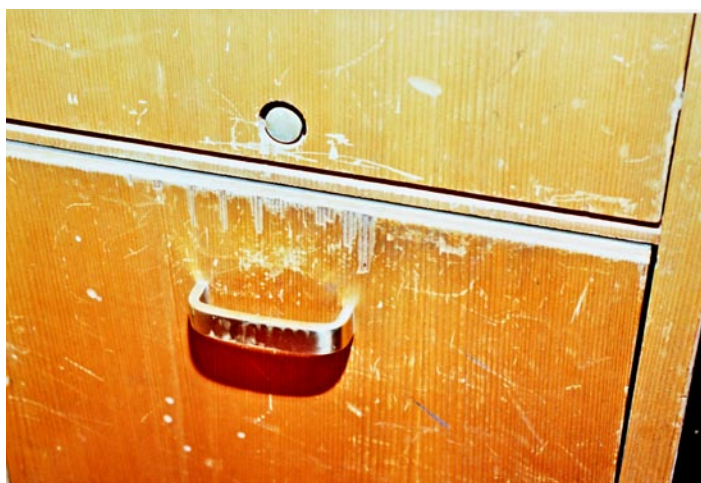
Figure 4. Gordon House filing cabinet showing worn area where finish sample was taken.

1. A finish sample was removed from the filing cabinet (fig. 4). The results of the analysis reveal the presence of cellulose nitrate modified with an acrylic.
2. A finish sample was removed from the office door. The results are similar to the filing cabinet; cellulose nitrate and acrylic.
3. A finish sample was removed from the office shelves. The results also include cellulose nitrate and acrylic along with the presence of a wax.
4. A finish sample was removed from the refrigerator paneling. The results from this sample include cellulose nitrate and acrylic along with wax as found in the other samples.

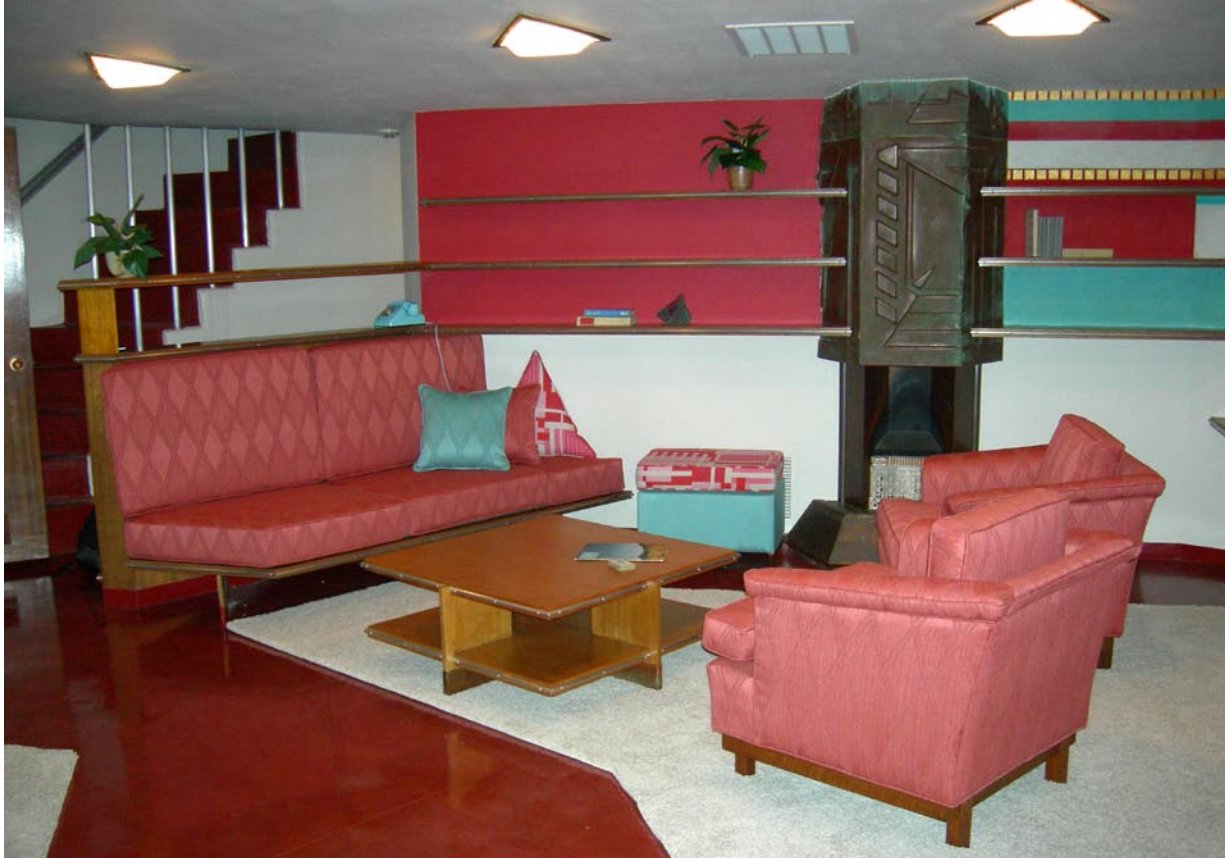
Figure 5. Price Tower apartment living area on the 17th floor after 2006 restoration.

A drawing, FLWF #5215.126 in the Frank Lloyd Wright archives, shows an interior perspective drawing of a typical apartment first floor. Notations include numbers of pieces of furniture: six hassocks, six dining room chairs, two upholstered arm chairs, one table, one desk chair, one built-in desk, one built-in seat, three shelves along the south wall and three shelves along east wall. There are 1954 plans #5215.126 in the Taliesin archives for the dining table and hassocks. An August 10th letter states "All 64 hassocks are completed as designed and approved." Two drawings, #5215.185 and #5215.186, depict the interior of a "typical" two-level apartment. This shows the shelves, dining table, built-in sofa desk and coffee table with a half round aluminum strip 5/8" wide and 5/16" thick.<sup>35</sup> (fig. 5)

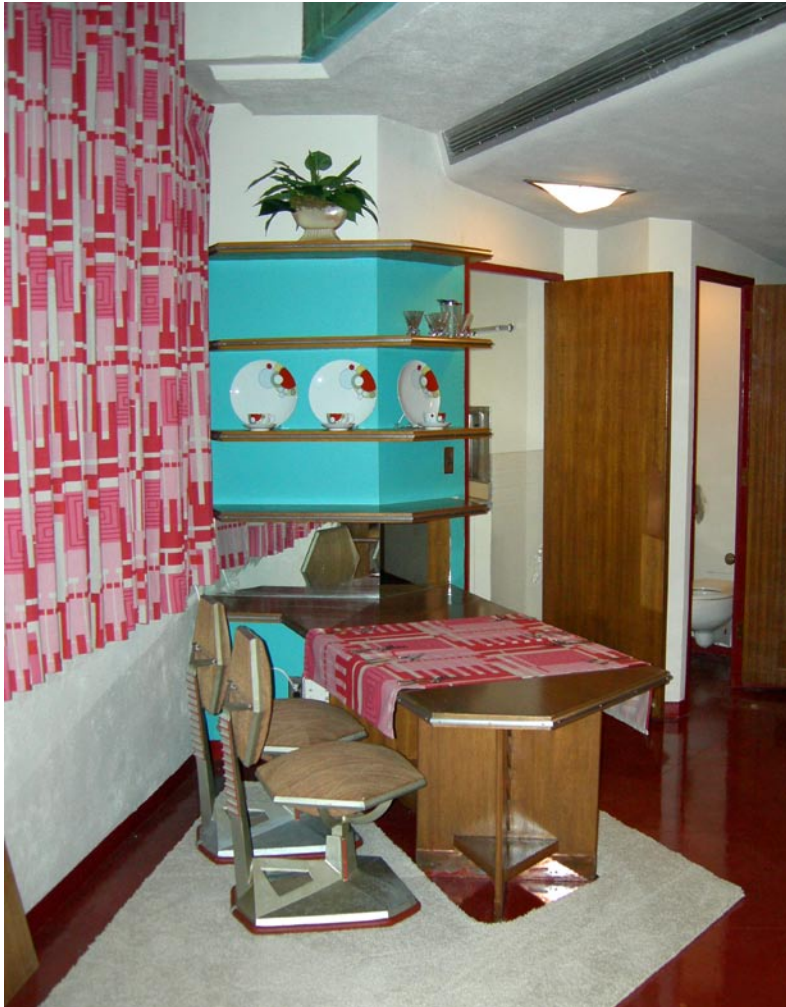
Figure 6. Price Tower Dining Room table and shelves on the 17th floor after 2006 restoration.

Shelves have been removed as well. These include shelves above the dining table and the shelves in the bedroom. The semicircular shelf and mirror originally attached to the mural have also been removed. The shelves under the window appear to be original, with replacement veneer attached to the tops and edges. The missing shelves on the 17th floor have now all been replicated based on photographs and physical evidence. (fig. 6)

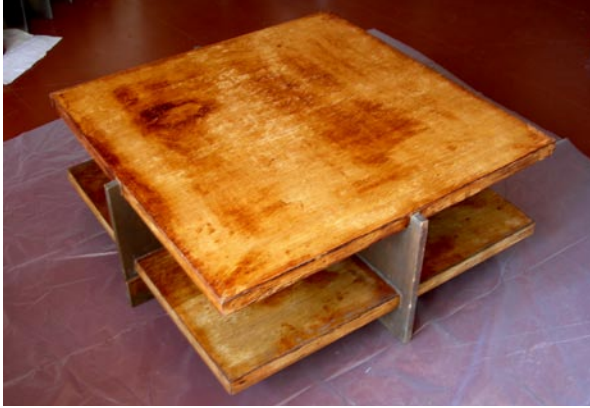
Figure 7. (left) Price Tower coffee table after the plastic laminate was removed revealing contact cement on the original Philippine mahogany veneer, before treatment.

There were some scratches and dings from use around hardware and on tops of tables and shelves. Some areas of veneer had become detached or were loose. The plastic laminate on the coffee table was removed and the original veneer remained. It was buckling and lifting off on the lower shelves.

on some items. The plastic laminate on the coffee table was removed to reveal a large amount of contact cement on the surface. The vertical boards had been colored to match the laminate using an oil-based stain.

There are construction drawings for this table in the Frank Lloyd Wright Foundation Archives.<sup>36</sup> Currently there are two coffee tables known to exist. One is in the collection of Carolyn Price with a slate top and one is in the Goff collection at the Price Tower. This table was covered in plastic wood grain laminate. Removal of the laminate revealed holes where aluminum trim had been attached previously and two of the copper sleeves for the feet were missing (figs. 7 and 8).

The coffee table in the collection required the use of acetone and mineral spirits to remove the contact cement that remained after the removal of the plastic laminate. The stain on the vertical boards was removed using Citristrip paint remover, wiped off and then cleared using mineral spirits. A considerable amount of the original finish remained. A barrier layer of Regal-Rez (with an elastomer Kraton G1650 and a light stabilizer Tinuvin 292 added) was applied along with thin layers of shellac to build up any areas of loss.

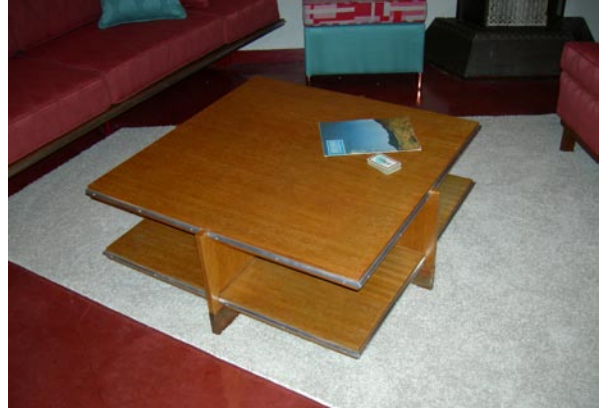
Figure 8. (right) Price Tower coffee table placed in the apartment living area on the 17th floor, after treatment.

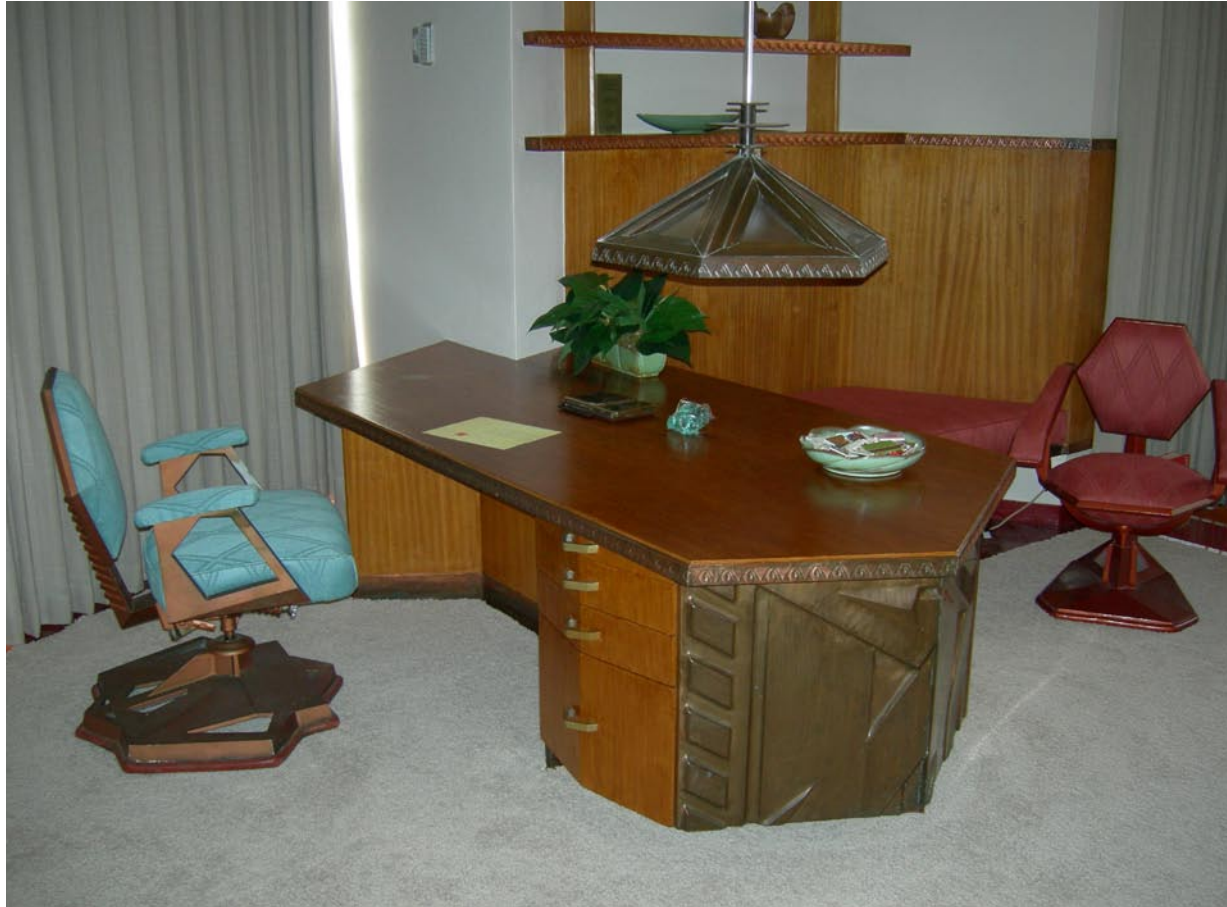
Figure 9. Price Tower executive office on the 19th floor, after treatment.

The furniture and shelves have matching copper trim. The desk also has a copper panel similar to the copper panels on the exterior, but smaller. A wood-burning fireplace hood made of patinated copper is in the office. It is considerably larger than the gas-burning fireplaces created for the apartments.

As mentioned earlier, the finish on the wooden panels and furniture has been bleached by the sun and is flaking. Areas of the surfaces appear to have been refinished or finish was added to consolidate the original flaking finish. The top of the door on the corner cabinet is believed to have retained original finish (see Analysis section). The sofa cushion retained may have the original foam interior with replacement orange leather or Naugahyde upholstery. There is a tear in the cover showing a brown highly degraded foam cushion that has stiffened and easily crumbles into a powder. This is characteristic of degraded latex foam, a material used for upholstery padding in the 1950s.<sup>37</sup>

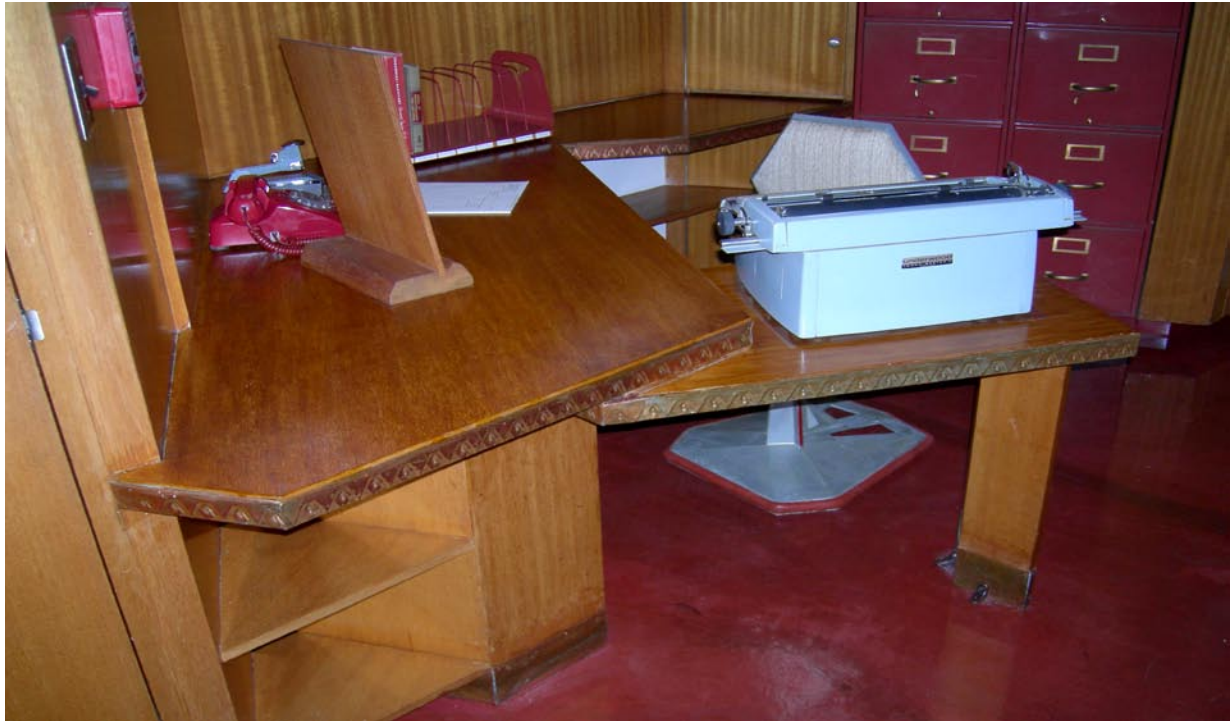
Figure 10. Price Tower secretary's office on the 19th floor, after treatment.

The secretary's office is a small space that retains its original Philippine mahogany wall paneling that continues across the ceiling (fig. 10). There is a built in desk, cabinets and shelves with a continuation of the copper trim found in Price's office. Two metal filing cabinets behind the desk in Cherokee red appear to be original. These are surrounded by the mahogany cabinetry.

The finish in this area appeared to be bleached from light exposure. The polyurethane finish found on the desk top (see Analysis section) as well as the dark scratches apparent under the finish indicates that this area has been refinished. The other desk tops also appears to have been refinished. Other areas less exposed to constant wear may retain original cellulose nitrate finish as found in Price's office.
