# Mid-Century Frank Lloyd Wright: Preserving the Price Tower and Gordon House Interiors

*Pamela Kirschner, Conservator, Fine Art Conservation, Waterford, New York*

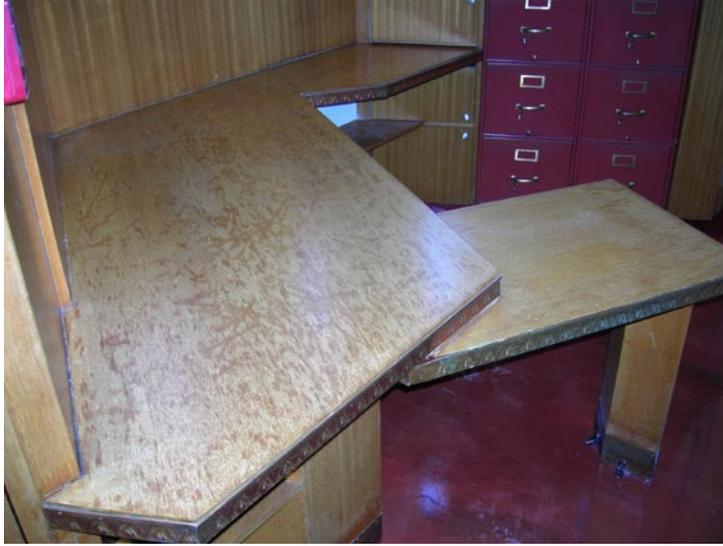
Figure 3. Price Tower secretary's office, 19th floor, before treatment.

The clear finish found in the Price office has faded and cracked, with lifting in some areas. It appears that there have been attempts at consolidation and some areas have been refinished. Ultraviolet light is the leading cause of degradation for modern plastic materials.<sup>16</sup> Thermal degradation will occur from exposure to visible and long-wave ultraviolet light causing nitrate groups to break off.<sup>17</sup> Photochemical absorption of UV light reduces the viscosity and length of the molecules causing yellowing, embrittlement and softening. Humidity changes can also cause degradation. The cellulose nitrate absorbs moisture readily, causing hydrolysis. The finish shrinks and cracks and is unable to expand and contract as the wood changes dimensionally in response to fluctuations in relative humidity.<sup>18</sup> In the office, the finish and the wood itself have

bleached due to light exposure. Low humidity, low temperature and continual air exchange as well as UV filters are recommended to preserve cellulose nitrate finishes and natural colorants in wood. Other areas of the interior, as well as freestanding furniture, appear darker. This may be due to refinishing or from the oils used as plasticizers in the finish that can darken with age and exposure to humidity changes. In the dark, cellulose nitrate can decompose releasing acidic nitrogen dioxide. This accelerates as acidic products accumulate and aids in further hydrolysis of nitrate as well as the cellulose chains themselves.<sup>19</sup> Desks from Price Tower that were kept in a barn at Starview Farm, the property where Carolyn and Harold Price Jr.'s home was located as well as residences for the Price Srs.' and their son Joe, had been exposed to extreme environmental changes. They are quite dark, but they appear to have their original finish.

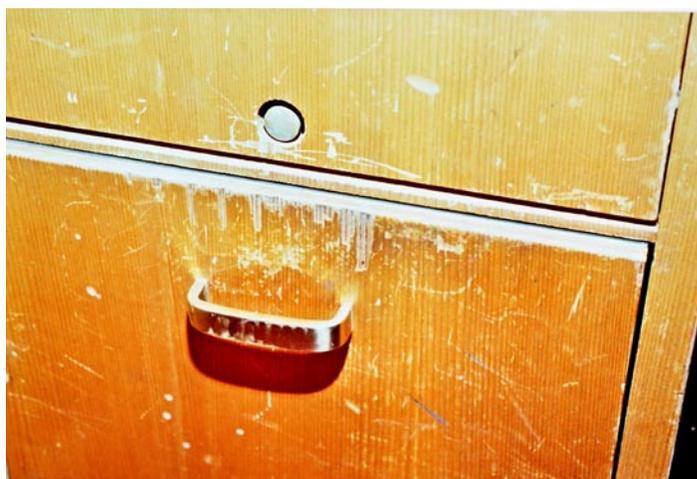
Figure 4. Gordon House filing cabinet showing worn area where finish sample was taken.

1. A finish sample was removed from the filing cabinet (fig. 4). The results of the analysis reveal the presence of cellulose nitrate modified with an acrylic.
2. A finish sample was removed from the office door. The results are similar to the filing cabinet; cellulose nitrate and acrylic.
3. A finish sample was removed from the office shelves. The results also include cellulose nitrate and acrylic along with the presence of a wax.
4. A finish sample was removed from the refrigerator paneling. The results from this sample include cellulose nitrate and acrylic along with wax as found in the other samples.

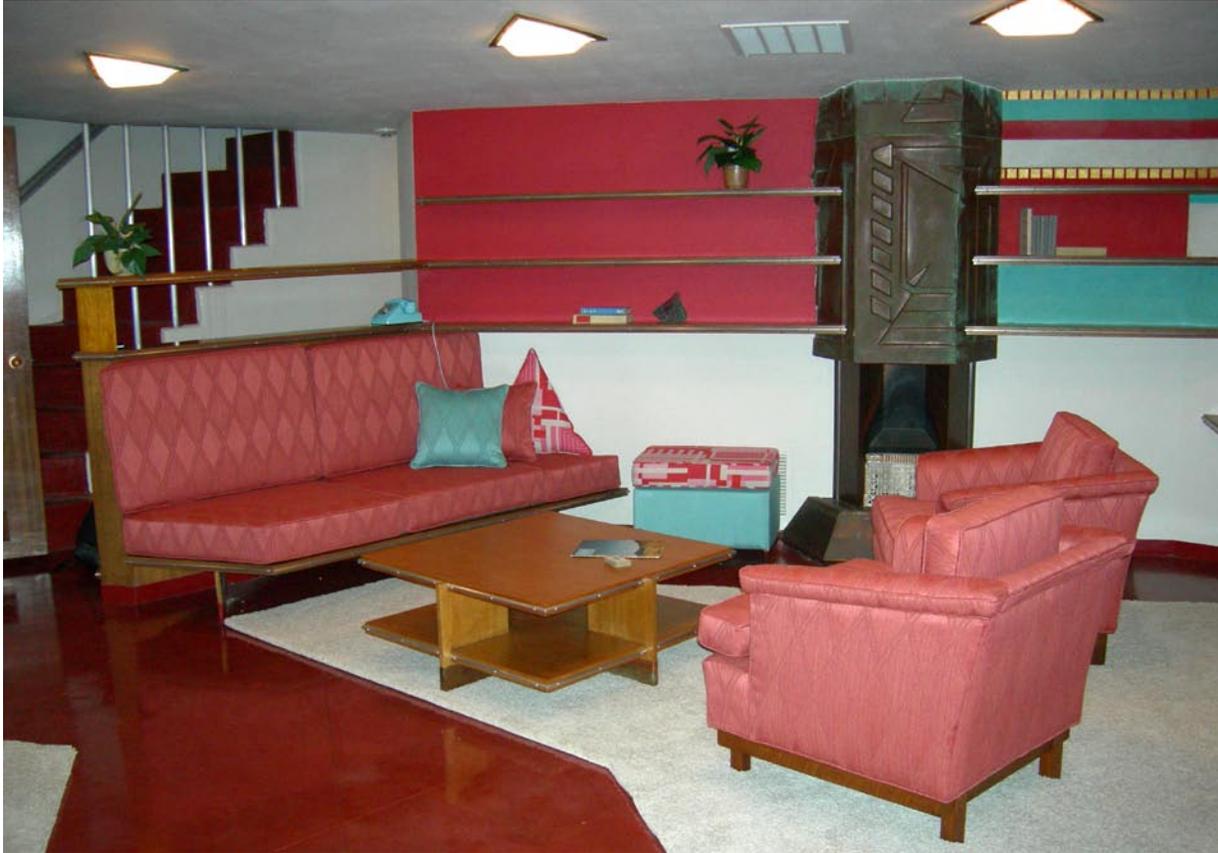
Figure 5. Price Tower apartment living area on the 17th floor after 2006 restoration.

A drawing, FLWF #5215.126 in the Frank Lloyd Wright archives, shows an interior perspective drawing of a typical apartment first floor. Notations include numbers of pieces of furniture: six hassocks, six dining room chairs, two upholstered arm chairs, one table, one desk chair, one built-in desk, one built-in seat, three shelves along the south wall and three shelves along east wall. There are 1954 plans #5215.126 in the Taliesin archives for the dining table and hassocks. An August 10th letter states "All 64 hassocks are completed as designed and approved." Two drawings, #5215.185 and #5215.186, depict the interior of a "typical" two-level apartment. This shows the shelves, dining table, built-in sofa desk and coffee table with a half round aluminum strip 5/8" wide and 5/16" thick.<sup>35</sup> (fig. 5)

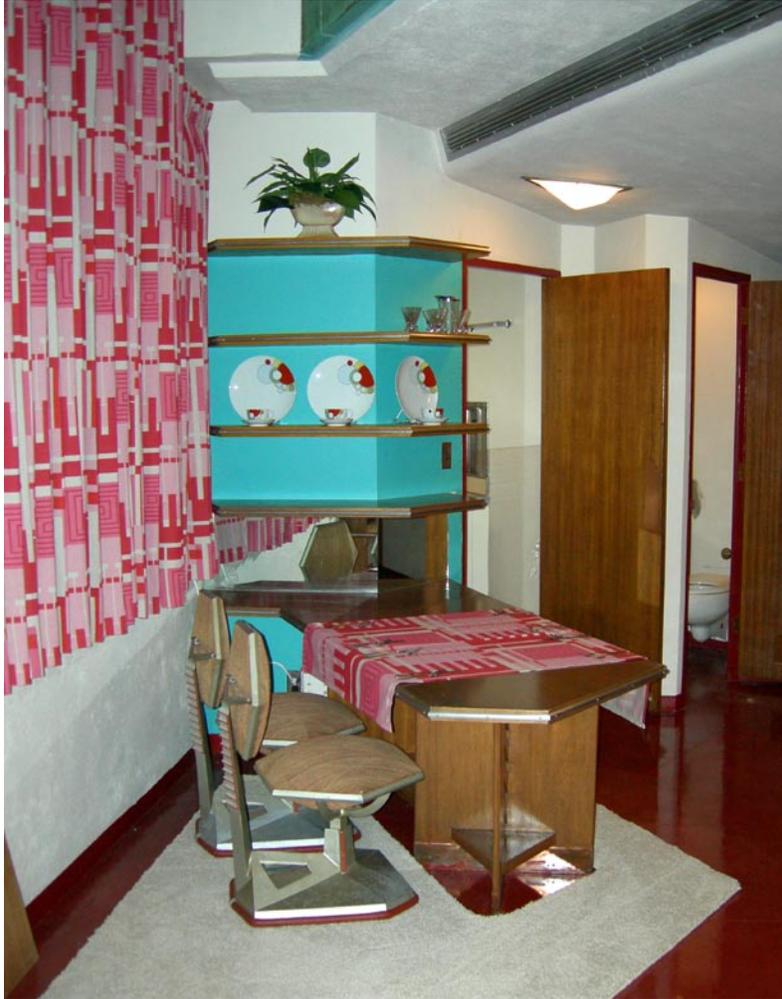
Figure 6. Price Tower Dining Room table and shelves on the 17th floor after 2006 restoration.

Shelves have been removed as well. These include shelves above the dining table and the shelves in the bedroom. The semicircular shelf and mirror originally attached to the mural have also been removed. The shelves under the window appear to be original, with replacement veneer attached to the tops and edges. The missing shelves on the 17th floor have now all been replicated based on photographs and physical evidence. (fig. 6)

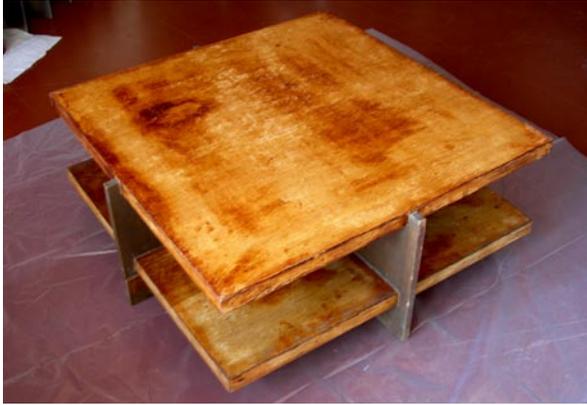
Figure 7. (left) Price Tower coffee table after the plastic laminate was removed revealing contact cement on the original Philippine mahogany veneer, before treatment.

There were some scratches and dings from use around hardware and on tops of tables and shelves. Some areas of veneer had become detached or were loose. The plastic laminate on the coffee table was removed and the original veneer remained. It was buckling and lifting off on the lower shelves.

on some items. The plastic laminate on the coffee table was removed to reveal a large amount of contact cement on the surface. The vertical boards had been colored to match the laminate using an oil-based stain.

There are construction drawings for this table in the Frank Lloyd Wright Foundation Archives.<sup>36</sup> Currently there are two coffee tables known to exist. One is in the collection of Carolyn Price with a slate top and one is in the Goff collection at the Price Tower. This table was covered in plastic wood grain laminate. Removal of the laminate revealed holes where aluminum trim had been attached previously and two of the copper sleeves for the feet were missing (figs. 7 and 8).

The coffee table in the collection required the use of acetone and mineral spirits to remove the contact cement that remained after the removal of the plastic laminate. The stain on the vertical boards was removed using Citristrip paint remover, wiped off and then cleared using mineral spirits. A considerable amount of the original finish remained. A barrier layer of Regal-Rez (with an elastomer Kraton G1650 and a light stabilizer Tinuvin 292 added) was applied along with thin layers of shellac to build up any areas of loss.

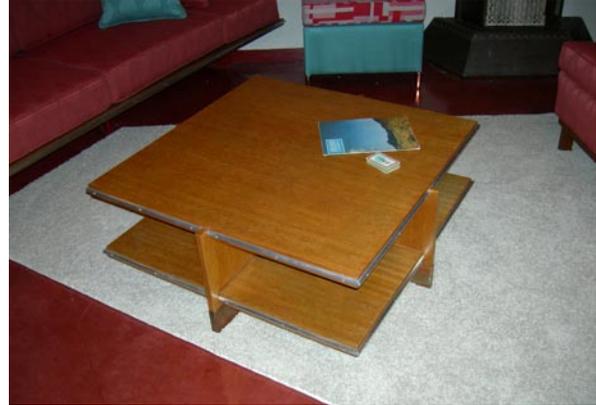
Figure 8. (right) Price Tower coffee table placed in the apartment living area on the 17th floor, after treatment.

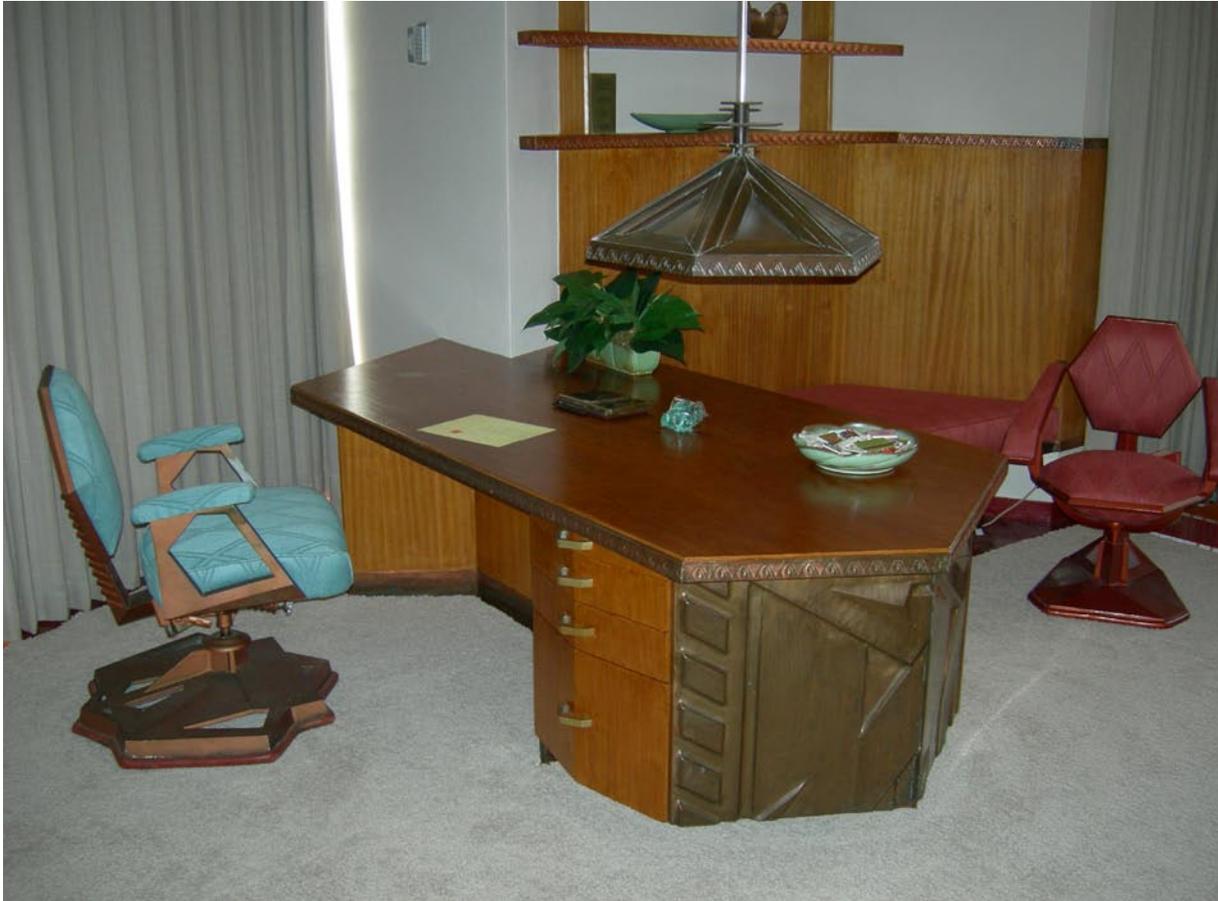
Figure 9. Price Tower executive office on the 19th floor, after treatment.

The furniture and shelves have matching copper trim. The desk also has a copper panel similar to the copper panels on the exterior, but smaller. A wood-burning fireplace hood made of patinated copper is in the office. It is considerably larger than the gas-burning fireplaces created for the apartments.

As mentioned earlier, the finish on the wooden panels and furniture has been bleached by the sun and is flaking. Areas of the surfaces appear to have been refinished or finish was added to consolidate the original flaking finish. The top of the door on the corner cabinet is believed to have retained original finish (see Analysis section). The sofa cushion retained may have the original foam interior with replacement orange leather or Naugahyde upholstery. There is a tear in the cover showing a brown highly degraded foam cushion that has stiffened and easily crumbles into a powder. This is characteristic of degraded latex foam, a material used for upholstery padding in the 1950s.<sup>37</sup>

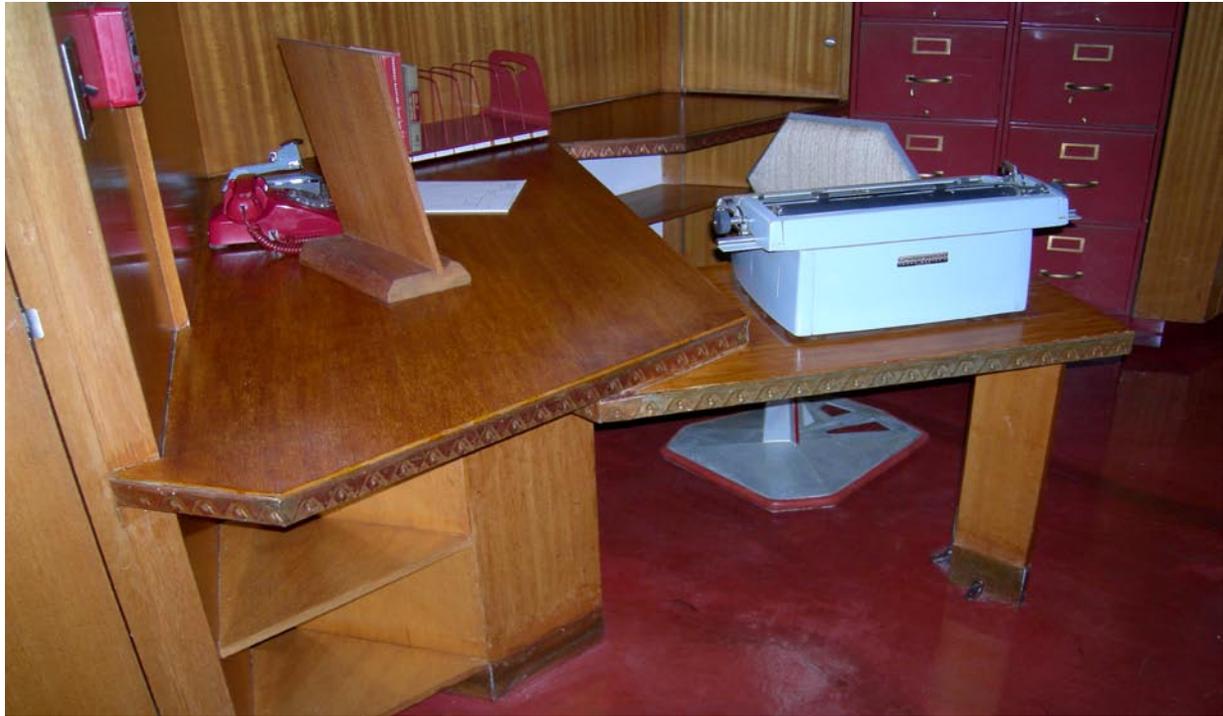
Figure 10. Price Tower secretary's office on the 19th floor, after treatment.

The secretary's office is a small space that retains its original Philippine mahogany wall paneling that continues across the ceiling (fig. 10). There is a built in desk, cabinets and shelves with a continuation of the copper trim found in Price's office. Two metal filing cabinets behind the desk in Cherokee red appear to be original. These are surrounded by the mahogany cabinetry.

The finish in this area appeared to be bleached from light exposure. The polyurethane finish found on the desk top (see Analysis section) as well as the dark scratches apparent under the finish indicates that this area has been refinished. The other desk tops also appears to have been refinished. Other areas less exposed to constant wear may retain original cellulose nitrate finish as found in Price's office.
